MEMORANDUM
Department of Ecology
P. O. Box 829
OLYMPIA, WASHINGTON
98504

Publication No. 72-e05

SUBJECT: Borden Chemical Company-Kent

TO: Pete Hildebrandt, Ron Pine, Bob McCormick & Files ✓
FROM: Stew Messman
SUBJECT: Survey Scoping - Borden Chemical Company
421 First Avenue North
Kent
DATE: January 11, 1972

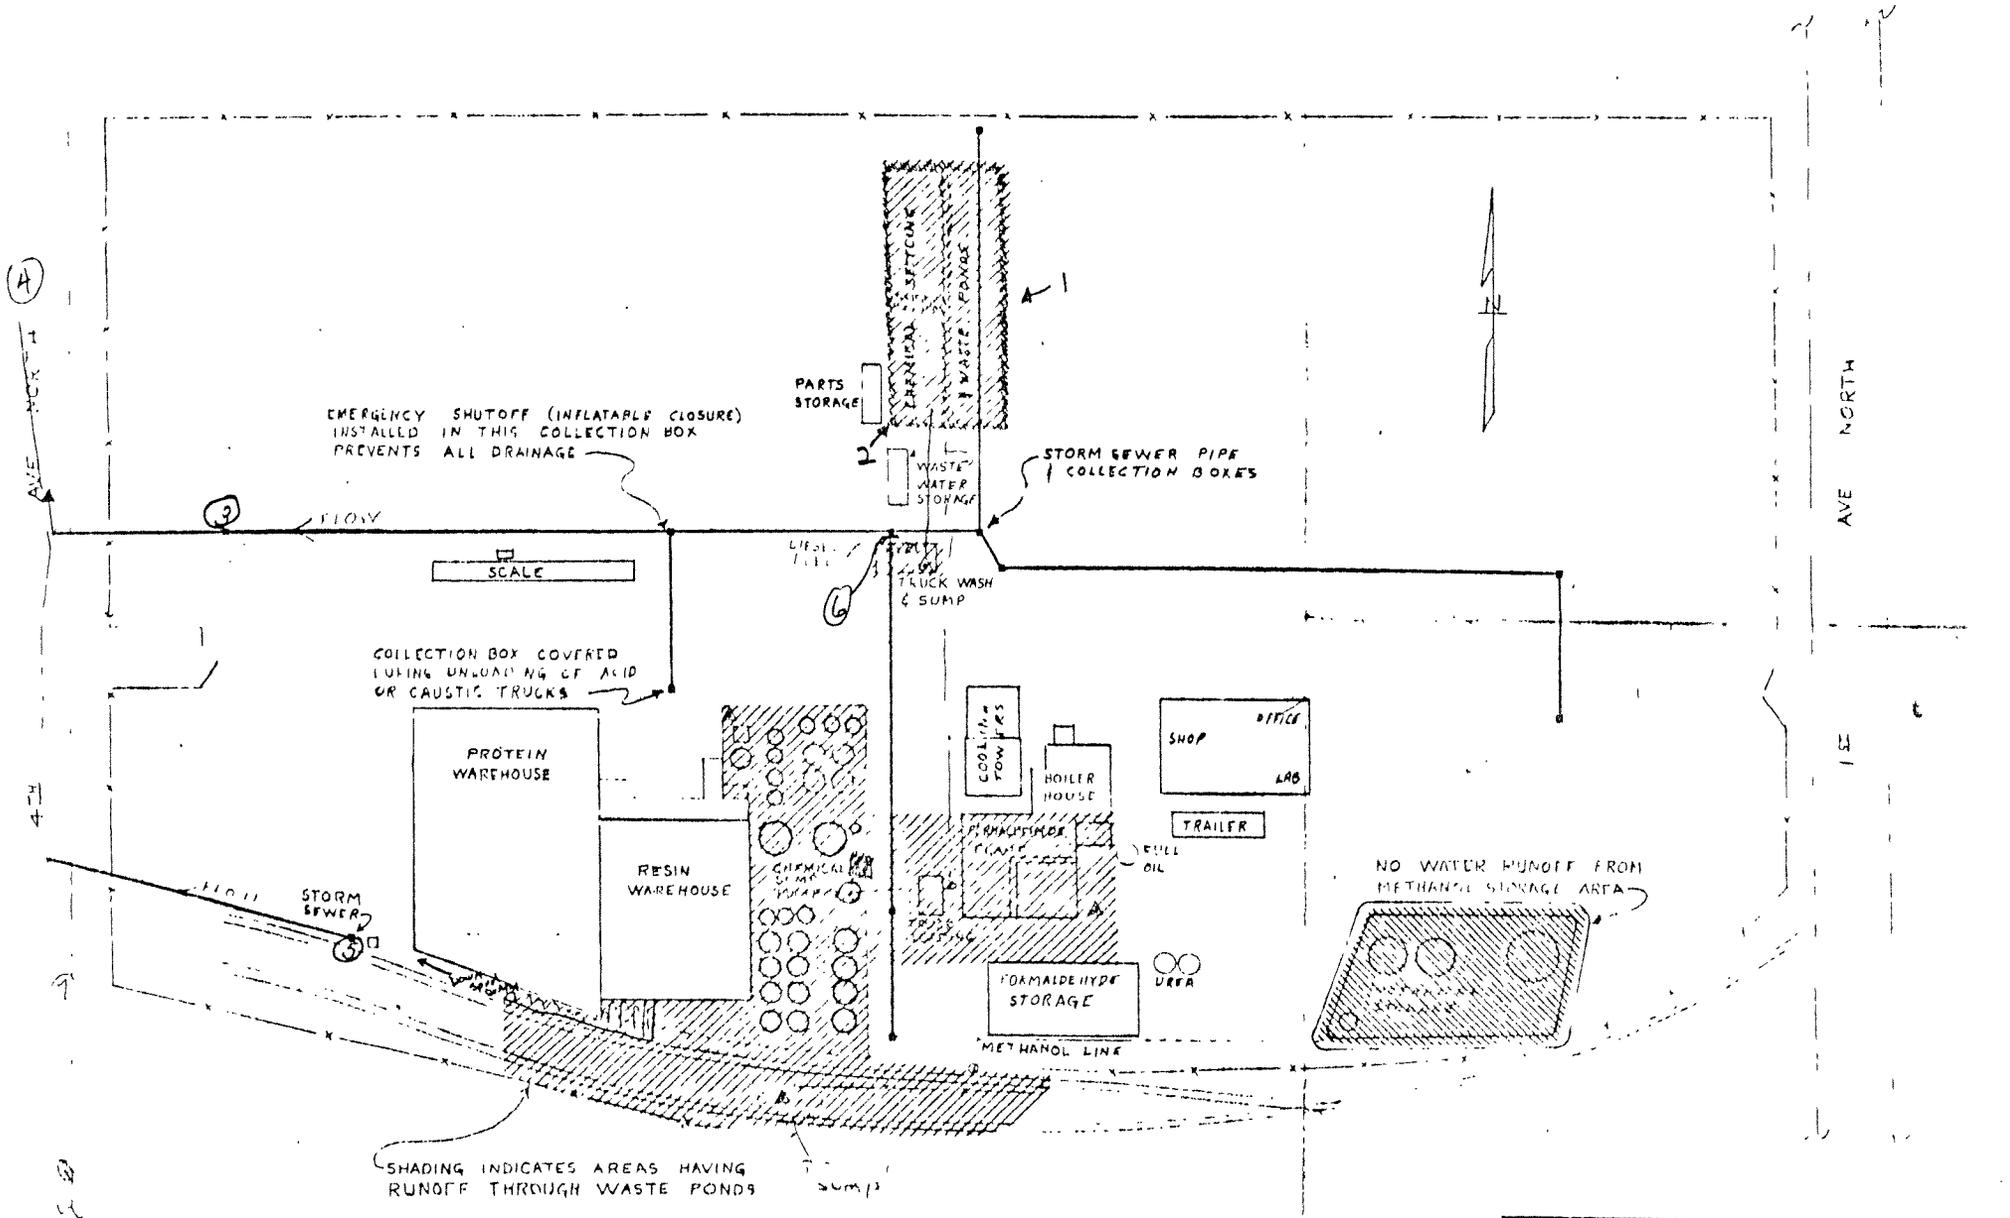
BORDEN CHEMICAL, INC. KEY		
SCALE 1" = 50'	APPROVED BY	DRAWN BY J. F. 4/27
DATE OCT 16, 51	REVISIONS	
SITE DRAINAGE PLAN

Scott Jeane sampled the Storm Sewer. Stations 3, 5 and 6 were located as designated by the attached map. Data obtained from field and laboratory analyses are attached on Data Report Form No. 1. While sampling Station 6, there was a large increase in flow, thought to be associated with a cooling water discharge. Station No. 4 was not sampled. It is doubtful that the city storm sewer trunk or lateral system flows as indicated by the map.

EMERGENCY SHUTOFF (INFLATABLE CLOSURE)
 INSTALLED IN THIS COLLECTION BOX
 PREVENTS ALL DRAINAGE

COLLECTION BOX COVERED
 DURING UNLOADING OF ACID
 OR CAUSTIC TRUCKS

NO WATER RUNOFF FROM
 METHANOL STORAGE AREA

SHADING INDICATES AREAS HAVING
 RUNOFF THROUGH WASTE PONDS
