August 11, 1972

Publication No. 72-e11

MEMO TO: S. A. Messman
FROM: Ron Devitt
SUBJECT: Re: Boise Creek Survey

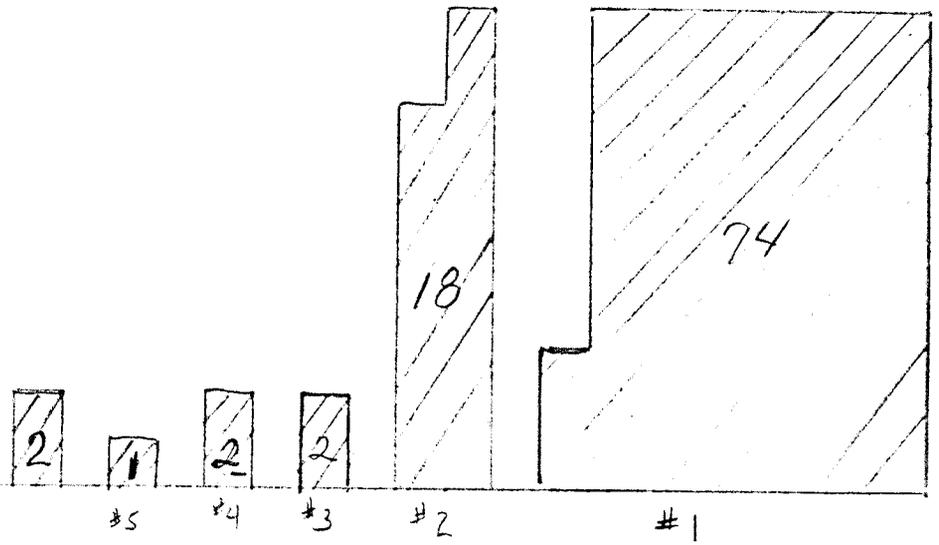
Sta. #
3

Groups # 5, 6, 7 in Sta. # 2A are identical to Group # 4, 5, 8 in Sta. # 3.

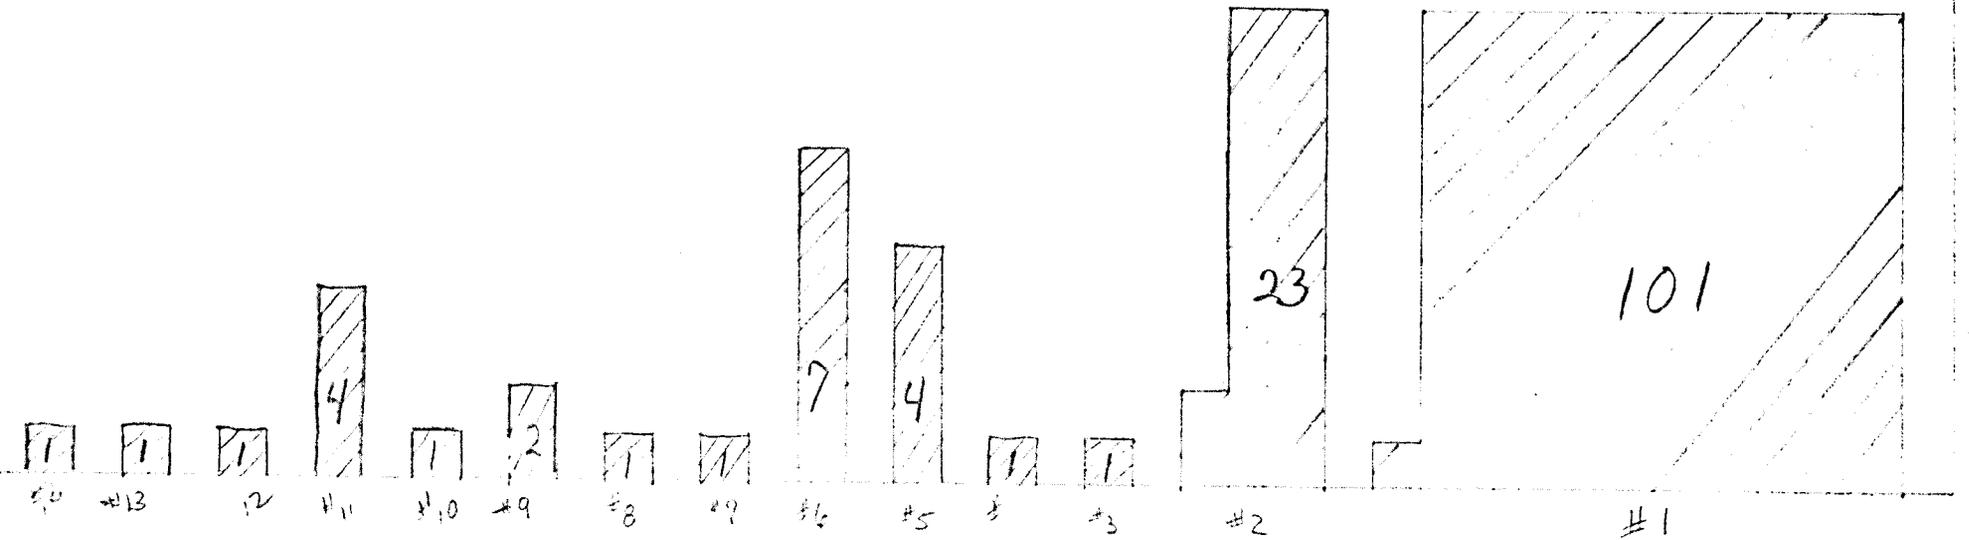
Sta. #
2A

The insect population was very diverse; the biomass was much greater than other stations. This is probably due to the enriched condition created by the log pond effluent. The dark color typical of the pond effluent was obvious. Mixing of effluent and creek not complete at this point.
