Publication No. 73-e40

MEMO TO: Bill Burwell
FROM: Ron Devitt *Red*
SUBJECT: Ace Galvanizing & Advance Electroplating

State of
Washington
Department
of Ecology

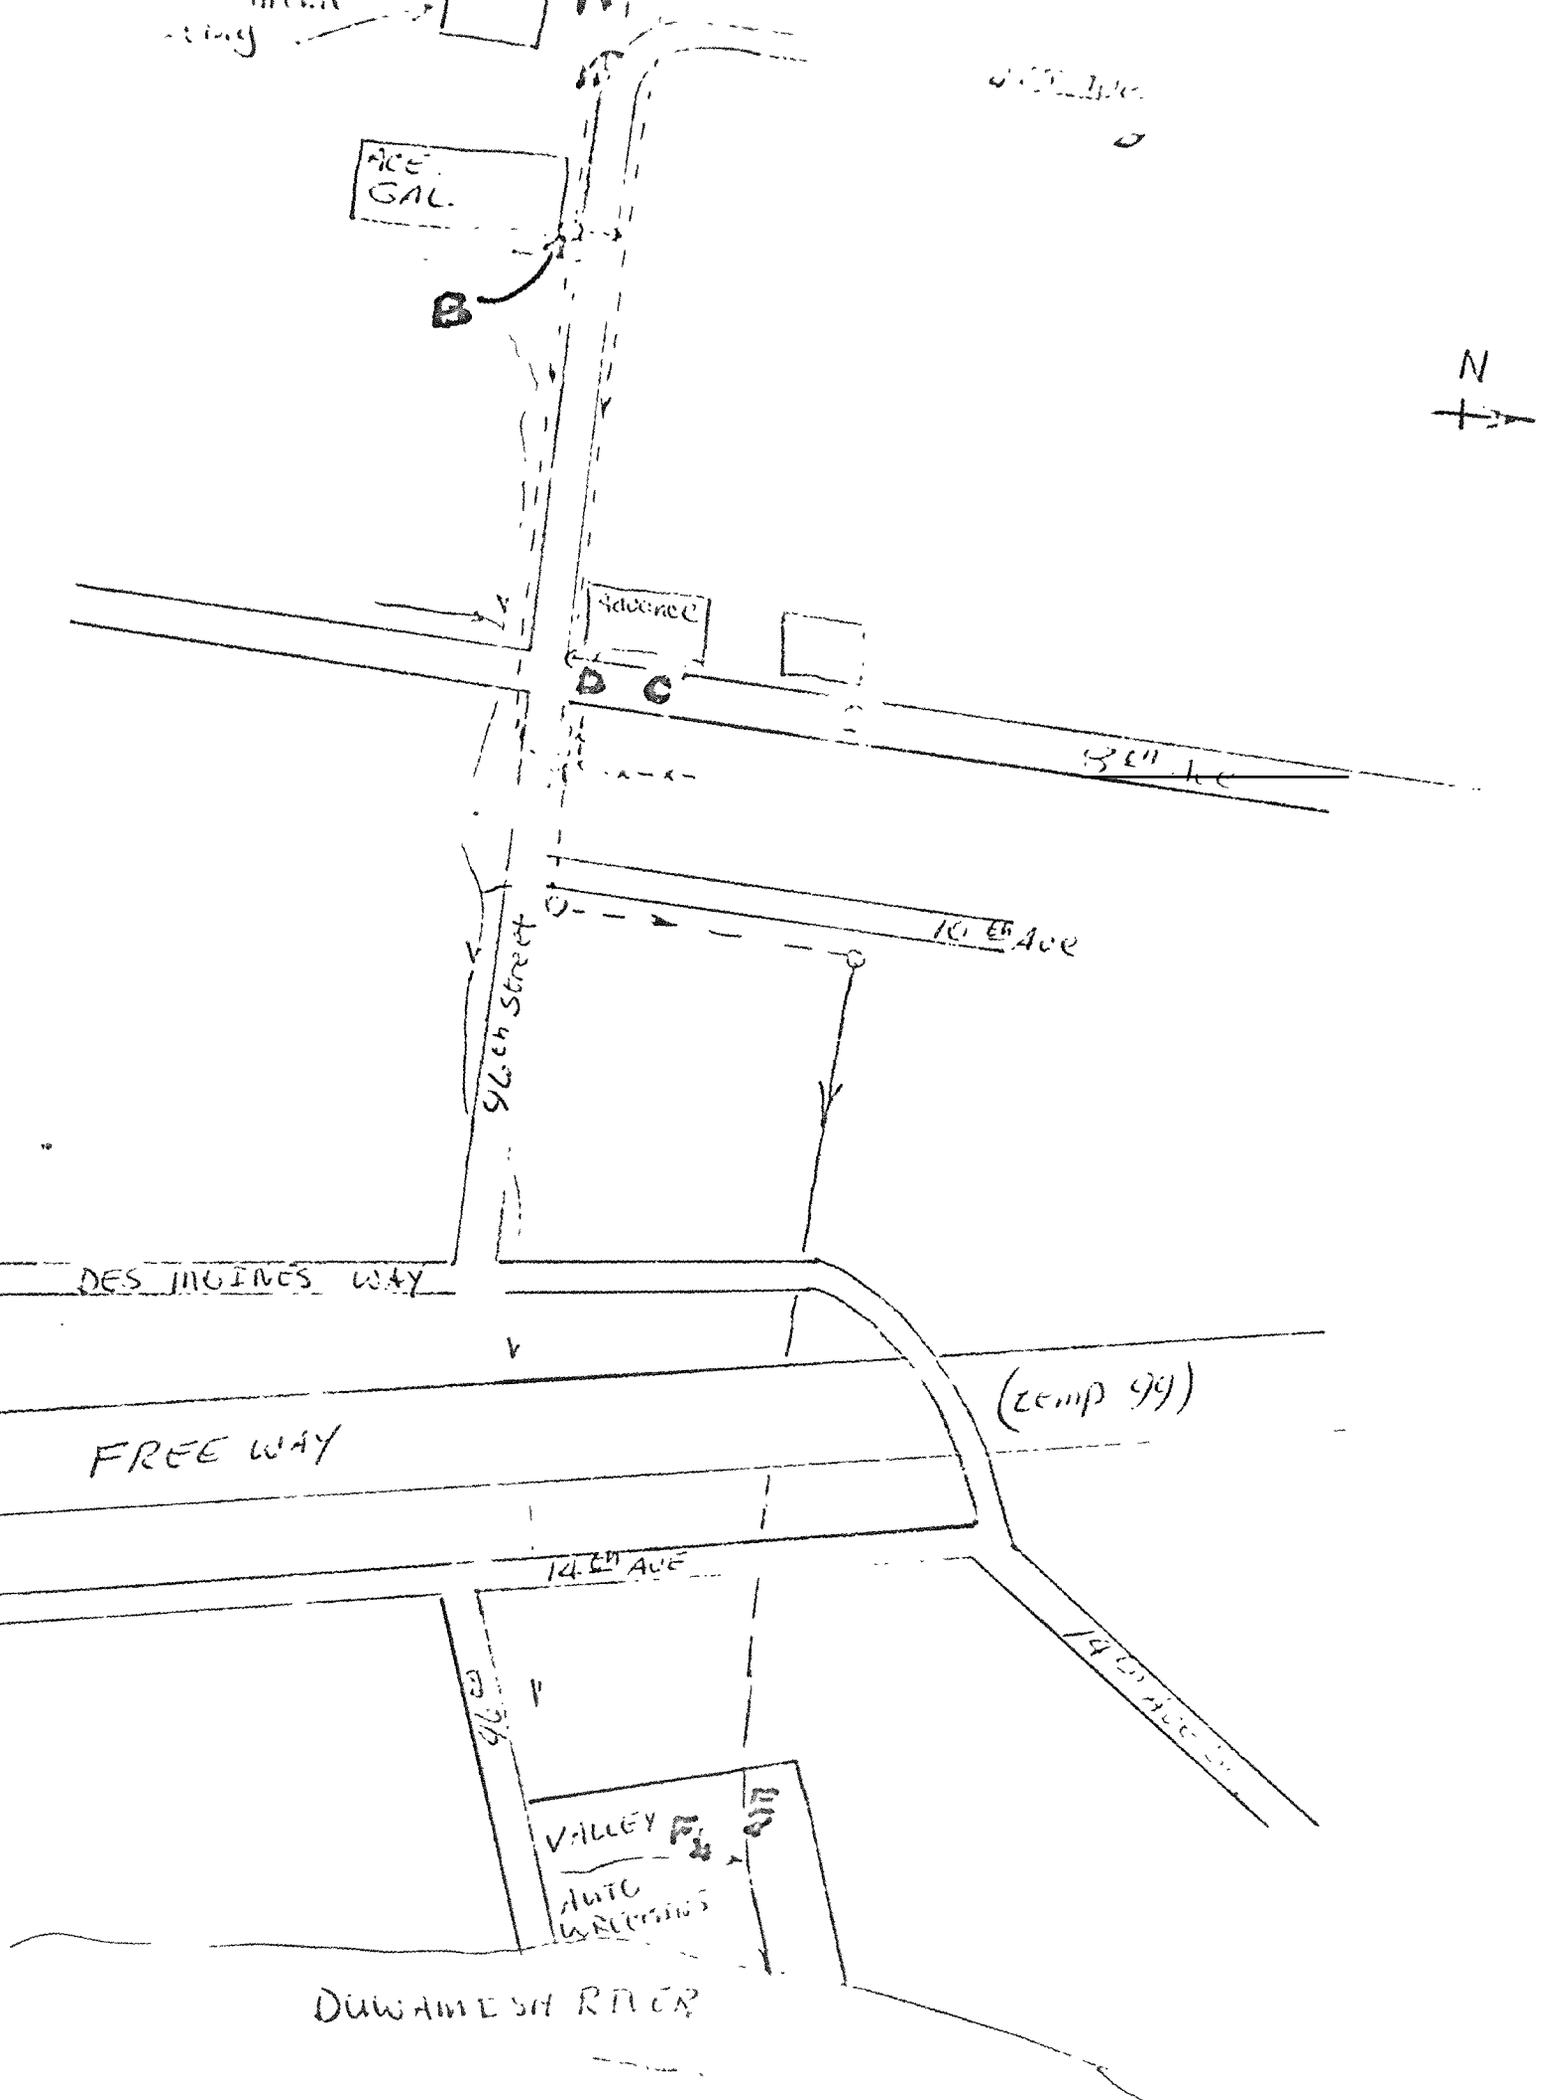
The following sampling locations were sampled as indicated by the attached schematic diagram:
