KILISUT HARBOR REPORT

Allen W. Moore

Washington State Department of Ecology

September 25, 1975

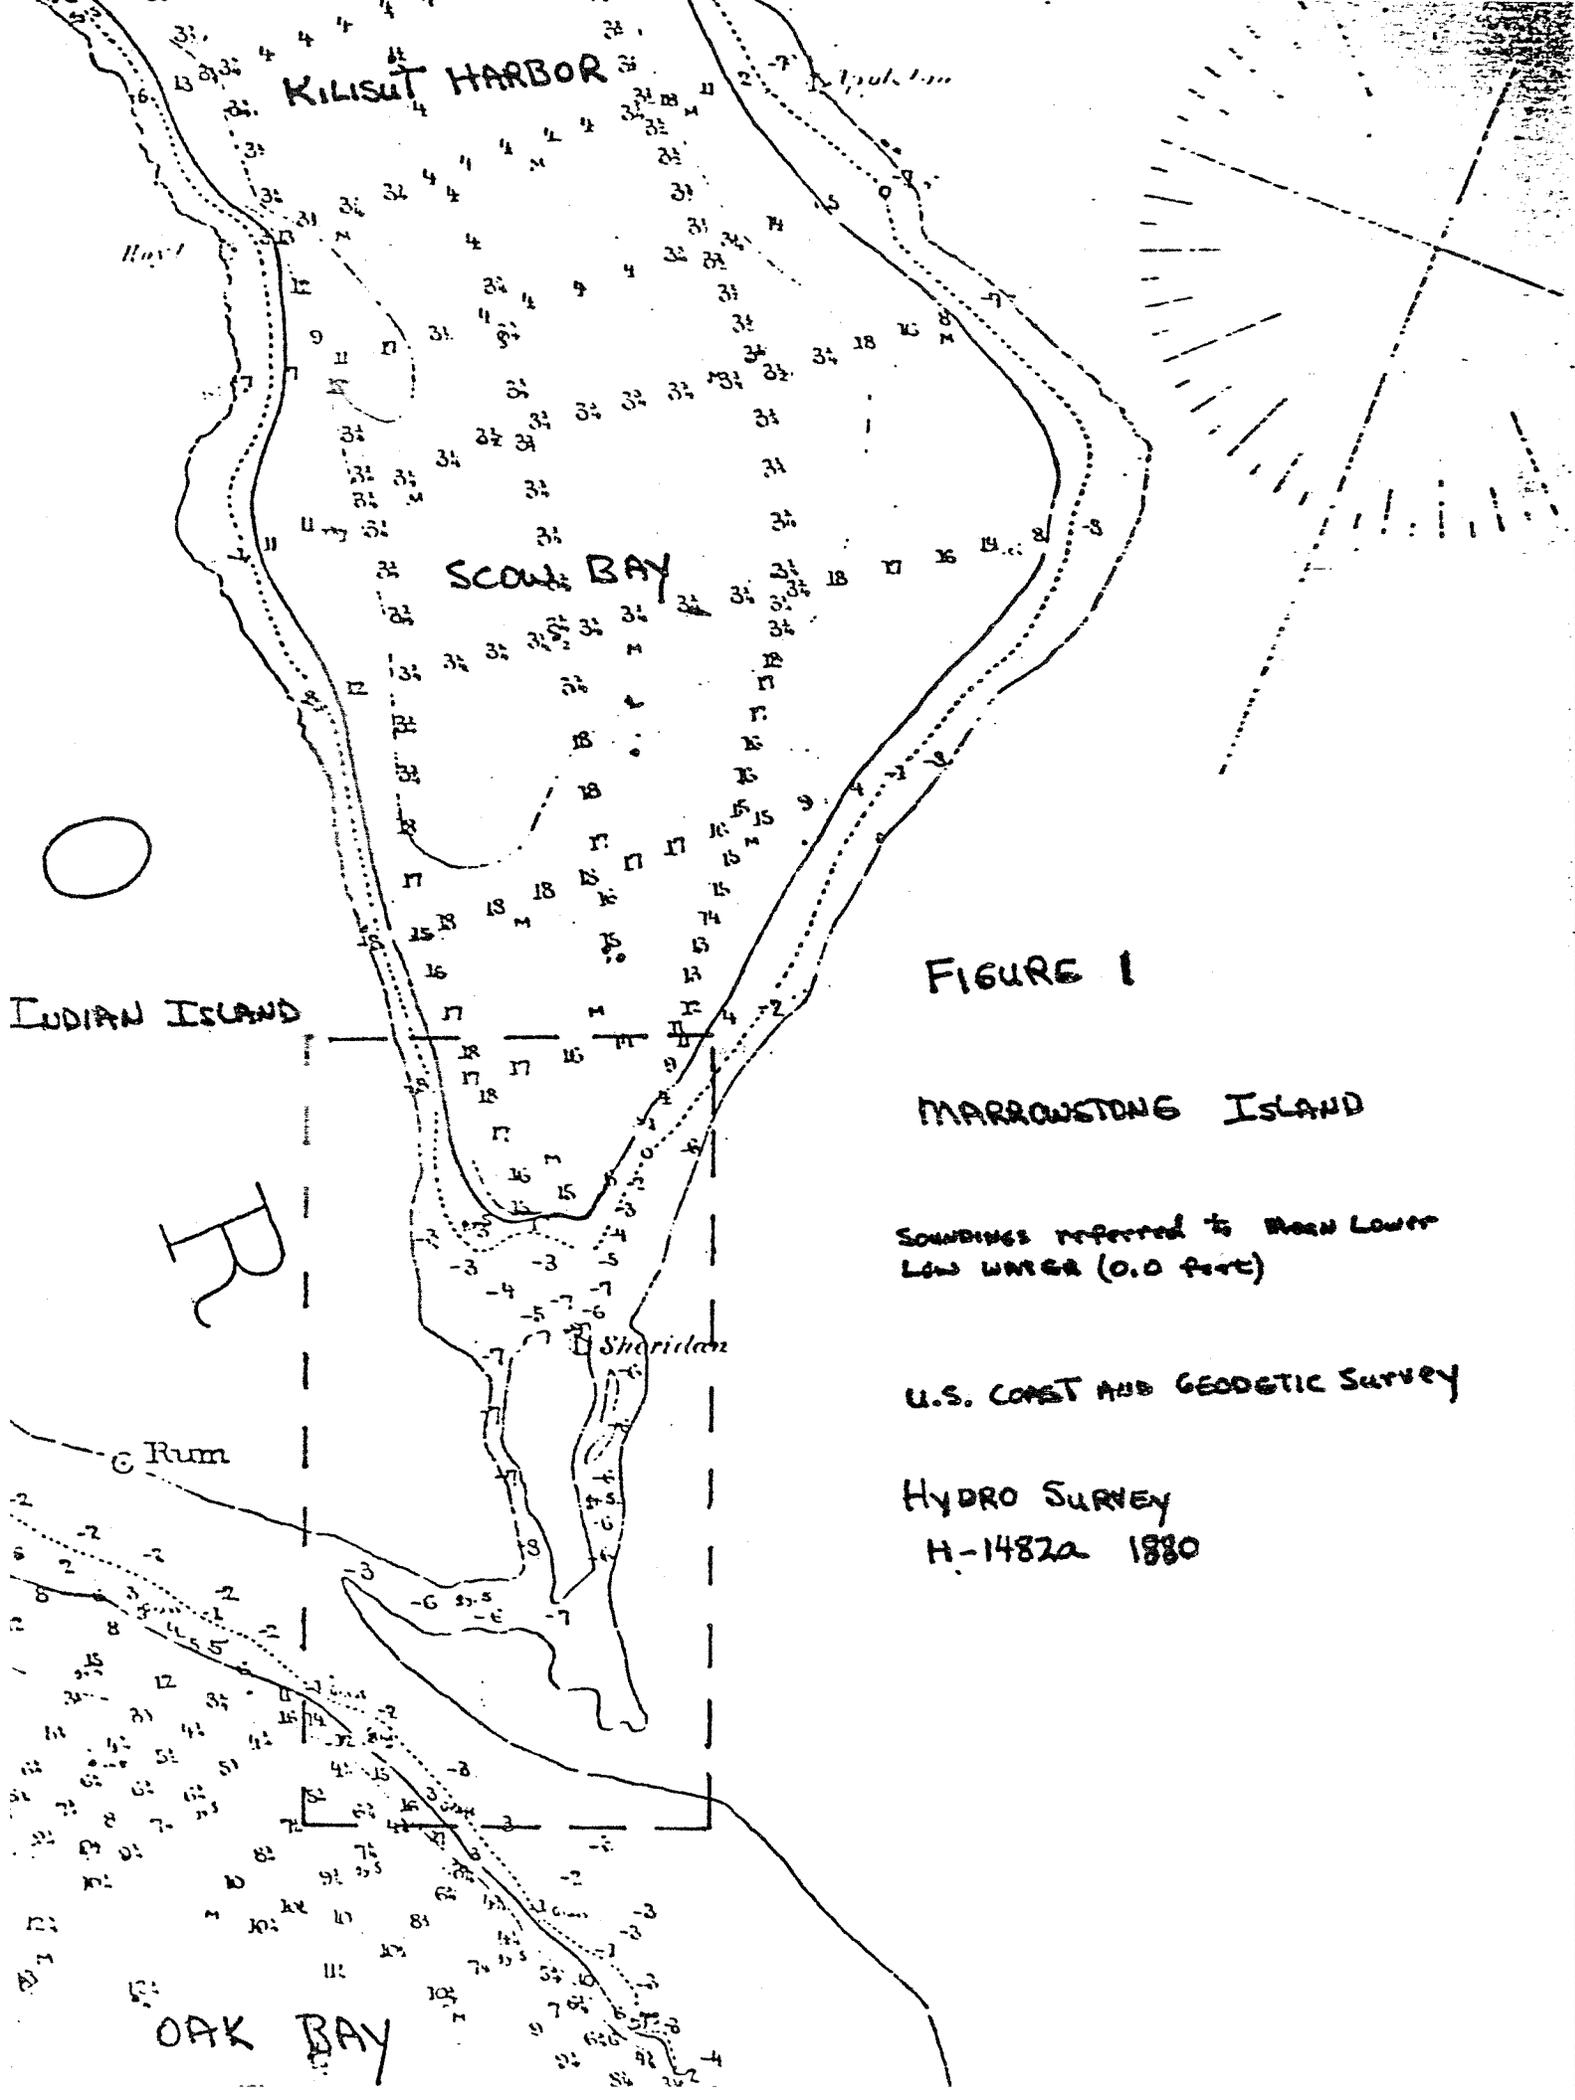
FIGURE 1

Kilisut Harbor is formed by Indian Island on the west and Marrowstone Island on the east. The mouth of the harbor opens to the northwest into Port Townsend. The south end has historically been open (as shown on Figure 1) with a small island formed by two channels which converge into one channel as it enters Oak Bay. On May 7, 1792, Mr. Johnstone of Captain George Vancouver's exploration party of Puget Sound rowed back and forth through the channel. He 'found the channel to be navigable for small boats only from half flood to half ebb and was dry at low water.' During the late 1880's and '90's the father of Ralph Johnson, a local native, sailed a 30 foot sloop through the channel. Also, cattle scows were run through the channel.

Harbor to the natural depths and widths indicated on the 1880 Coast and Geodetic Survey chart shown on Figure 1. Bridges would then have to be constructed over the channels for transportation to Marrowstone Island.

The conditions which have been causing the red tides and consequent shellfish kills during the late summer of 1974 and 1975 will continue and perhaps intensify as the sediments build up with decomposed materials. The young Dungeness crab mortalities may also deplete the commercial crab fishery at the north end of Kilisut Harbor. The only logical way to reverse these conditions would be to restore the channels at the south end of Kilisut

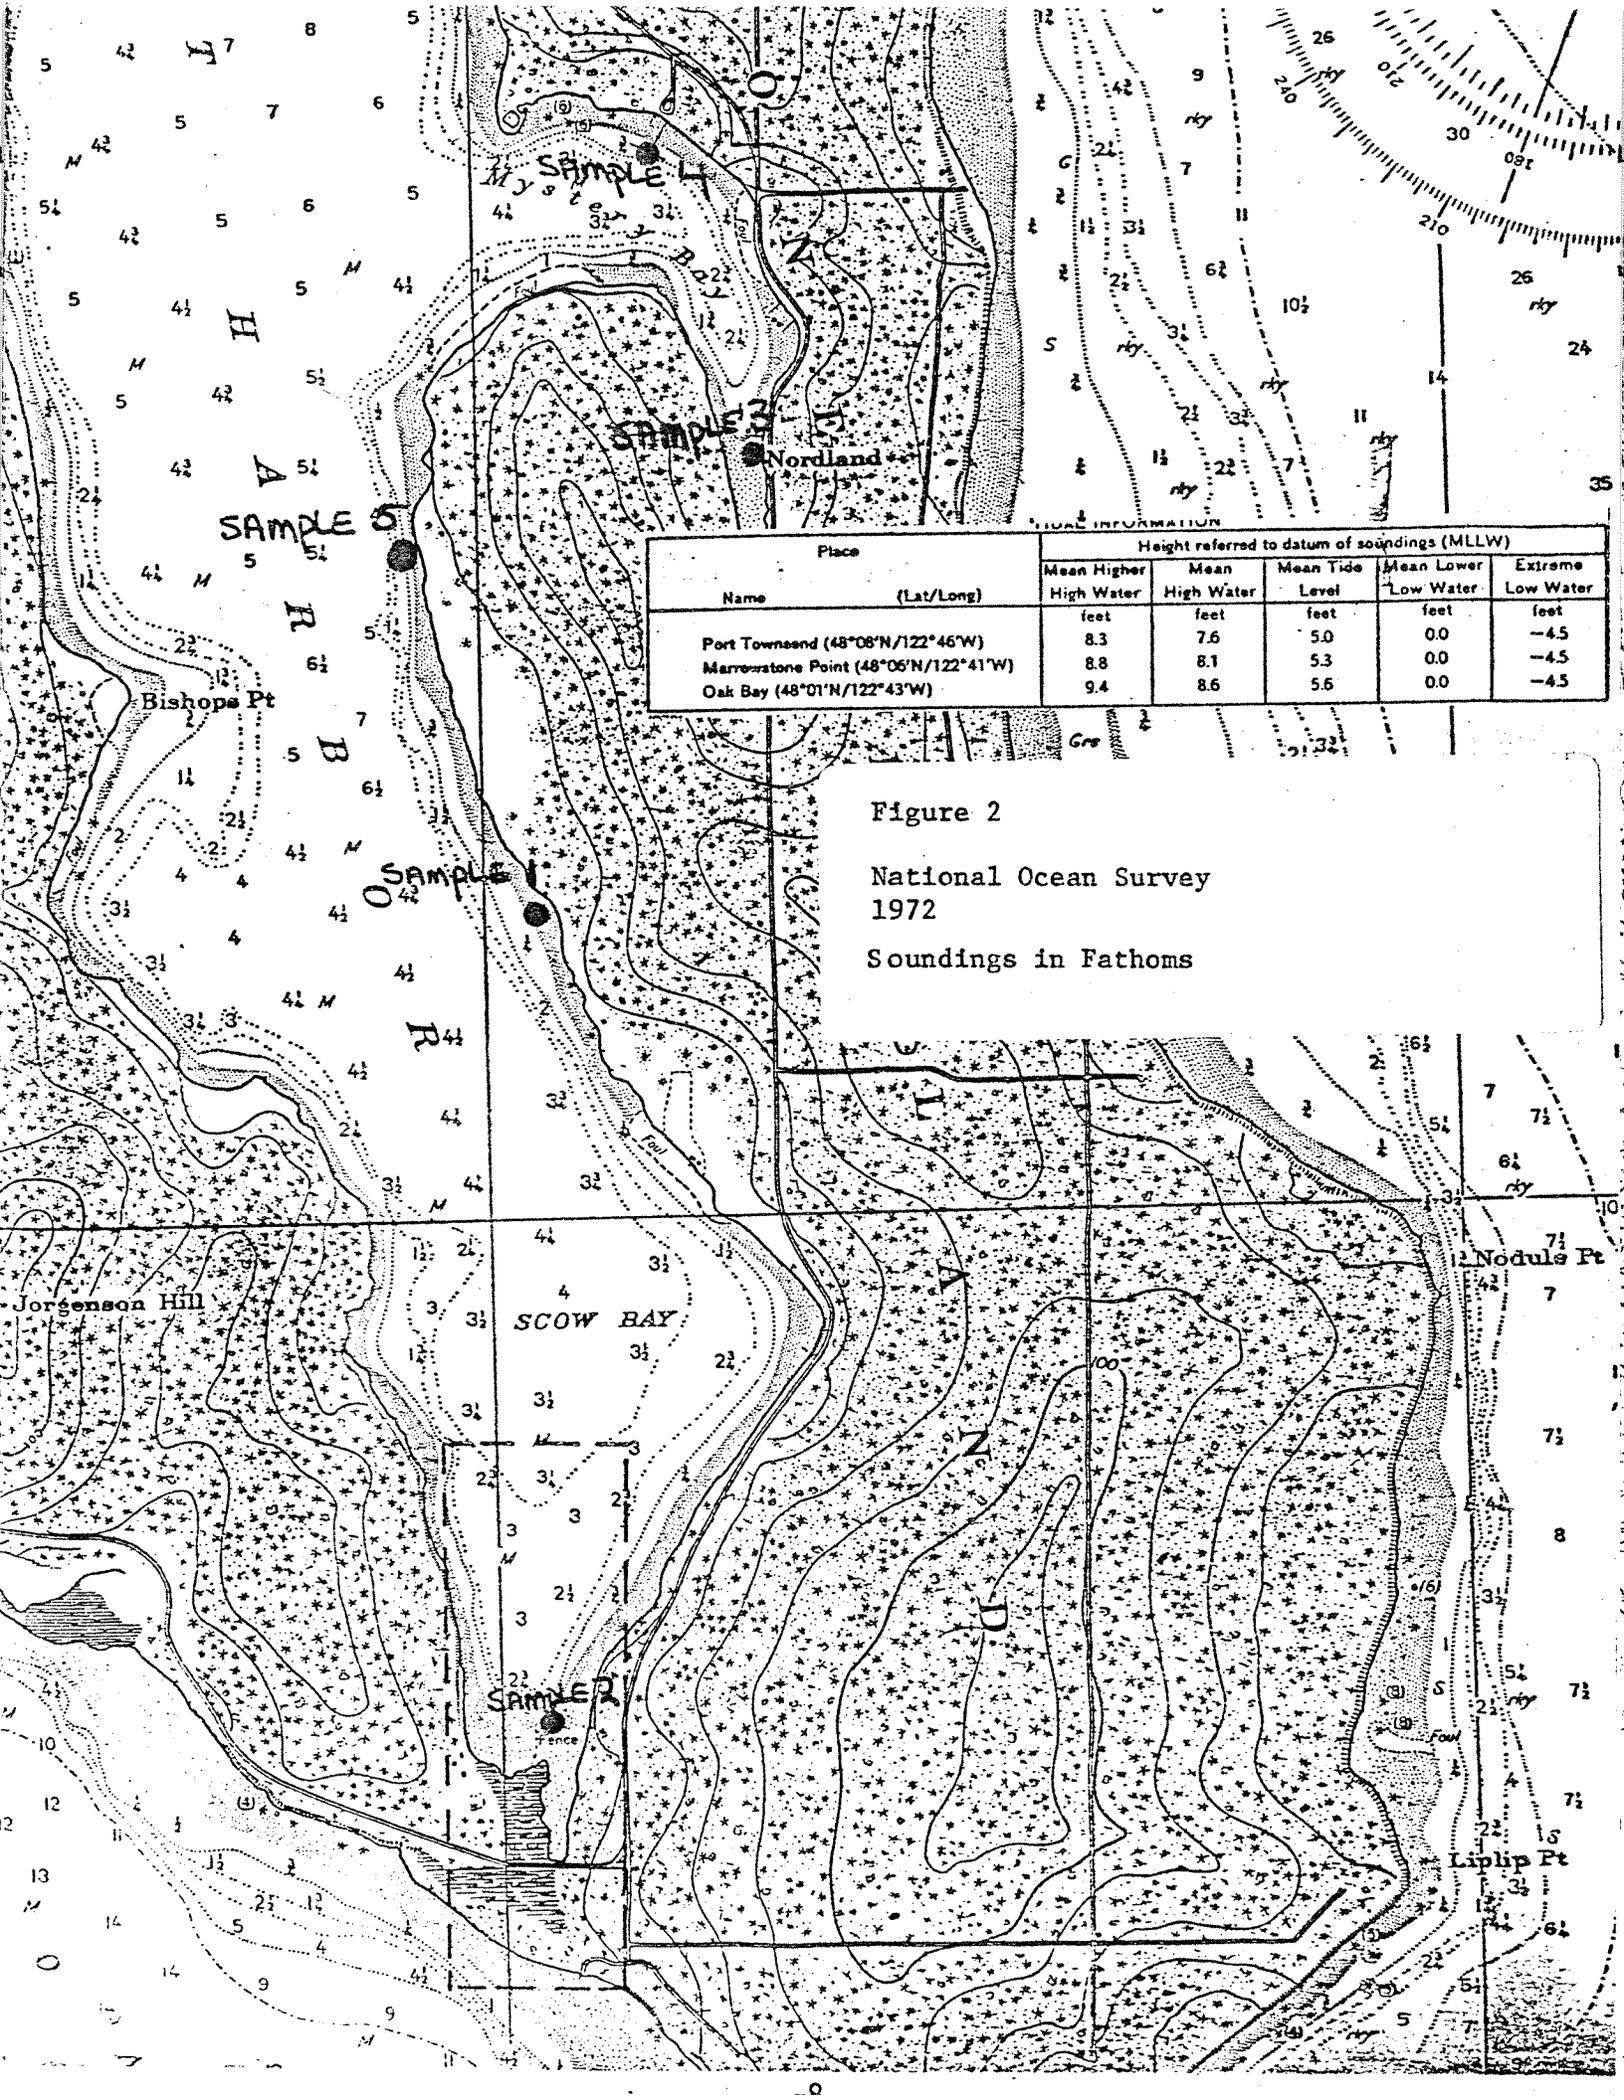
Figure 2  
 National Ocean Survey  
 1972  
 Soundings in Fathoms

This situation again occurred in late August and early September of 1975 but to a lesser extent. In August 1975 the problem was brought to the attention of the Department of Ecology. On September 3, 1975 my assistant, Darrel Anderson and I drove to Kilisut Harbor and met Dr. Taylor at his house. He showed us the area in front of his house where the gray water was again occurring. Dead cockles, crabs and sand dollars were found on the beach. The eelgrass was also dying in large amounts and decaying along with the dead invertebrates. Water samples were taken on 5 locations in the harbor. Figure 2 shows the sample locations and the table lists the lab data.

The low numbers of total and fecal coliforms indicates little or no influence from any nonpoint sewage in the area. Nutrients were somewhat normal with the exception of the ammonia which was quite high probably be-

cause of the breakdown of the dead invertebrates and eelgrass. Total phosphates were high with a highest reading of 0.13 ppm at the south end of the bay. This value could indicate a buildup of nutrients.
