M E M O R A N D U M

March 14, 1978

To: Jim Oberlander  
From: Bill Yake, Ambient & Effluent Monitoring  
Re: Flow Measurement at Crystal Mountain STP,  
Pierce County

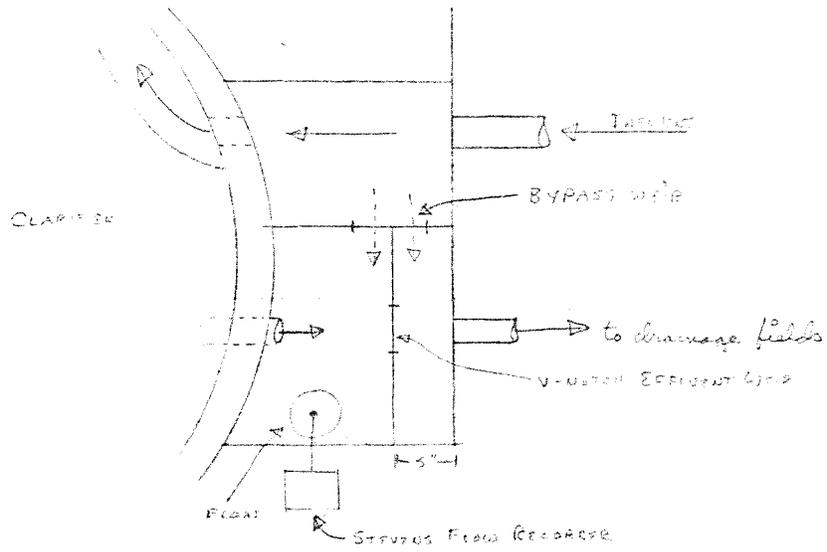
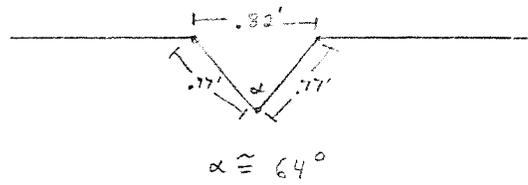
Figure 1. Crystal Mt. STP - Configuration of Inflow and Outfall.

Inspection was made of the flow measuring and recording equipment at the Crystal Mountain STP on March 12, 1978. The configuration of the inflow and outfall structures of the plant is presented in Figure 1. The Stevens 61R recorder, which is activated by a float behind a V-notch weir, records instantaneous and totalized flow. The instantaneous flow is indicated by a needle which scribes a strip chart. The instantaneous flow dial is graduated from 0 to .175. The script chart graduation are not denoted. It is assumed that the 0 to .175 graduations are mgd units. The totalizer is provided with a digital readout. One unit represents 50 gallons. The outfall configuration is poorly designed for accurate flow measurement. The following deficiencies were noted:

- 1) The weir is not a standard 60° weir. The base angle is about 64°, thus real flows are underestimated.
- 2) The weir is not sharp crested and the nappe does not spring free from the weir in the lower section of the V-notch.
- 3) The flow through the weir is not allowed enough drop to prevent weir submergence when flows are high.
- 4) Dimensions of the outfall structure are cramped making accurate calibration almost impossible.
