**CLALLAM BAY SEWAGE TREATMENT PLANT  
SEKIU SEWAGE TREATMENT PLANT  
JULY 28 and 29, 1987  
CLASS II INSPECTION REPORTS**

by  
**Marc Heffner**

February 1988

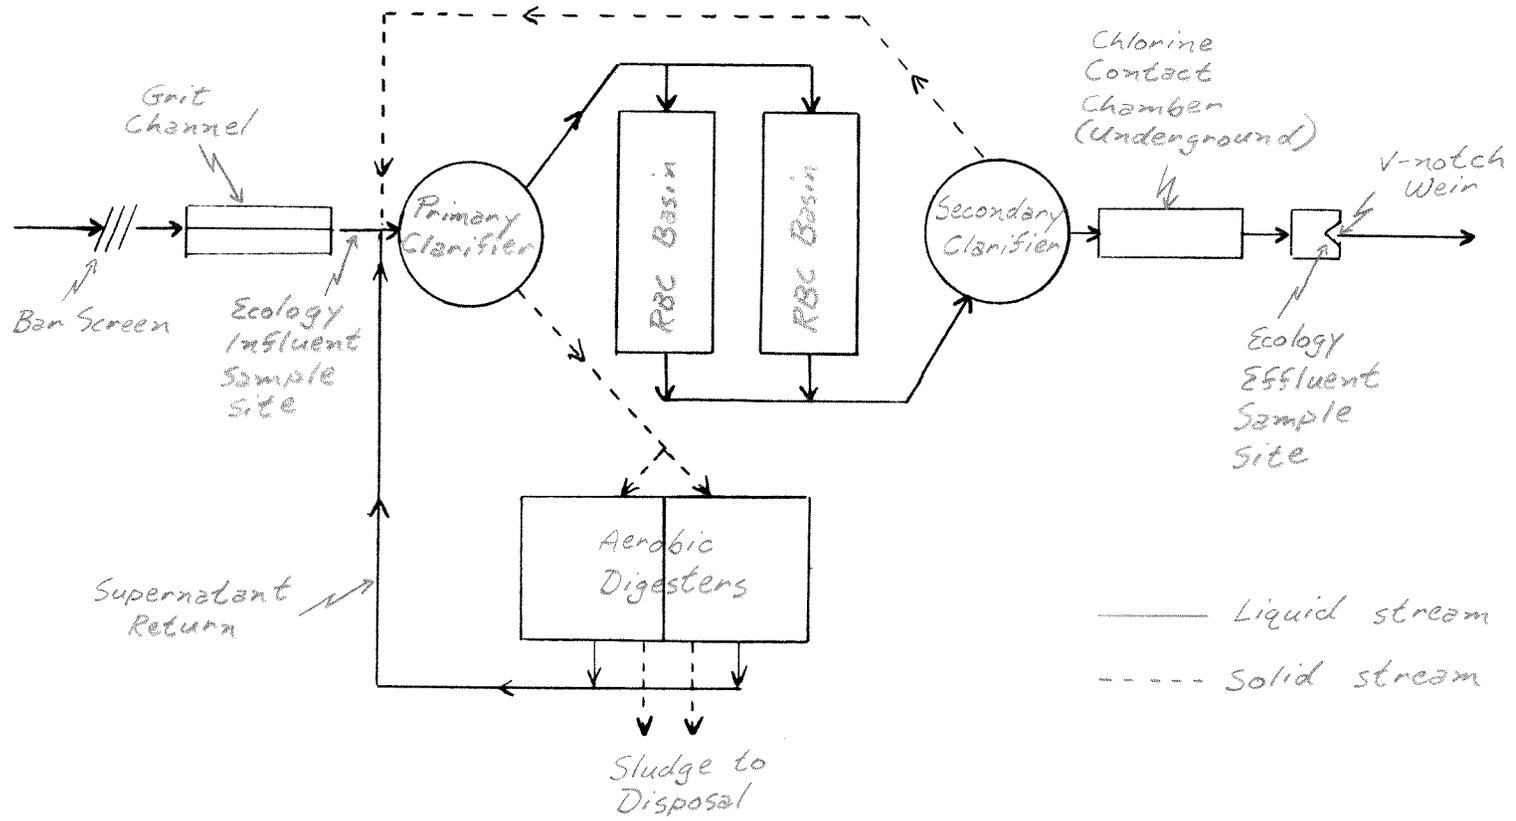
The flow schemes for the two plants were the same (Figure 1). Wastewater first passes through a bar screen and enters a grit channel. The influent is then combined with secondary sludge before entering the primary clarifier. The primary effluent is split and run through one of two RBCs. The RBCs are run in parallel with each unit baffled to provide two stages of treatment per shaft (CWC-HDR, 1986). Flow from the RBCs is sent to a secondary clarifier, then through an underground chlorine contact chamber. Flow is measured at an effluent 60 degree V-notch weir and discharged into the Strait of Juan de Fuca.

Figure 1. Flow scheme - Clallam Bay/Sekiu, July 1987.
