PCBs in Sediments at Selected Sites in Puget Sound

Publication No. 02-03-003

by
Morgan Roose and Keith Seiders

Watershed Ecology Section
Environmental Assessment Program
Olympia, Washington 98504-7710

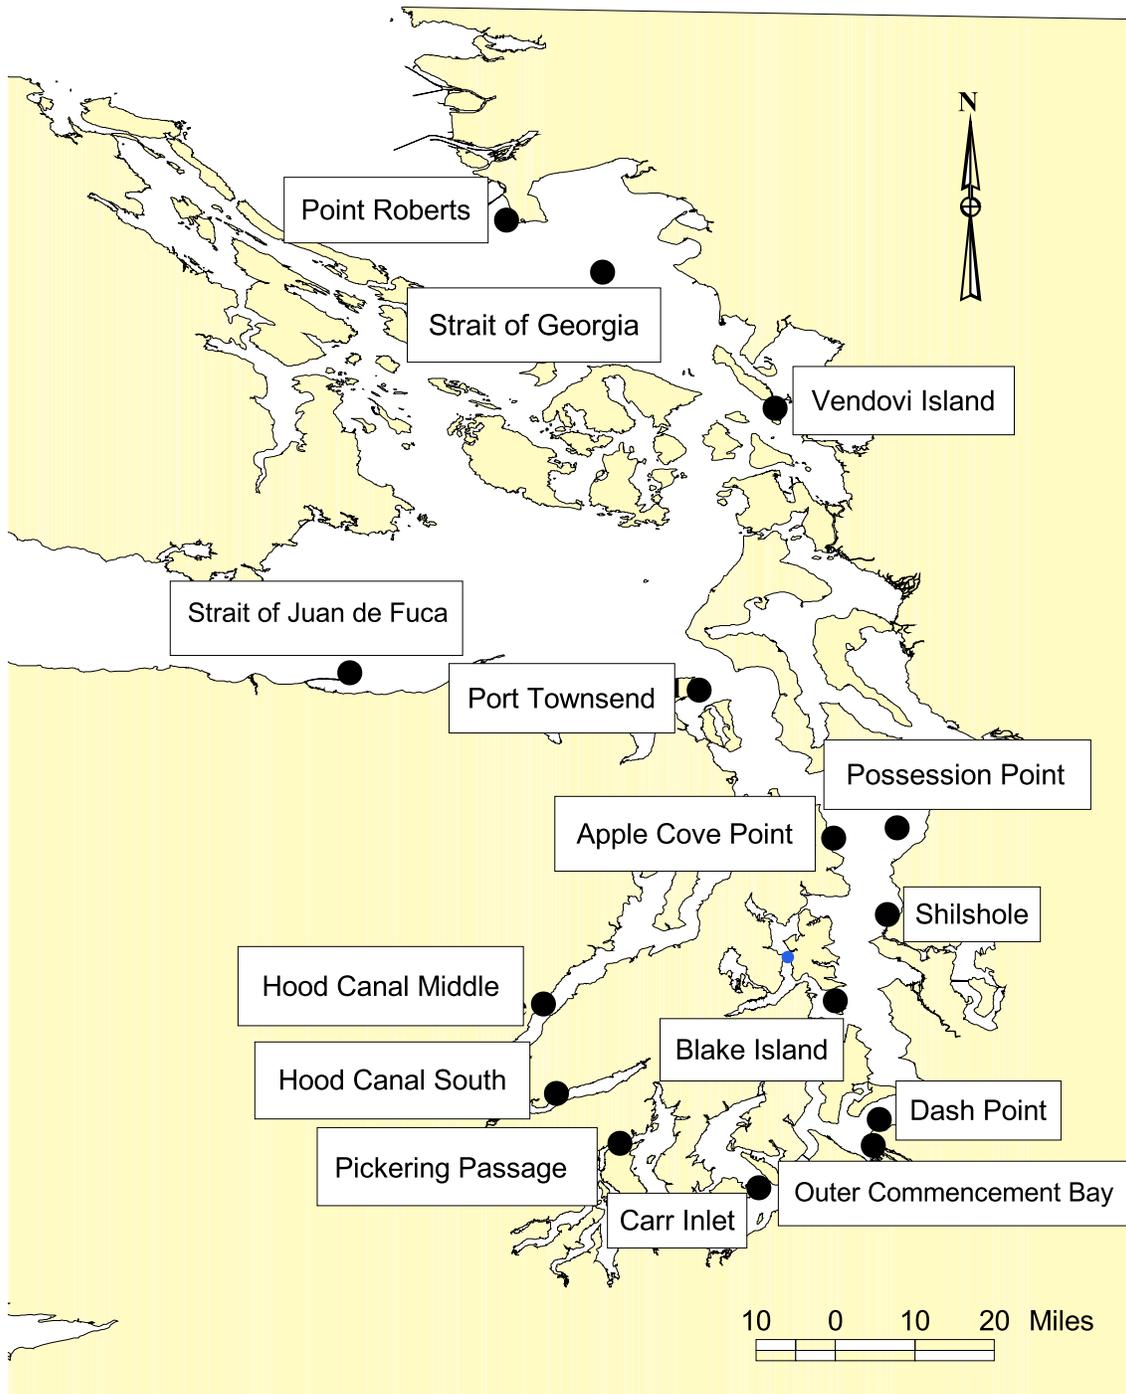
Figure 1: Sediment Sampling Sites in Puget Sound

Surface sediments from the top 2-3 cm were sampled from 15 locations in Puget Sound (Figure 1). Detailed information on site locations are provided in Appendix A. The 15 locations were selected by the Washington State Department of Ecology (Ecology) and the Washington Department of Fish and Wildlife (WDFW) after review of historic sediment and fish tissue PCB data (Seiders and Roose, 2001).
