Eyes Over Puget Sound

Surface Conditions Report November, 15th 2011

Up-to-date observations of visible water quality conditions in Puget Sound and the Strait of Juan de Fuca

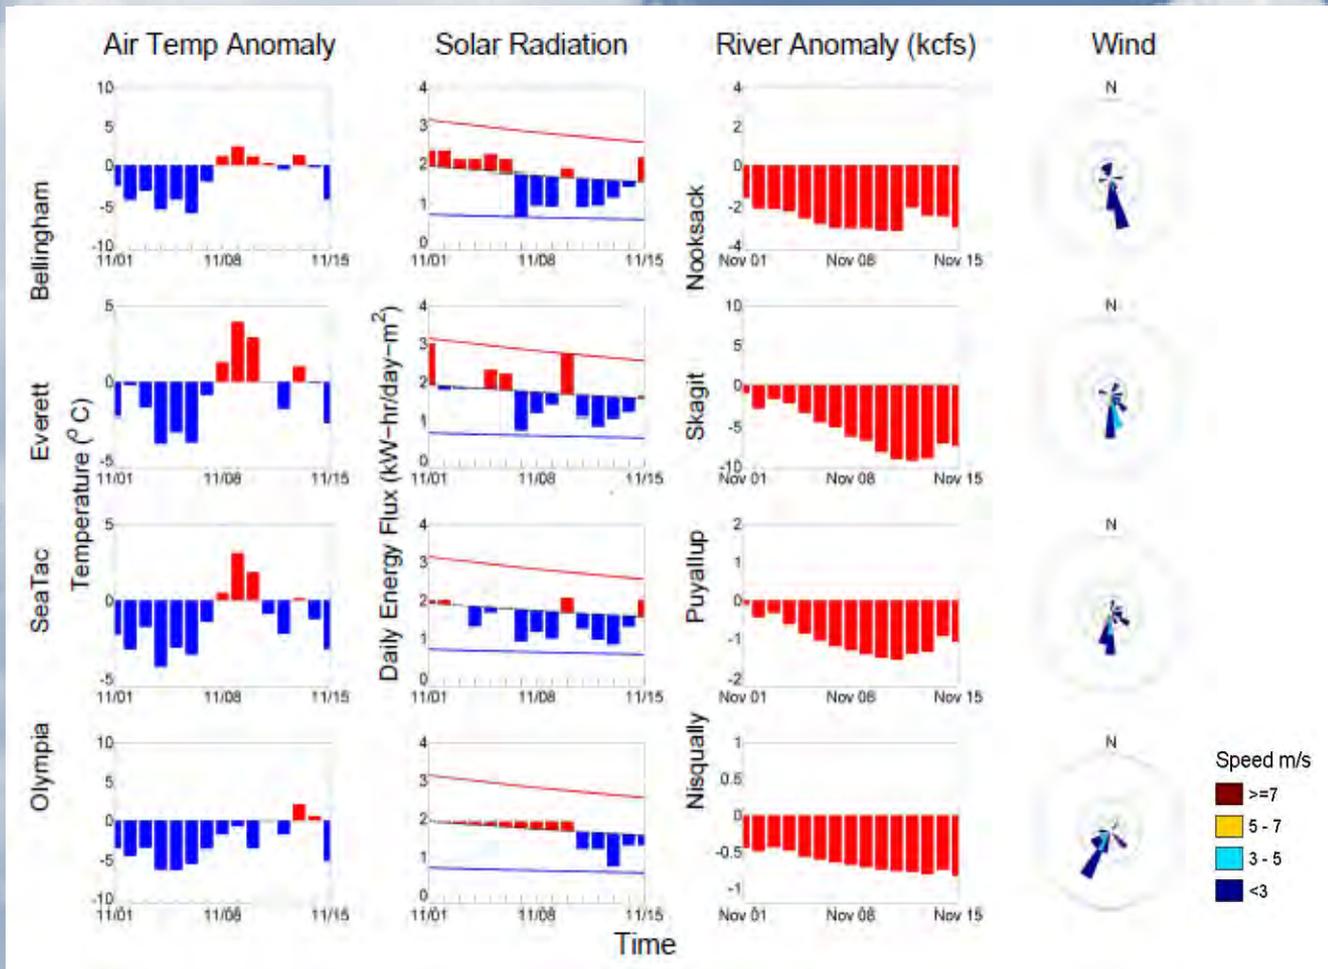
Weather of the last two weeks Nov. 1 -15, 2011

Air temperatures during the past few days have been average, or cooler than expected.

Solar radiation has been weak and declining.

Rivers have been running below normal in all locations.

Winds have been from predominantly from the south – more SE at Northern Puget Sound stations, and more SW at Southern Puget Sound sites.

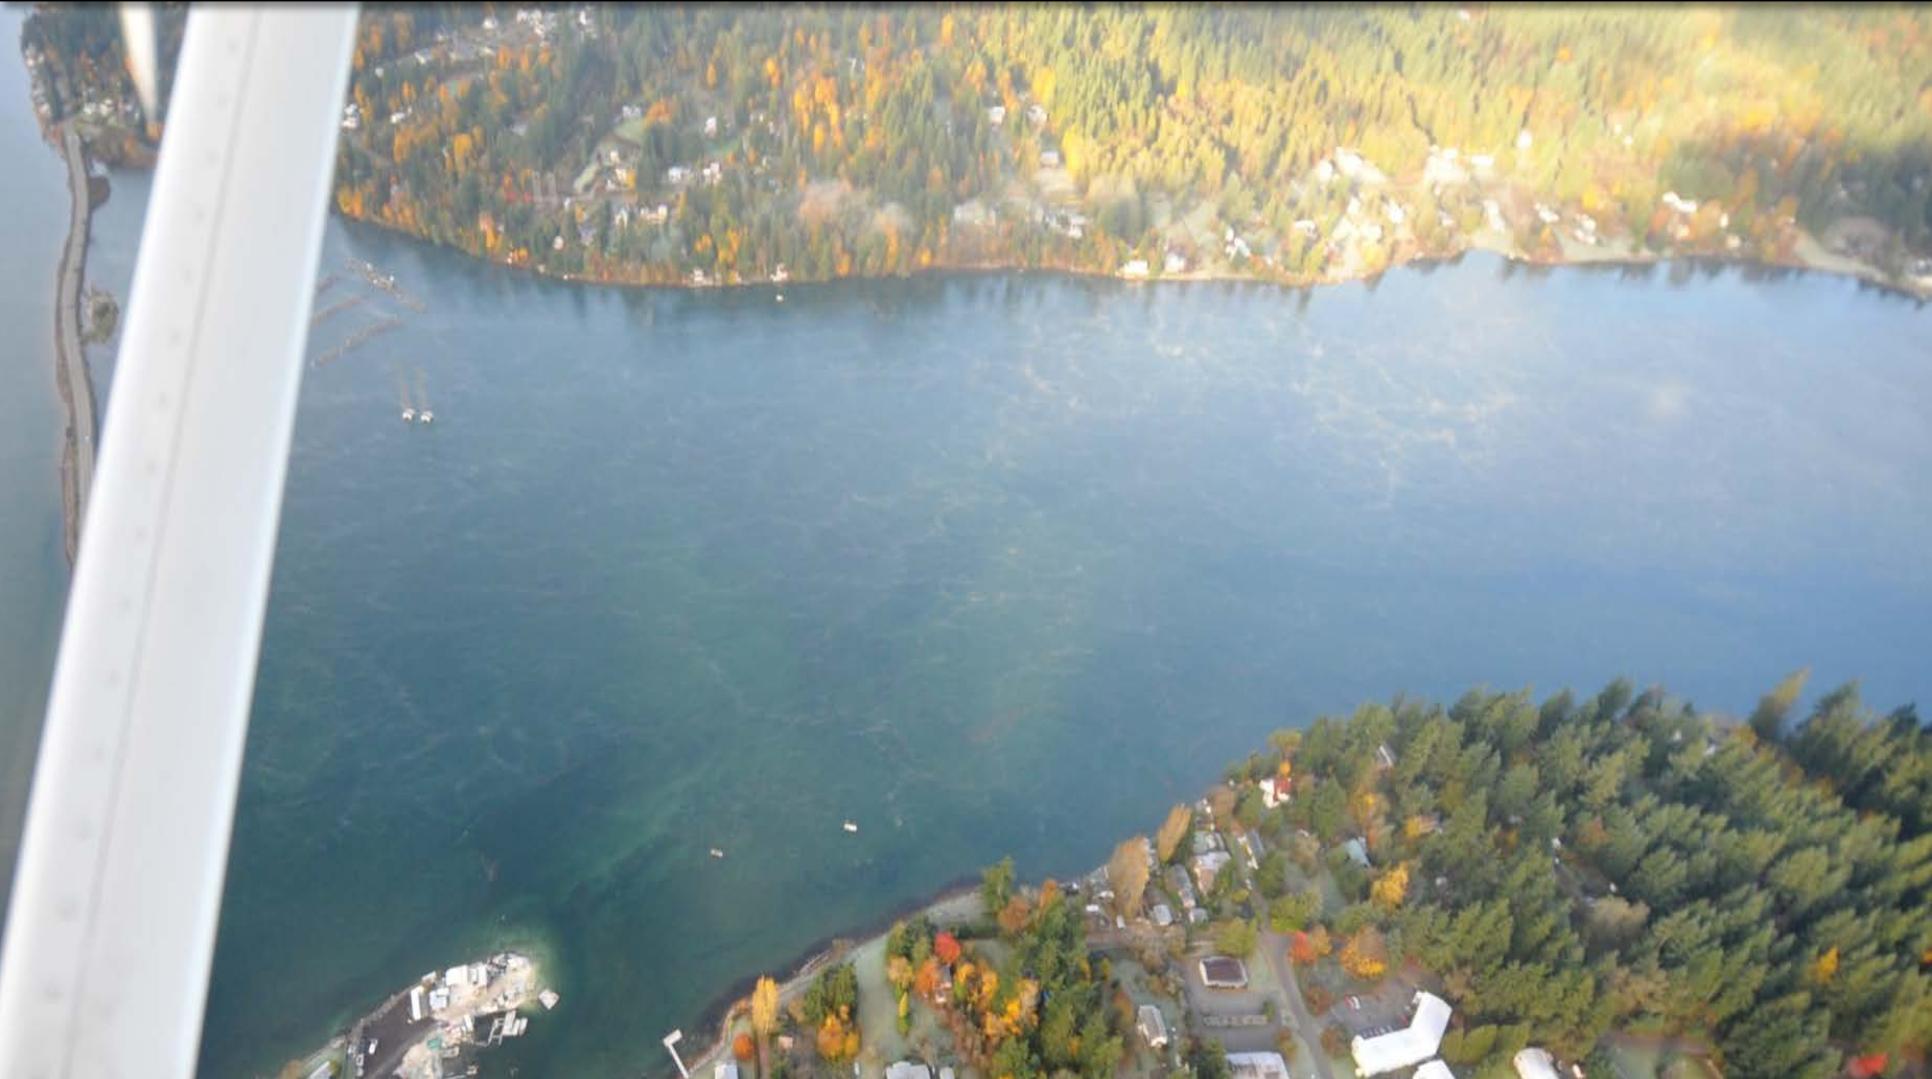
Steaming water (= latent heat flux). Location: Head of Carr Inlet (South Sound), 8:50 AM

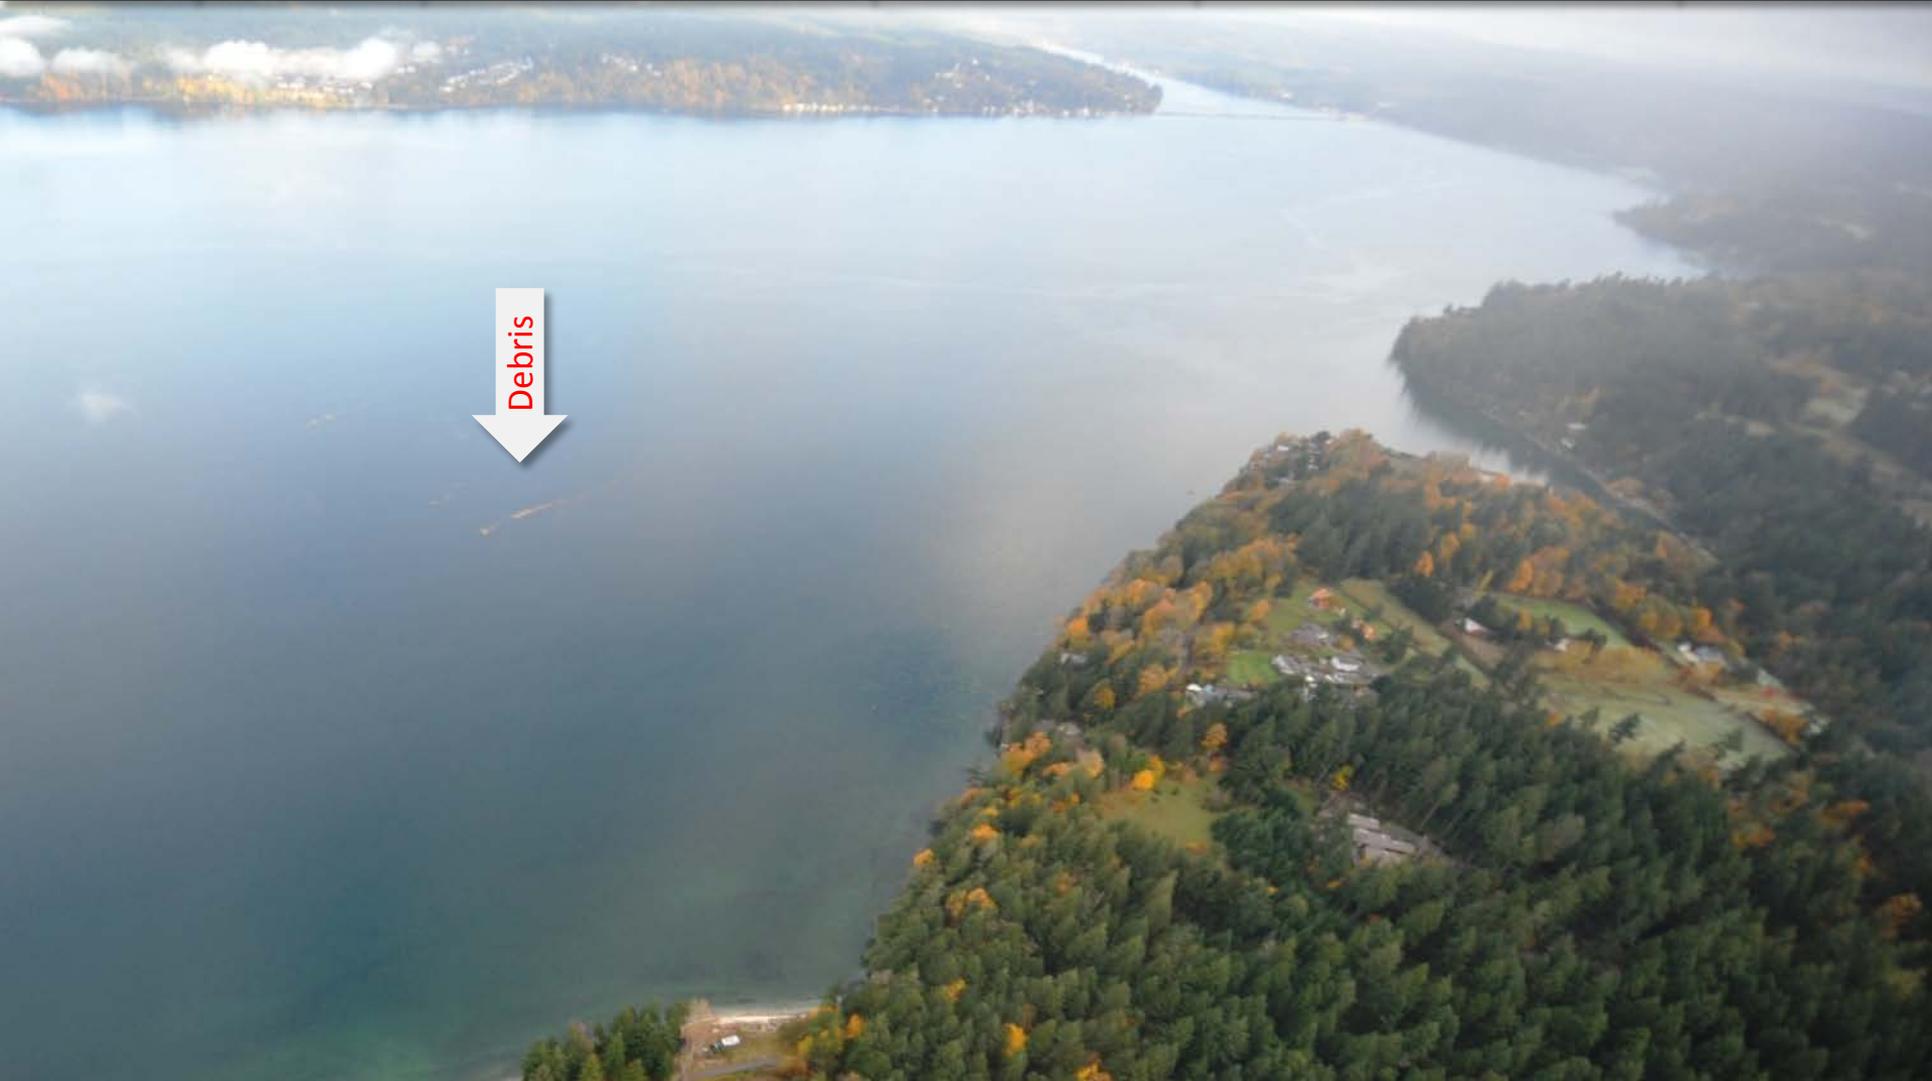
Debris line. Location: Northern Carr Inlet (South Sound), 8:52 AM

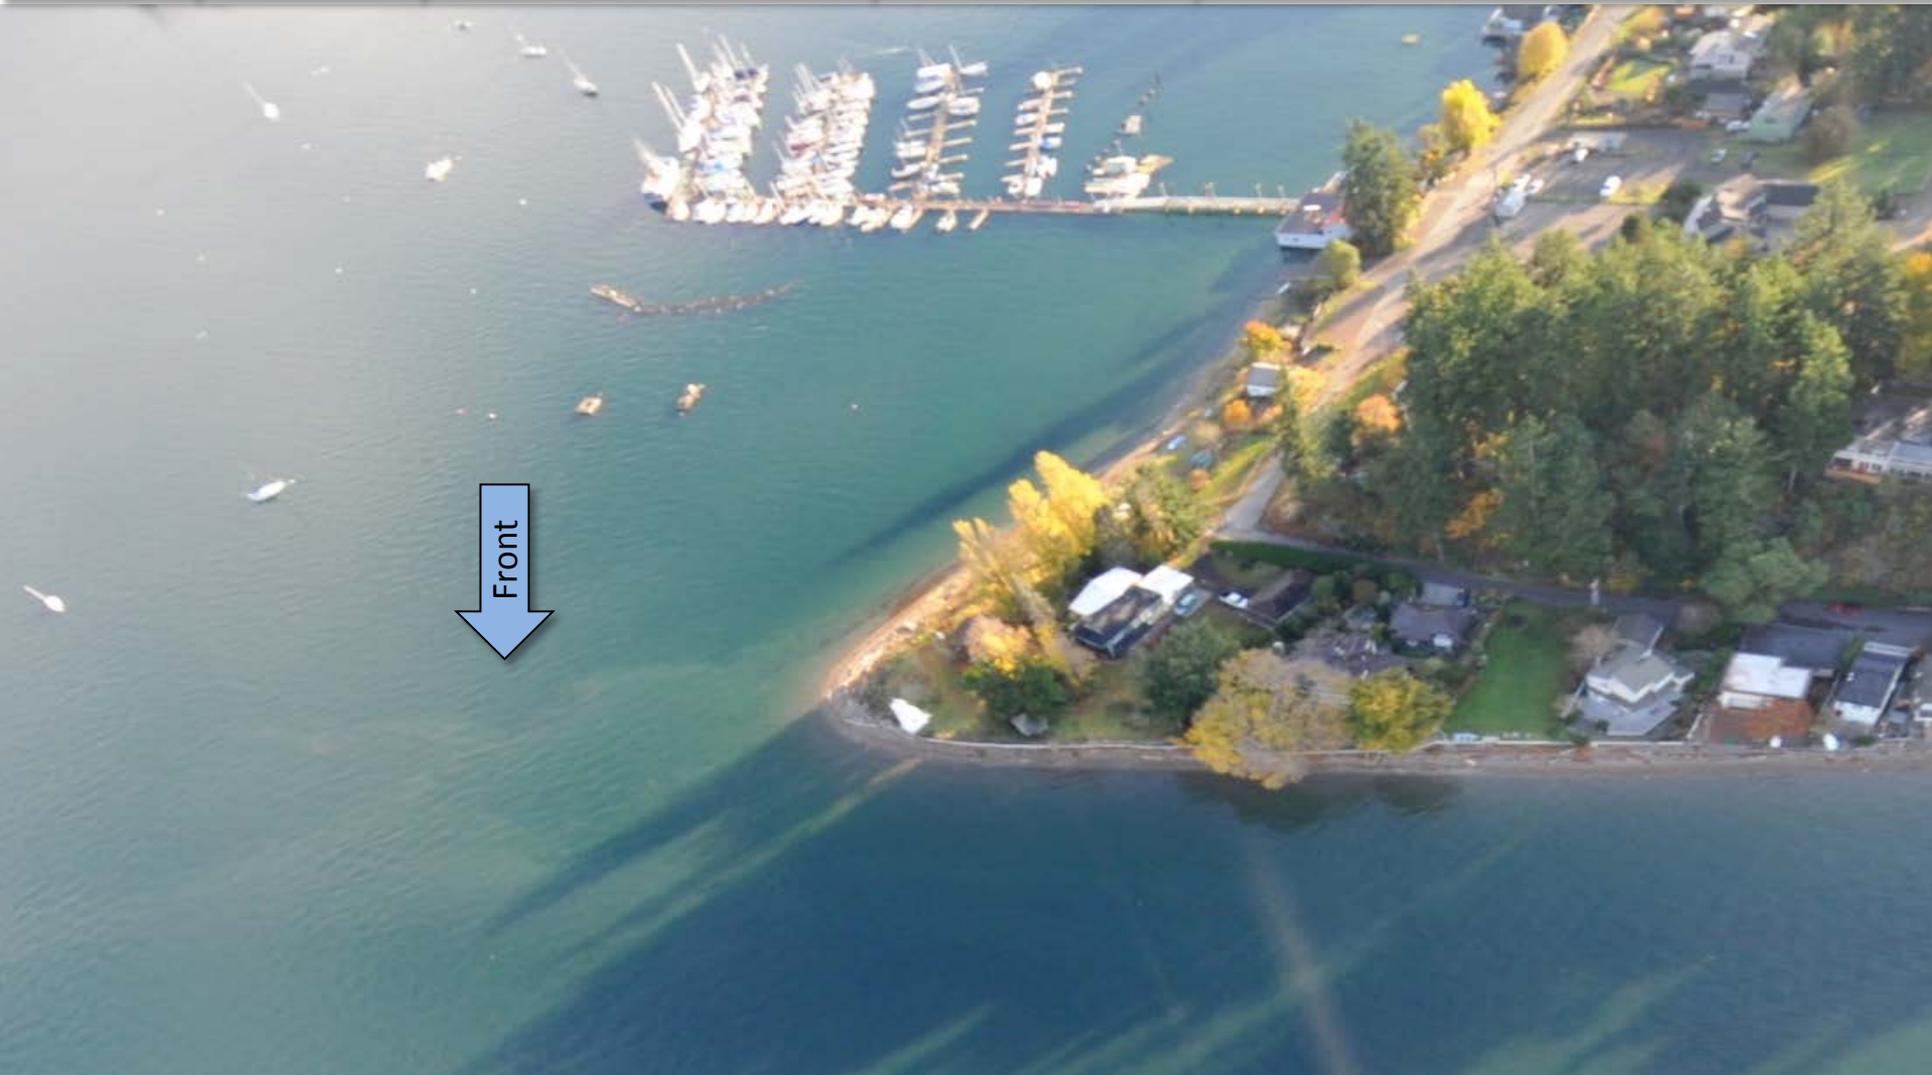
Small front. Location: Boston Harbor (South Sound), 9:03 AM

Mixing and Fronts: 6 7 11

Budd Inlet, Dana Passage, Commencement Bay

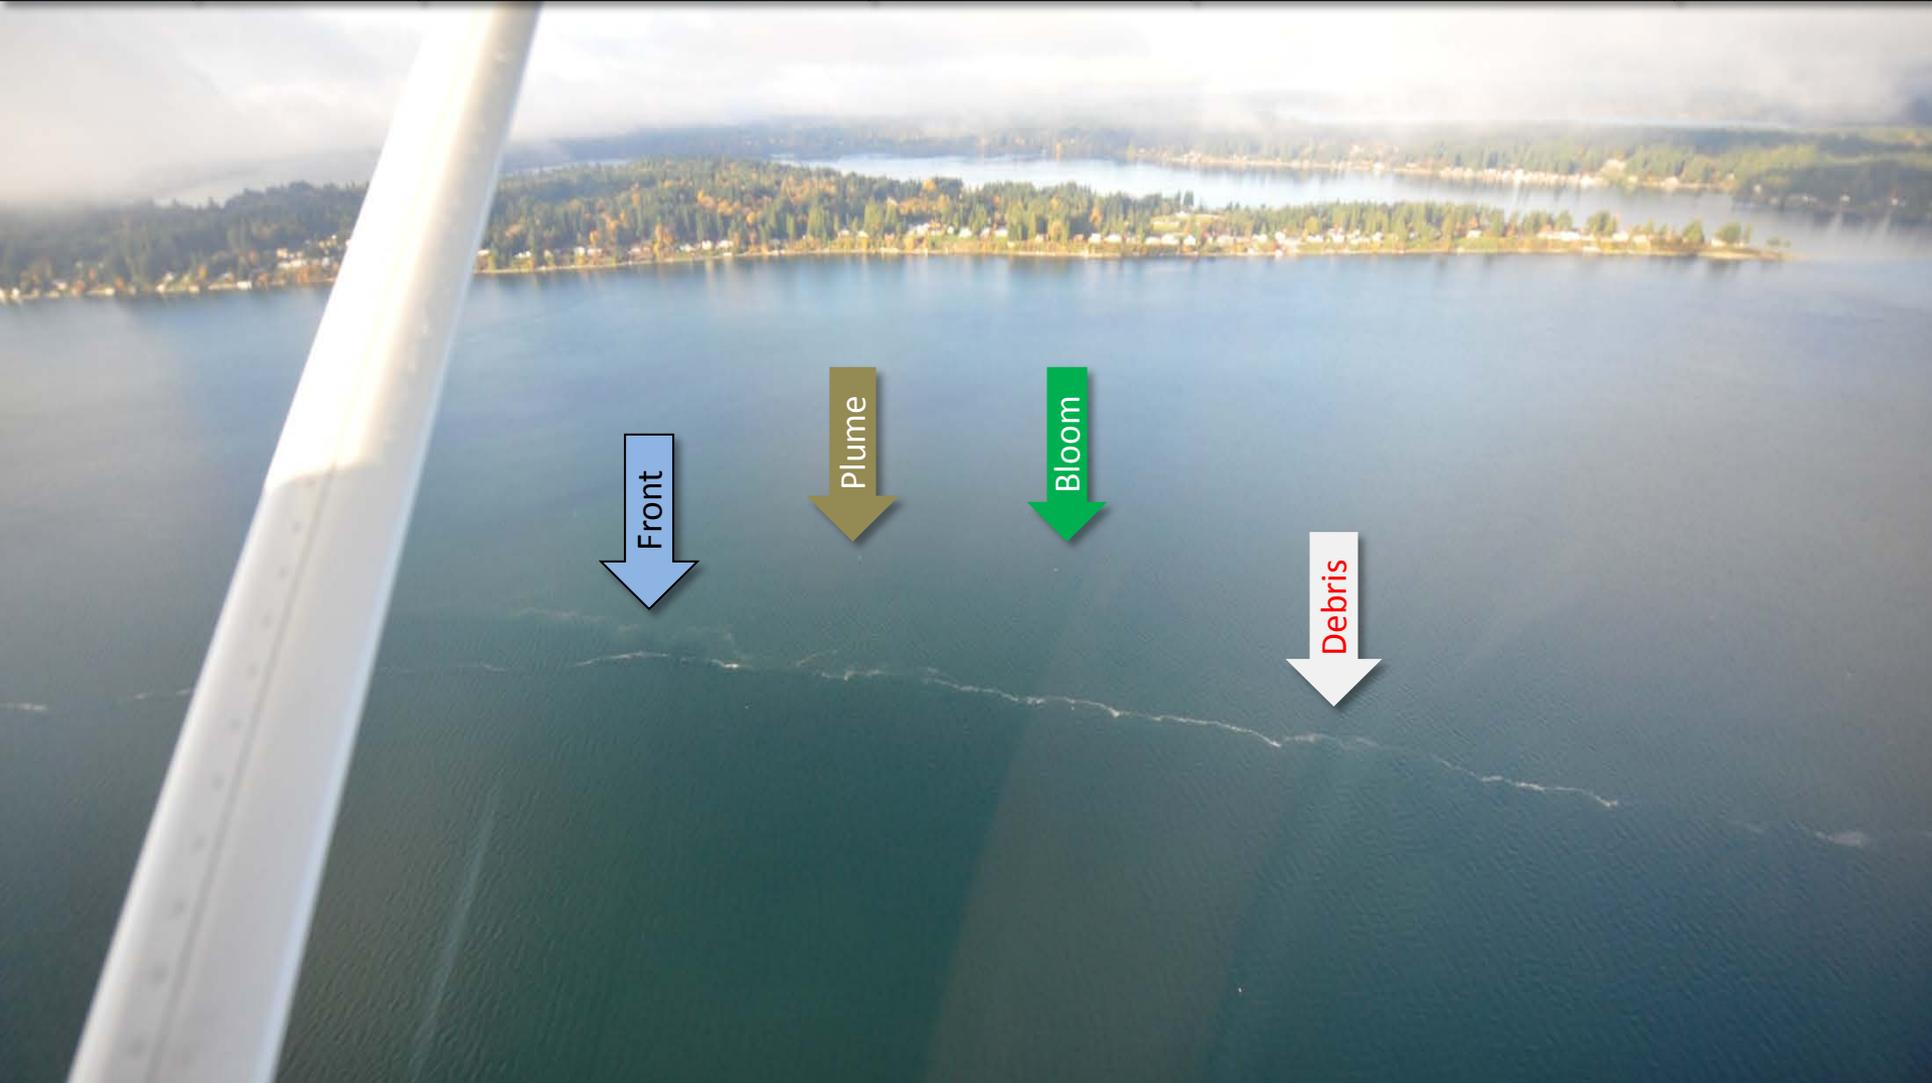
Different surface water and debris line. Location: Budd Inlet (South Sound), 9:03 AM

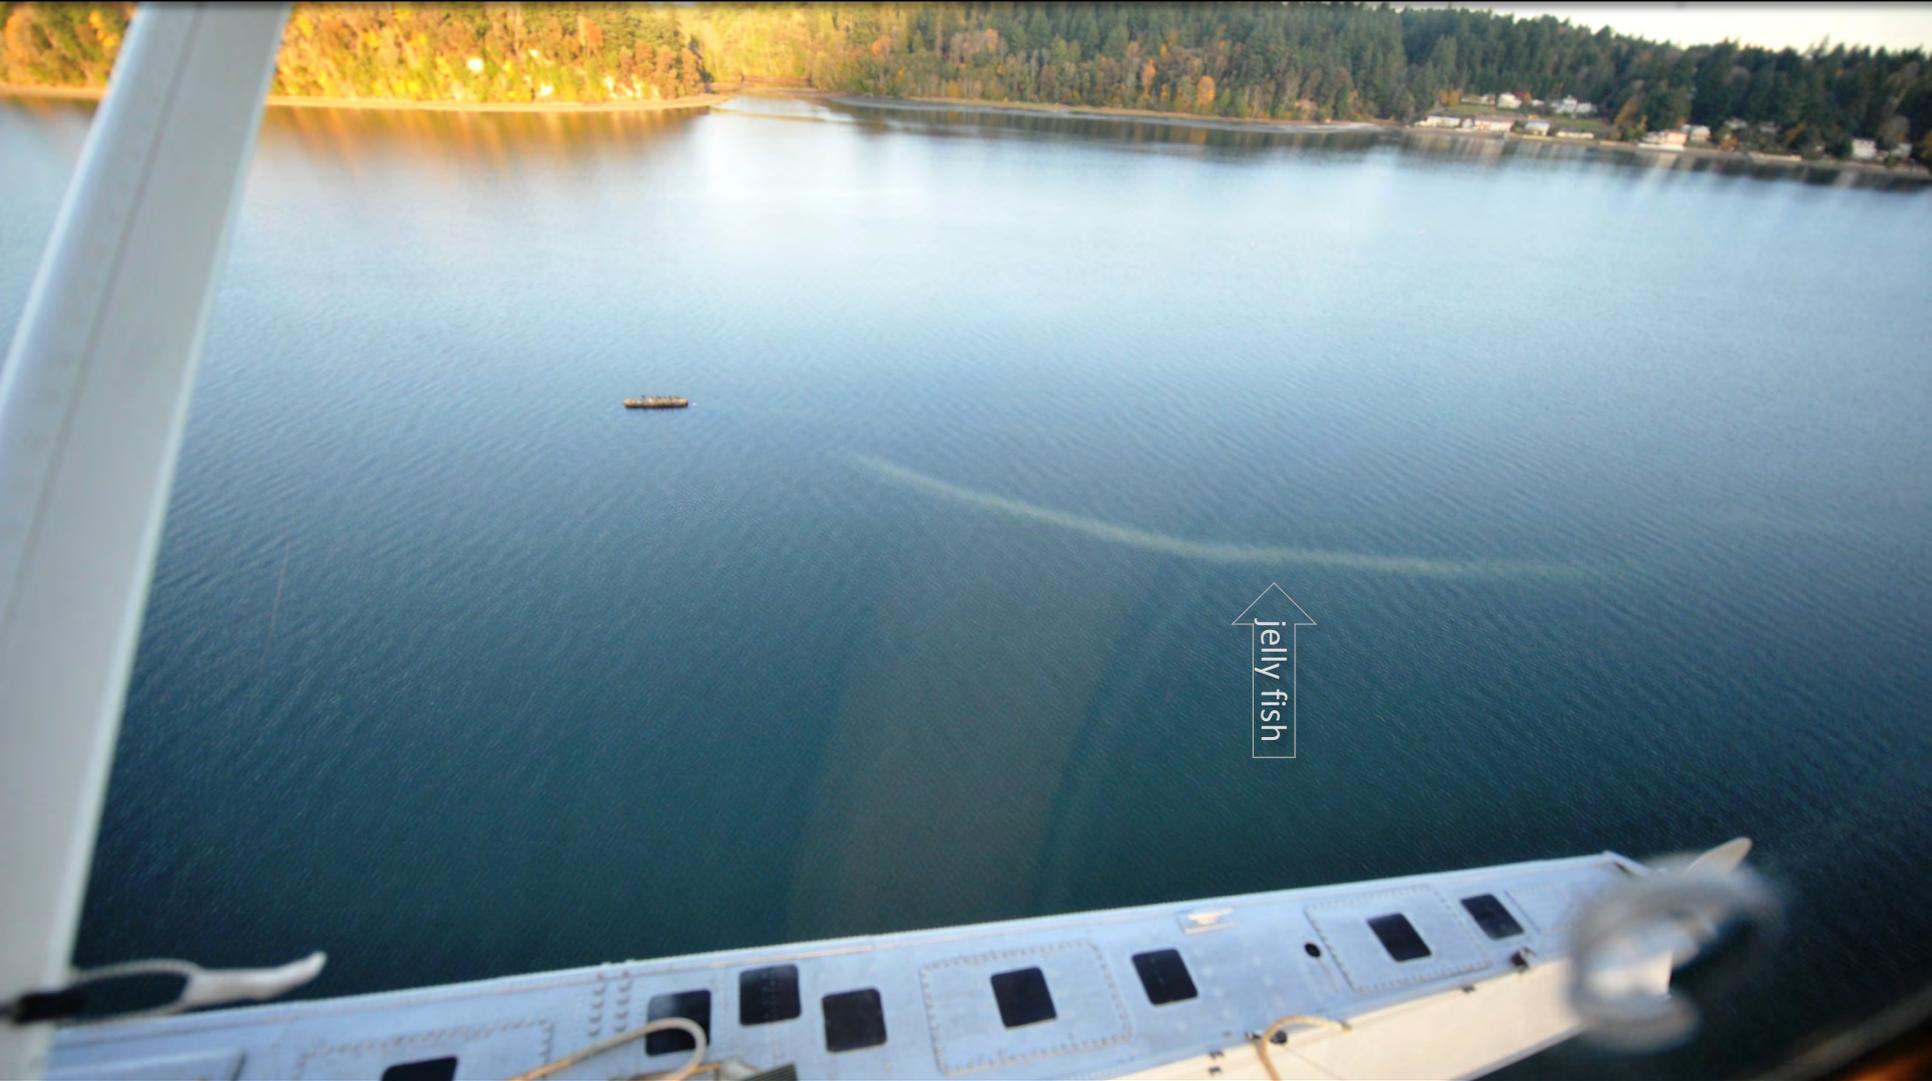
Jelly fish-looks like Aurelia. Location: Budd Inlet (South Sound), 4:23 PM

Jelly fish still abundant in Budd Inlet

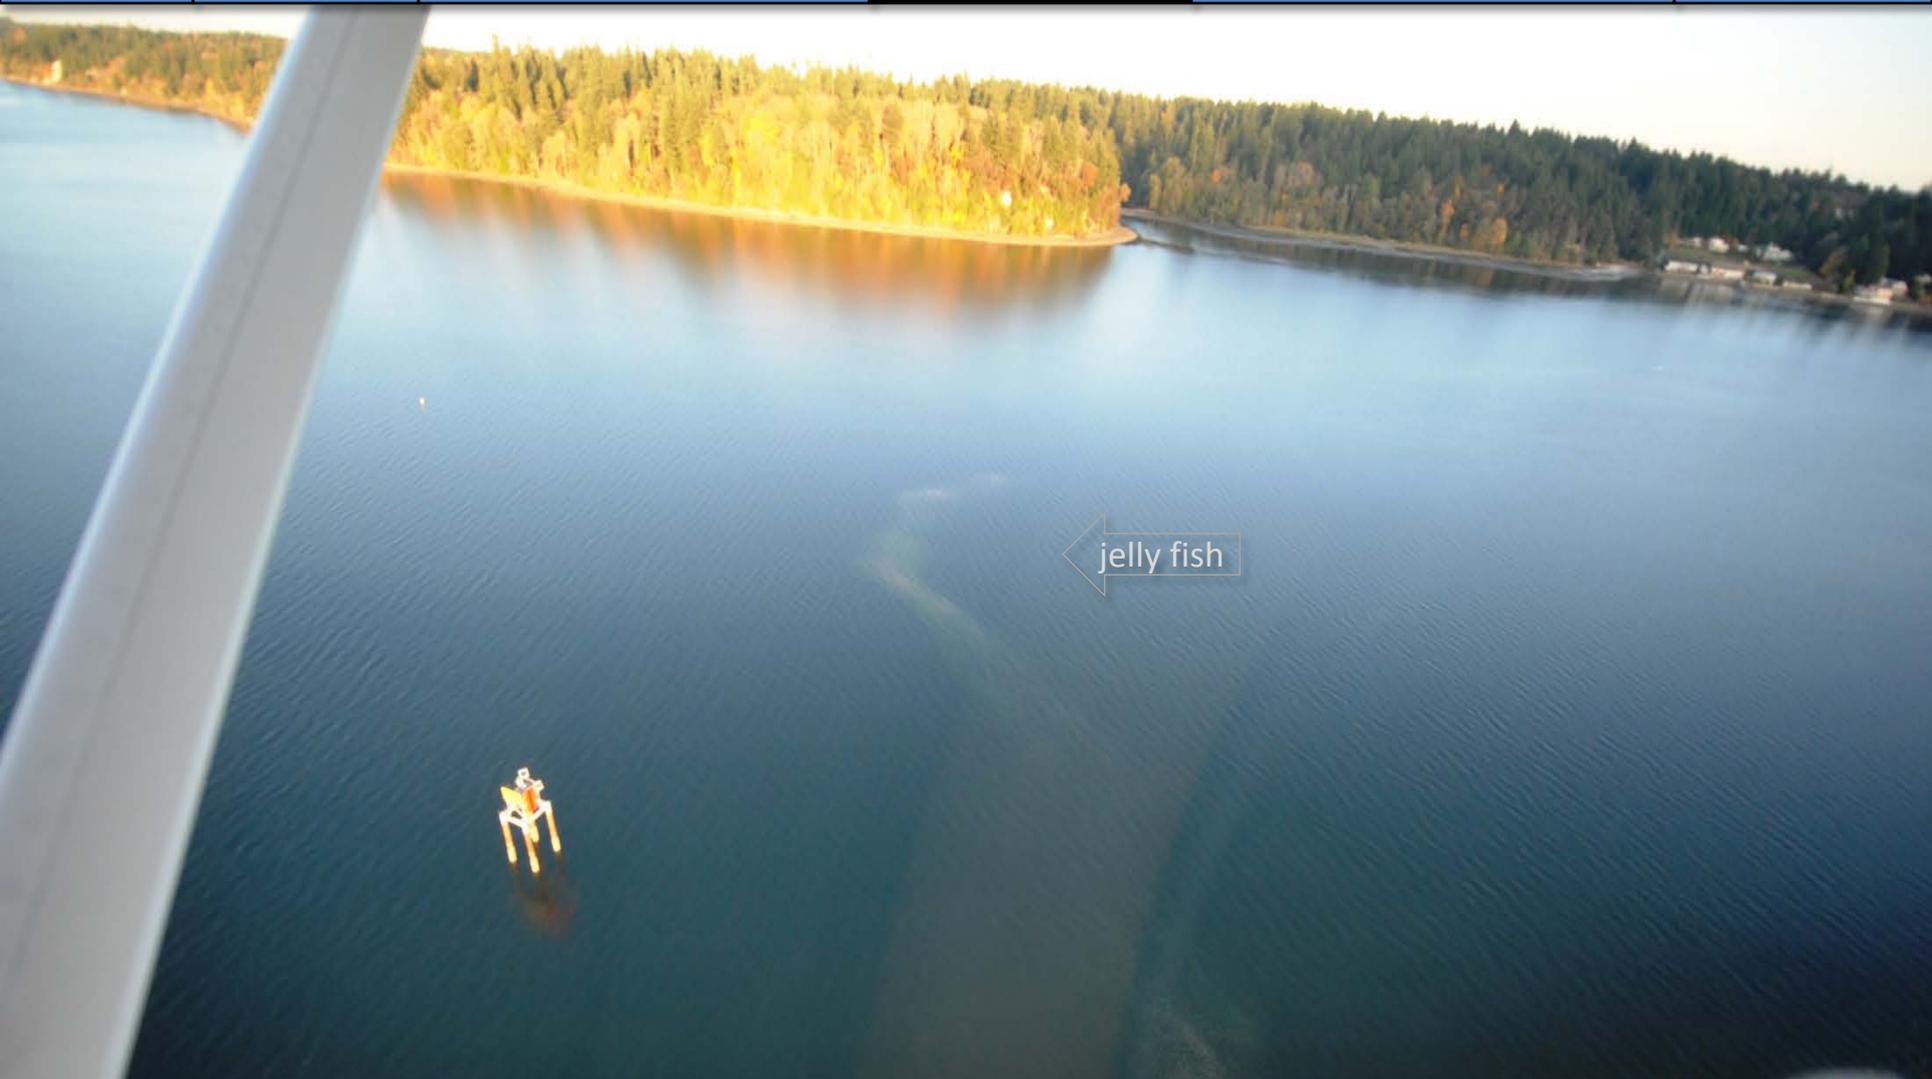
Jellyfish aggregations. Location: Budd Inlet (South Sound), 3:53 PM

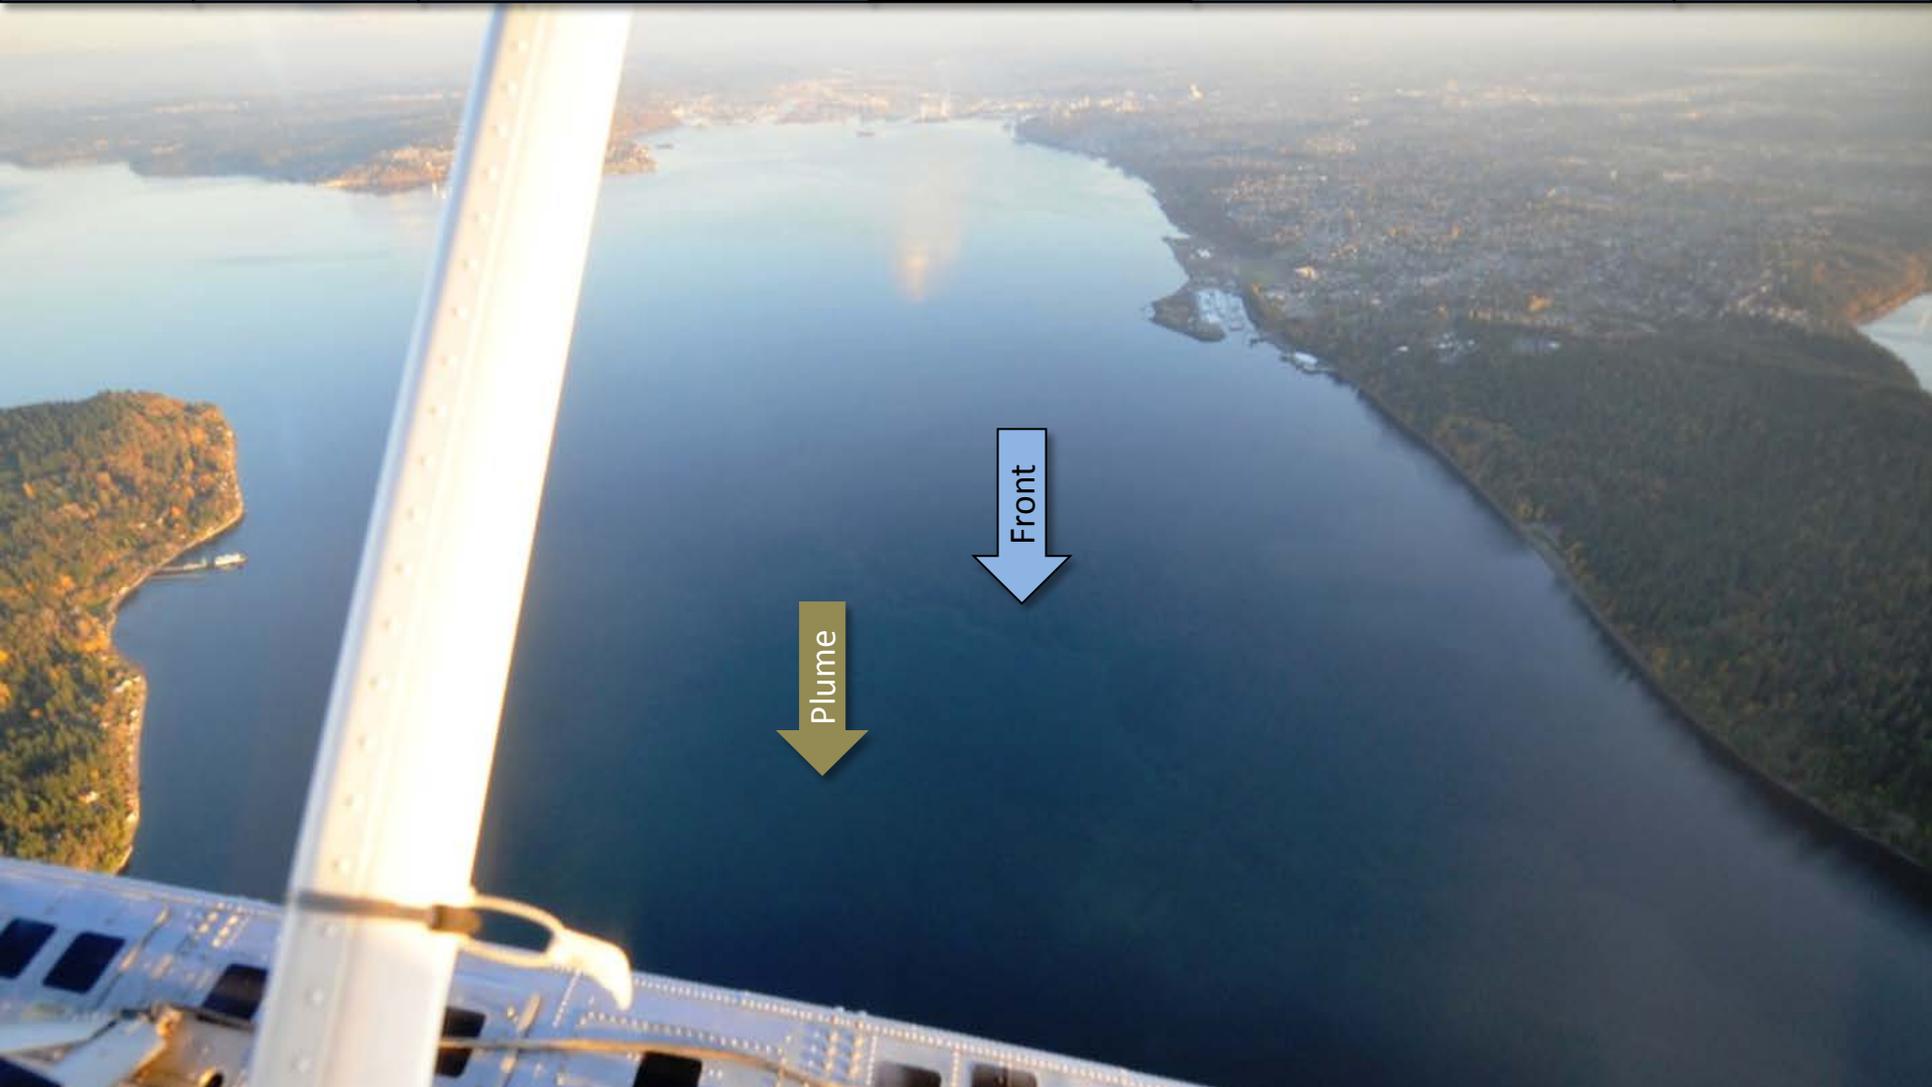
Water masses meet. Location: Near Point Defiance, Tacoma (Central Sound), 4:09PM

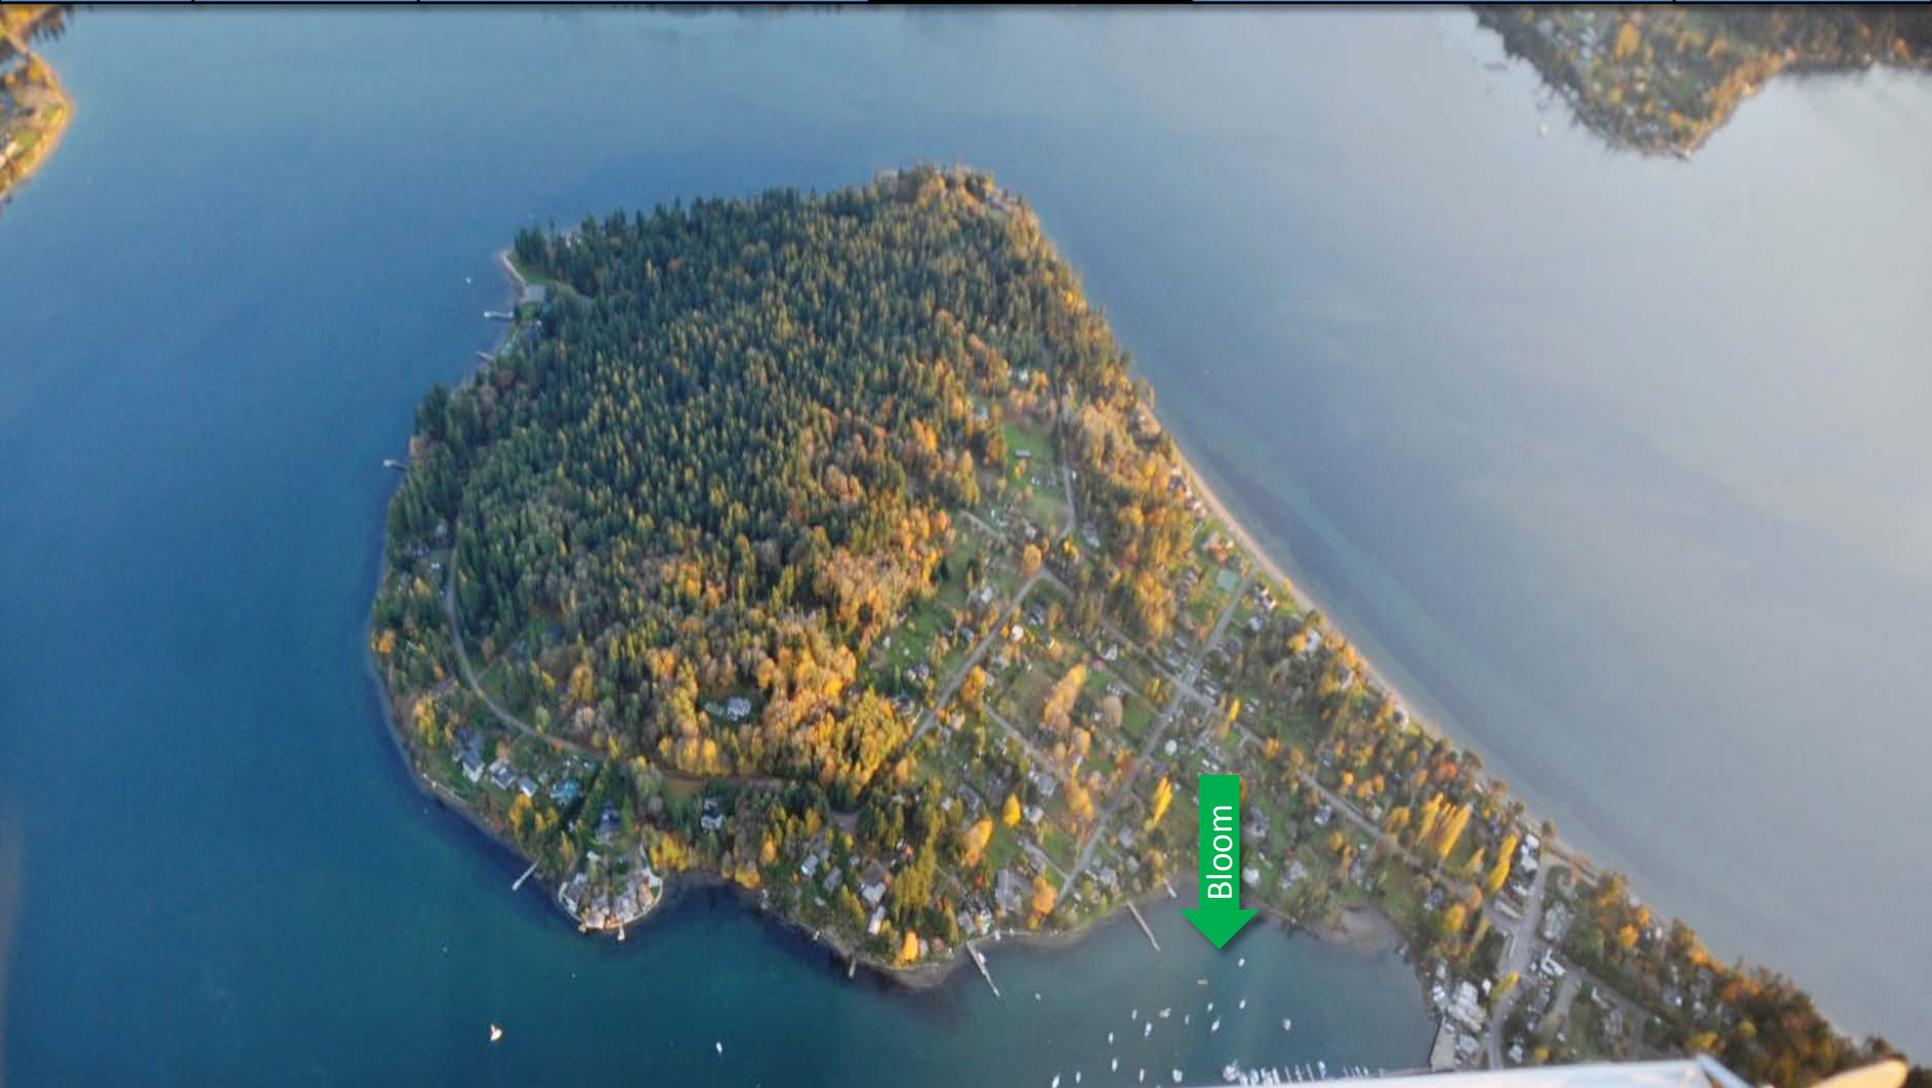
Higher algal abundance. Location: Northern Quartermaster Harbor (Central Sound), 4:12 PM

Visible blooms: 13

Green: Northern end of Quartermaster Harbor

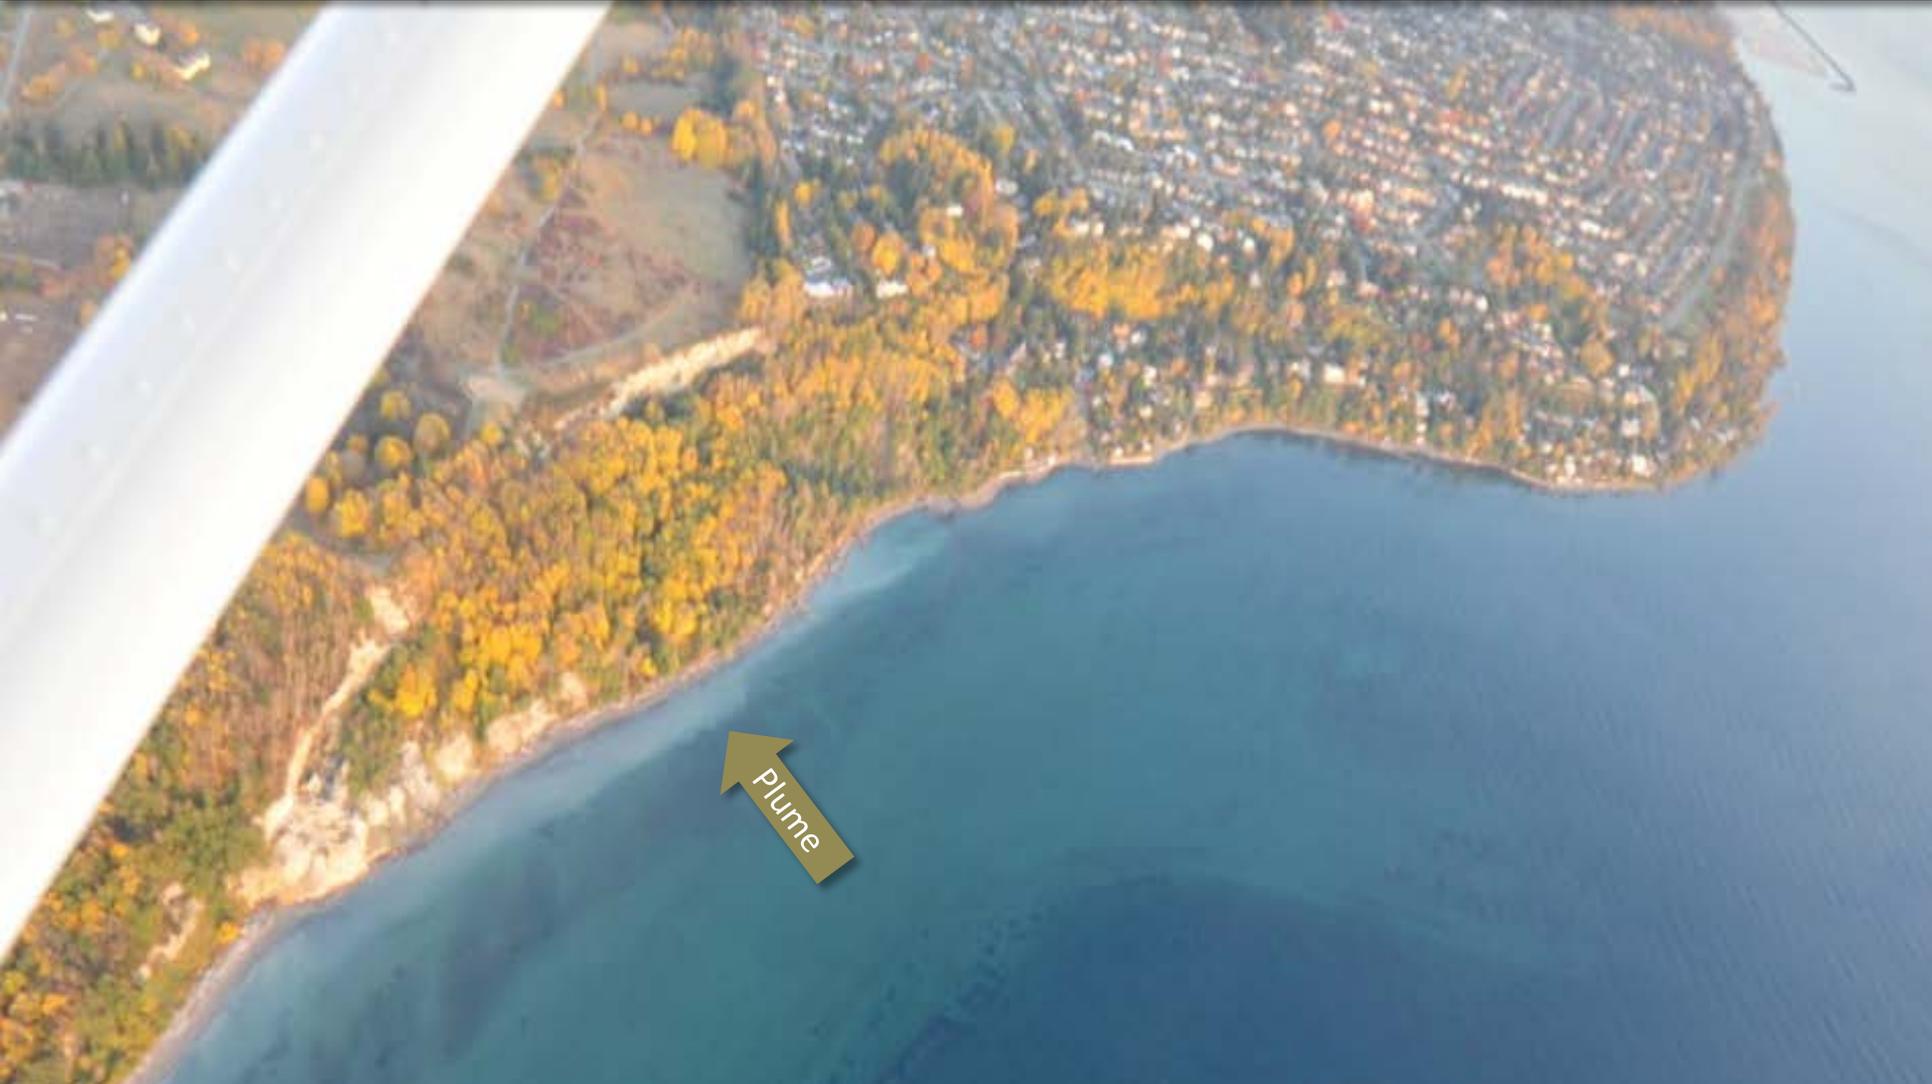
Beach erosion or freshwater? Location: Discovery Park, Seattle (Central Sound), 4:22 PM

Suspended sediment: 15

South of Discovery Park, Seattle

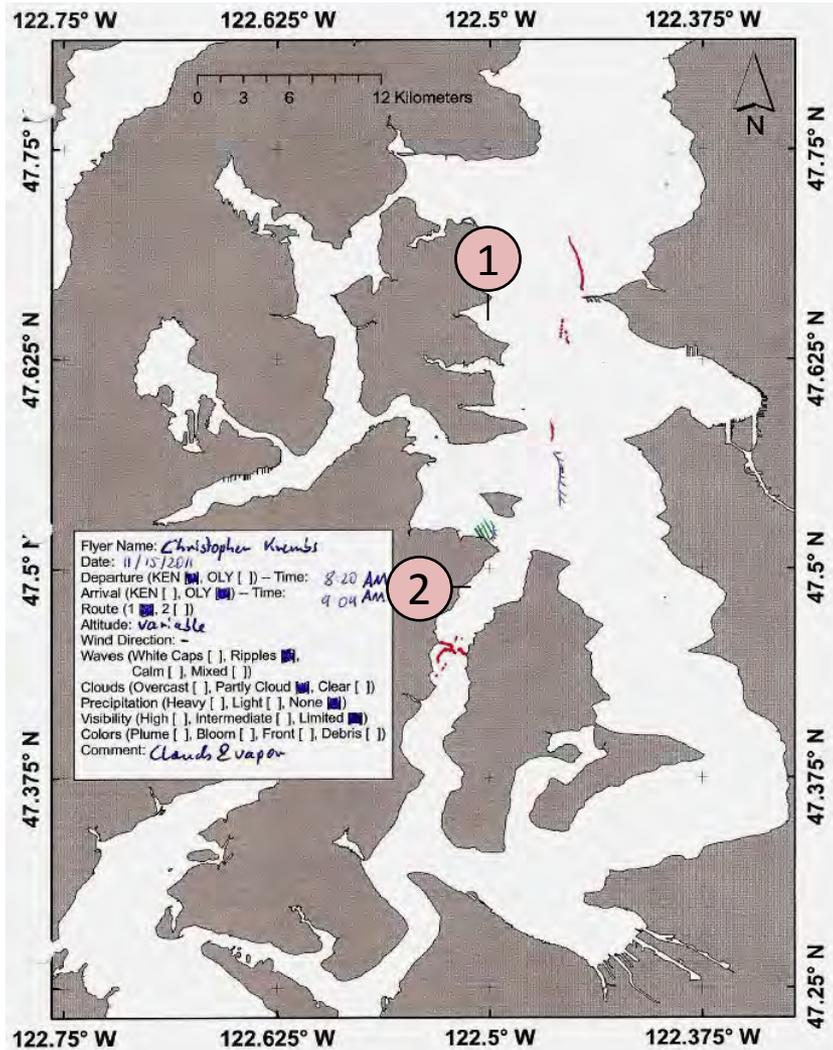
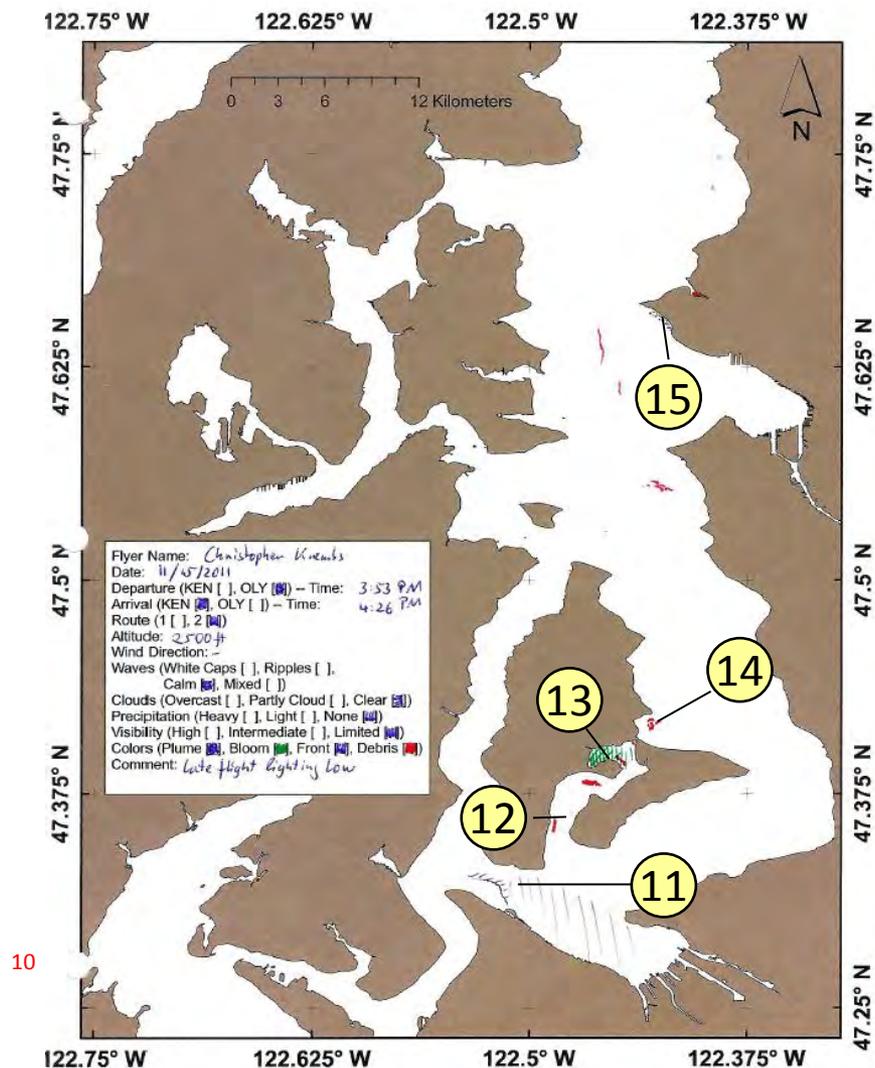
Aerial photography observations in Central Sound

Numbers on map refer to picture numbers for spatial reference

Maps are produced by observers during and after flight and intended to give an approximate reconstruction of surface conditions on scales that connect to and overlap with satellite images in the following section.
