Eyes Over Puget Sound

Surface Conditions Report November, 15th 2011

Up-to-date observations of visible water quality conditions in Puget Sound and the Strait of Juan de Fuca

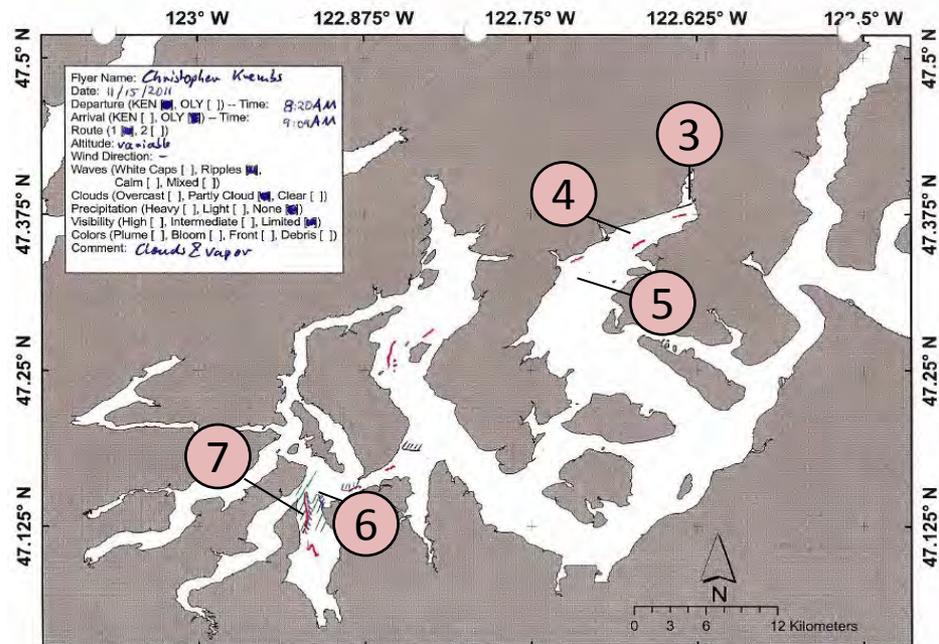
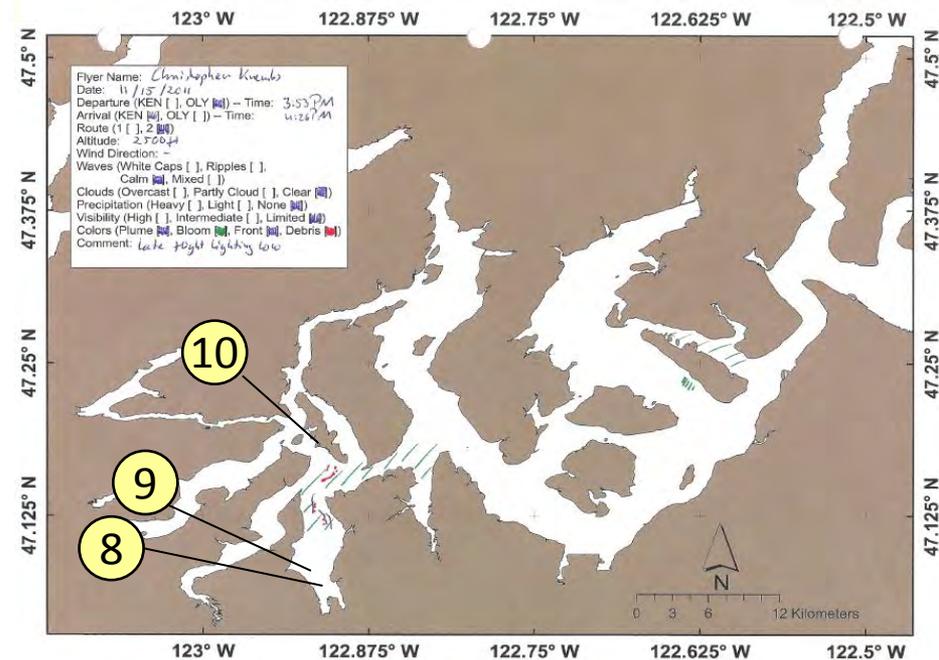
Observations in
South Sound:
11-15-2011

Numbers on map refer to picture
numbers for spatial reference

Maps are produced by observers during and after flight and intended to give an approximate reconstruction of surface conditions on scales that connect to and overlap with satellite images in the following section.

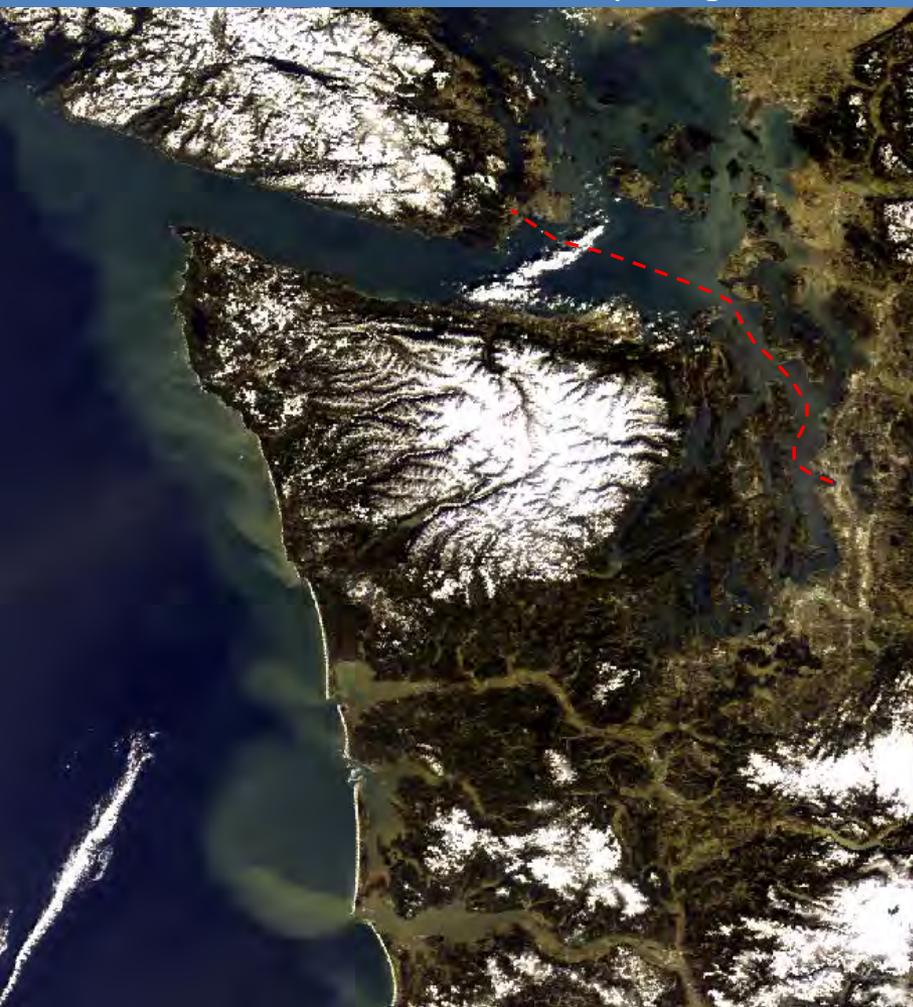
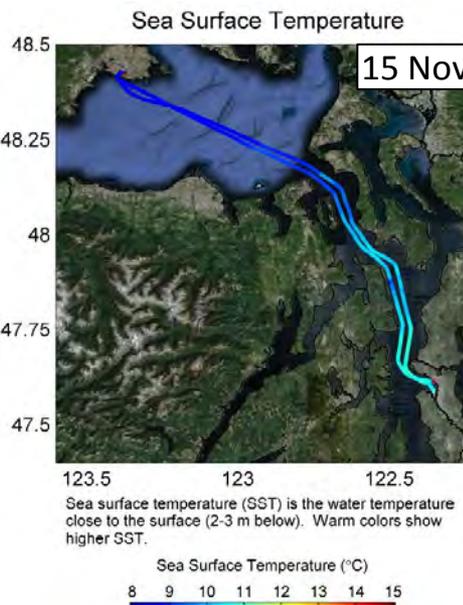
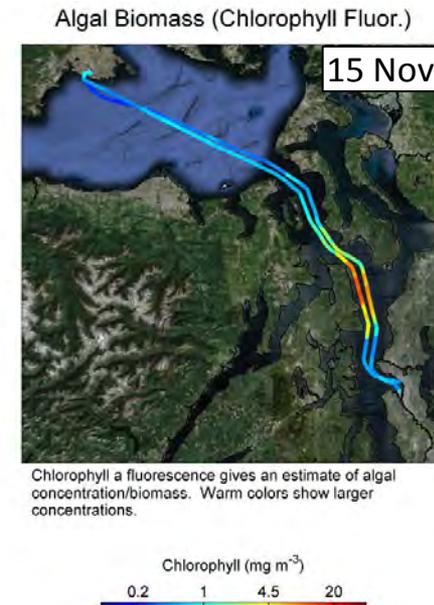
Daily ferry and satellite observations in Central Sound, 11-15-2011

Current Conditions: Phytoplankton bloom can be seen in Central Sound (associated with increased river discharge); lowest fluorescence values in Strait of Juan de Fuca; surface temperatures in Central Sound range from 10-11 °C and 9-10 °C in Strait of Juan de Fuca.

MERIS True Color image used for spatial context (19 February 2011). Image is not coincident with ferry data shown on right

Temperatures continue to cool and increased stratification near entrance to Whidbey Basin promotes brief phytoplankton bloom

A relatively short-lived, but intense, phytoplankton bloom followed the latest pulse of freshwater entering Puget Sound from Whidbey Basin.

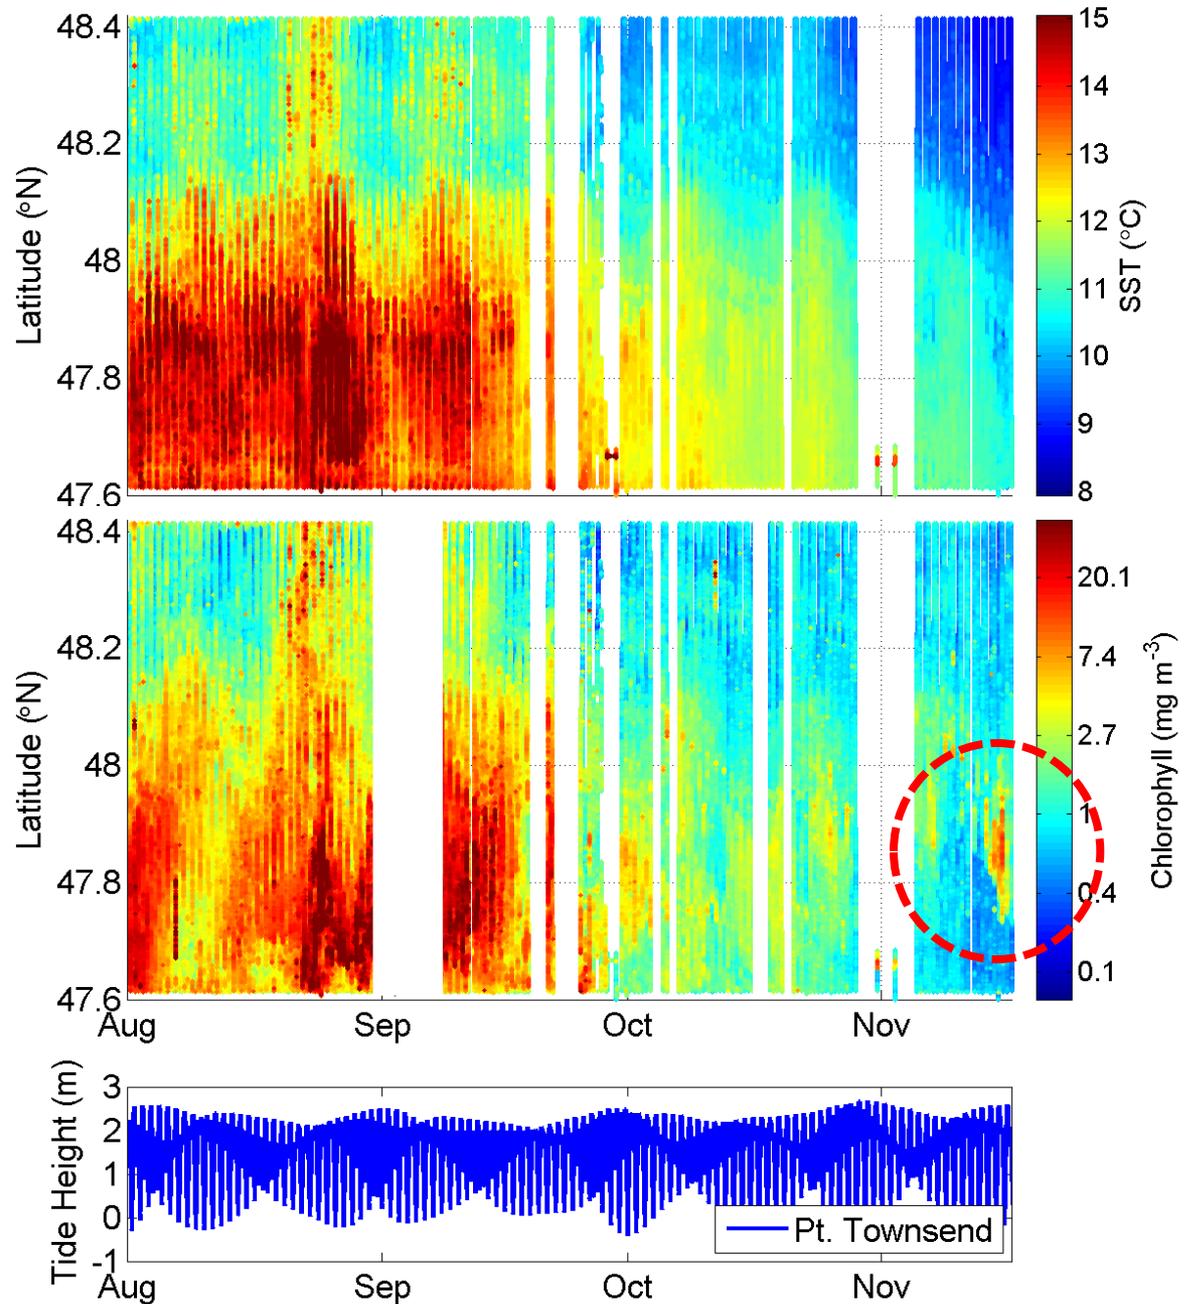
CDOM fluorescence as an indicator of freshwater influence in Central Sound

A primary source of [Colored Dissolved Organic Matter](#) (CDOM) to Puget Sound is from rivers.

Recent rainfall events and increasing river discharge lead to highly colored pulses of water moving from Whidbey Basin (dashed black line) into Central Sound.

Latest freshwater pulse likely lead to increased stratification that promoted a brief phytoplankton bloom.

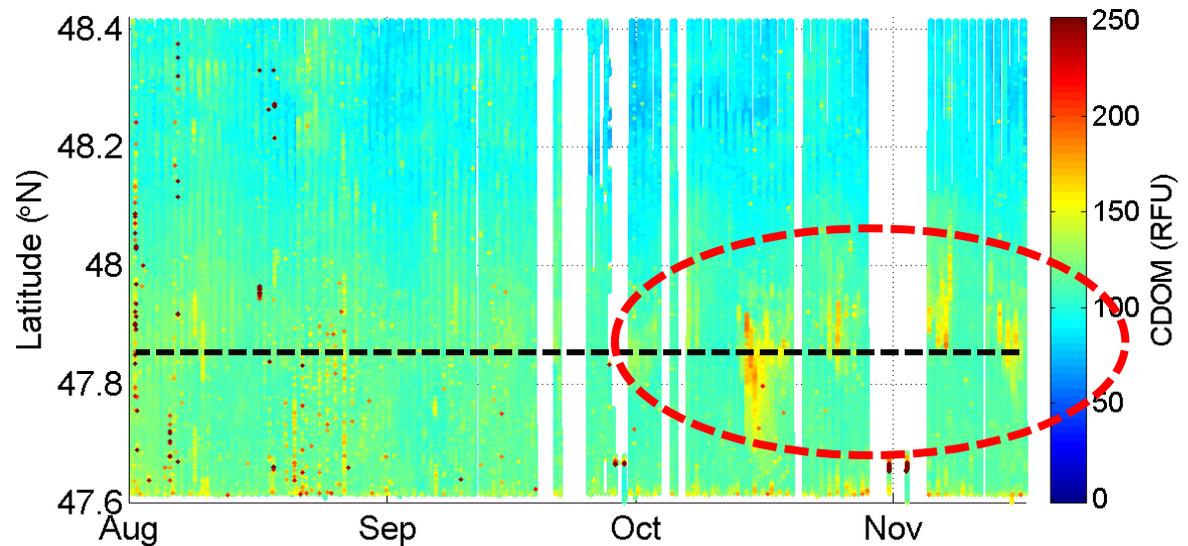
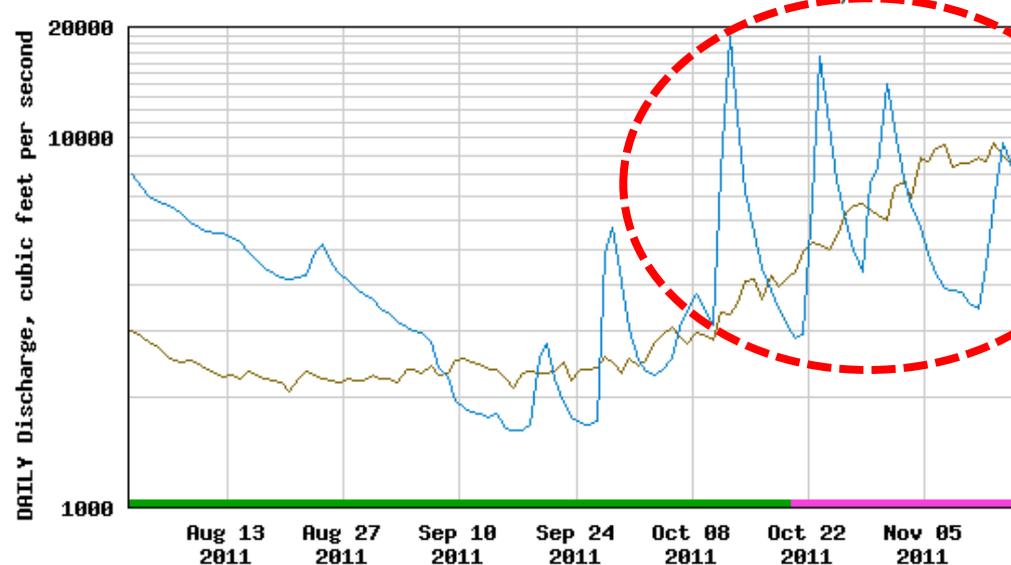
USGS 12150800 SNOHOMISH RIVER NEAR MONROE, WA

— Median daily statistic (48 years) — Period of approved data
 — Daily mean discharge — Period of provisional data

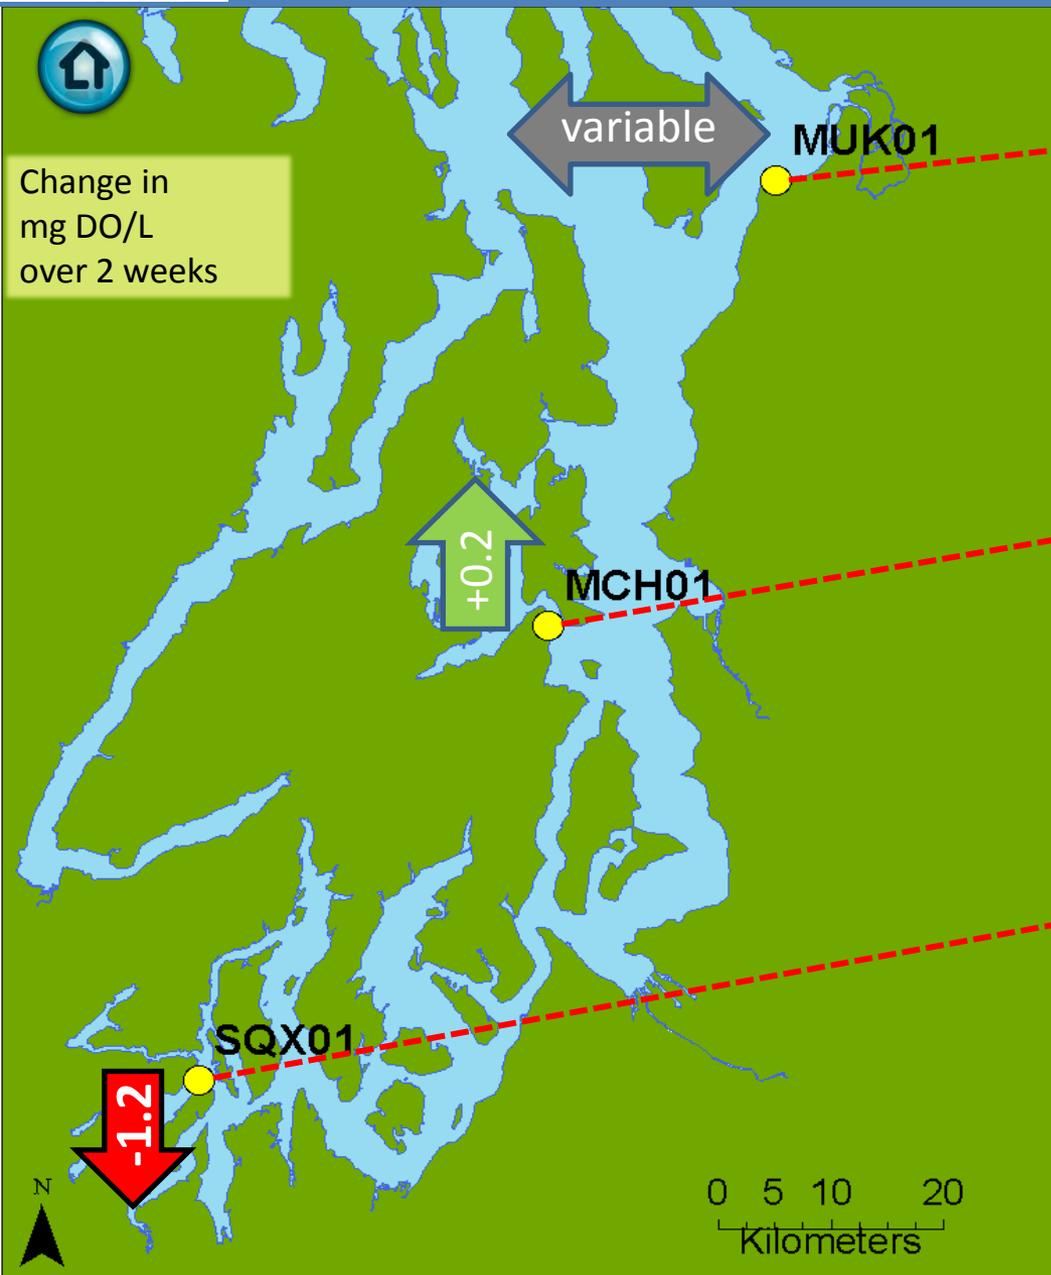
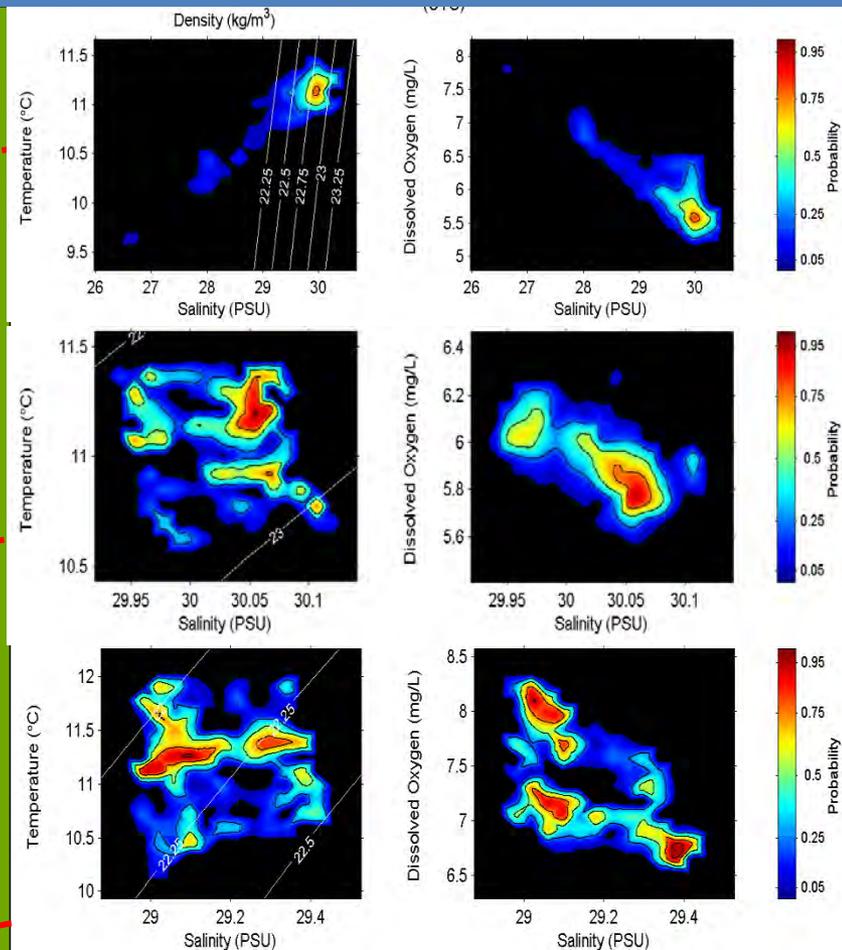
Water Masses and DO from our Moorings: Nov. 2-16, 2011

Left Panel: Probability of finding a specific density over the past two-week period. High probability shown in warm colors.

Right Panel: Dissolved oxygen concentration in relation to salinity. High probability shown in warm colors.

Summary: Over the past 2 weeks, waters have become colder, fresher in Whidbey Basin, colder in the Central Basin, colder and saltier in South Sound, accompanied by a decline in DO.
