M E M O R A N D U M

Subject: Conditions Encountered in Pt. Angeles Harbor
on Marine Flight II

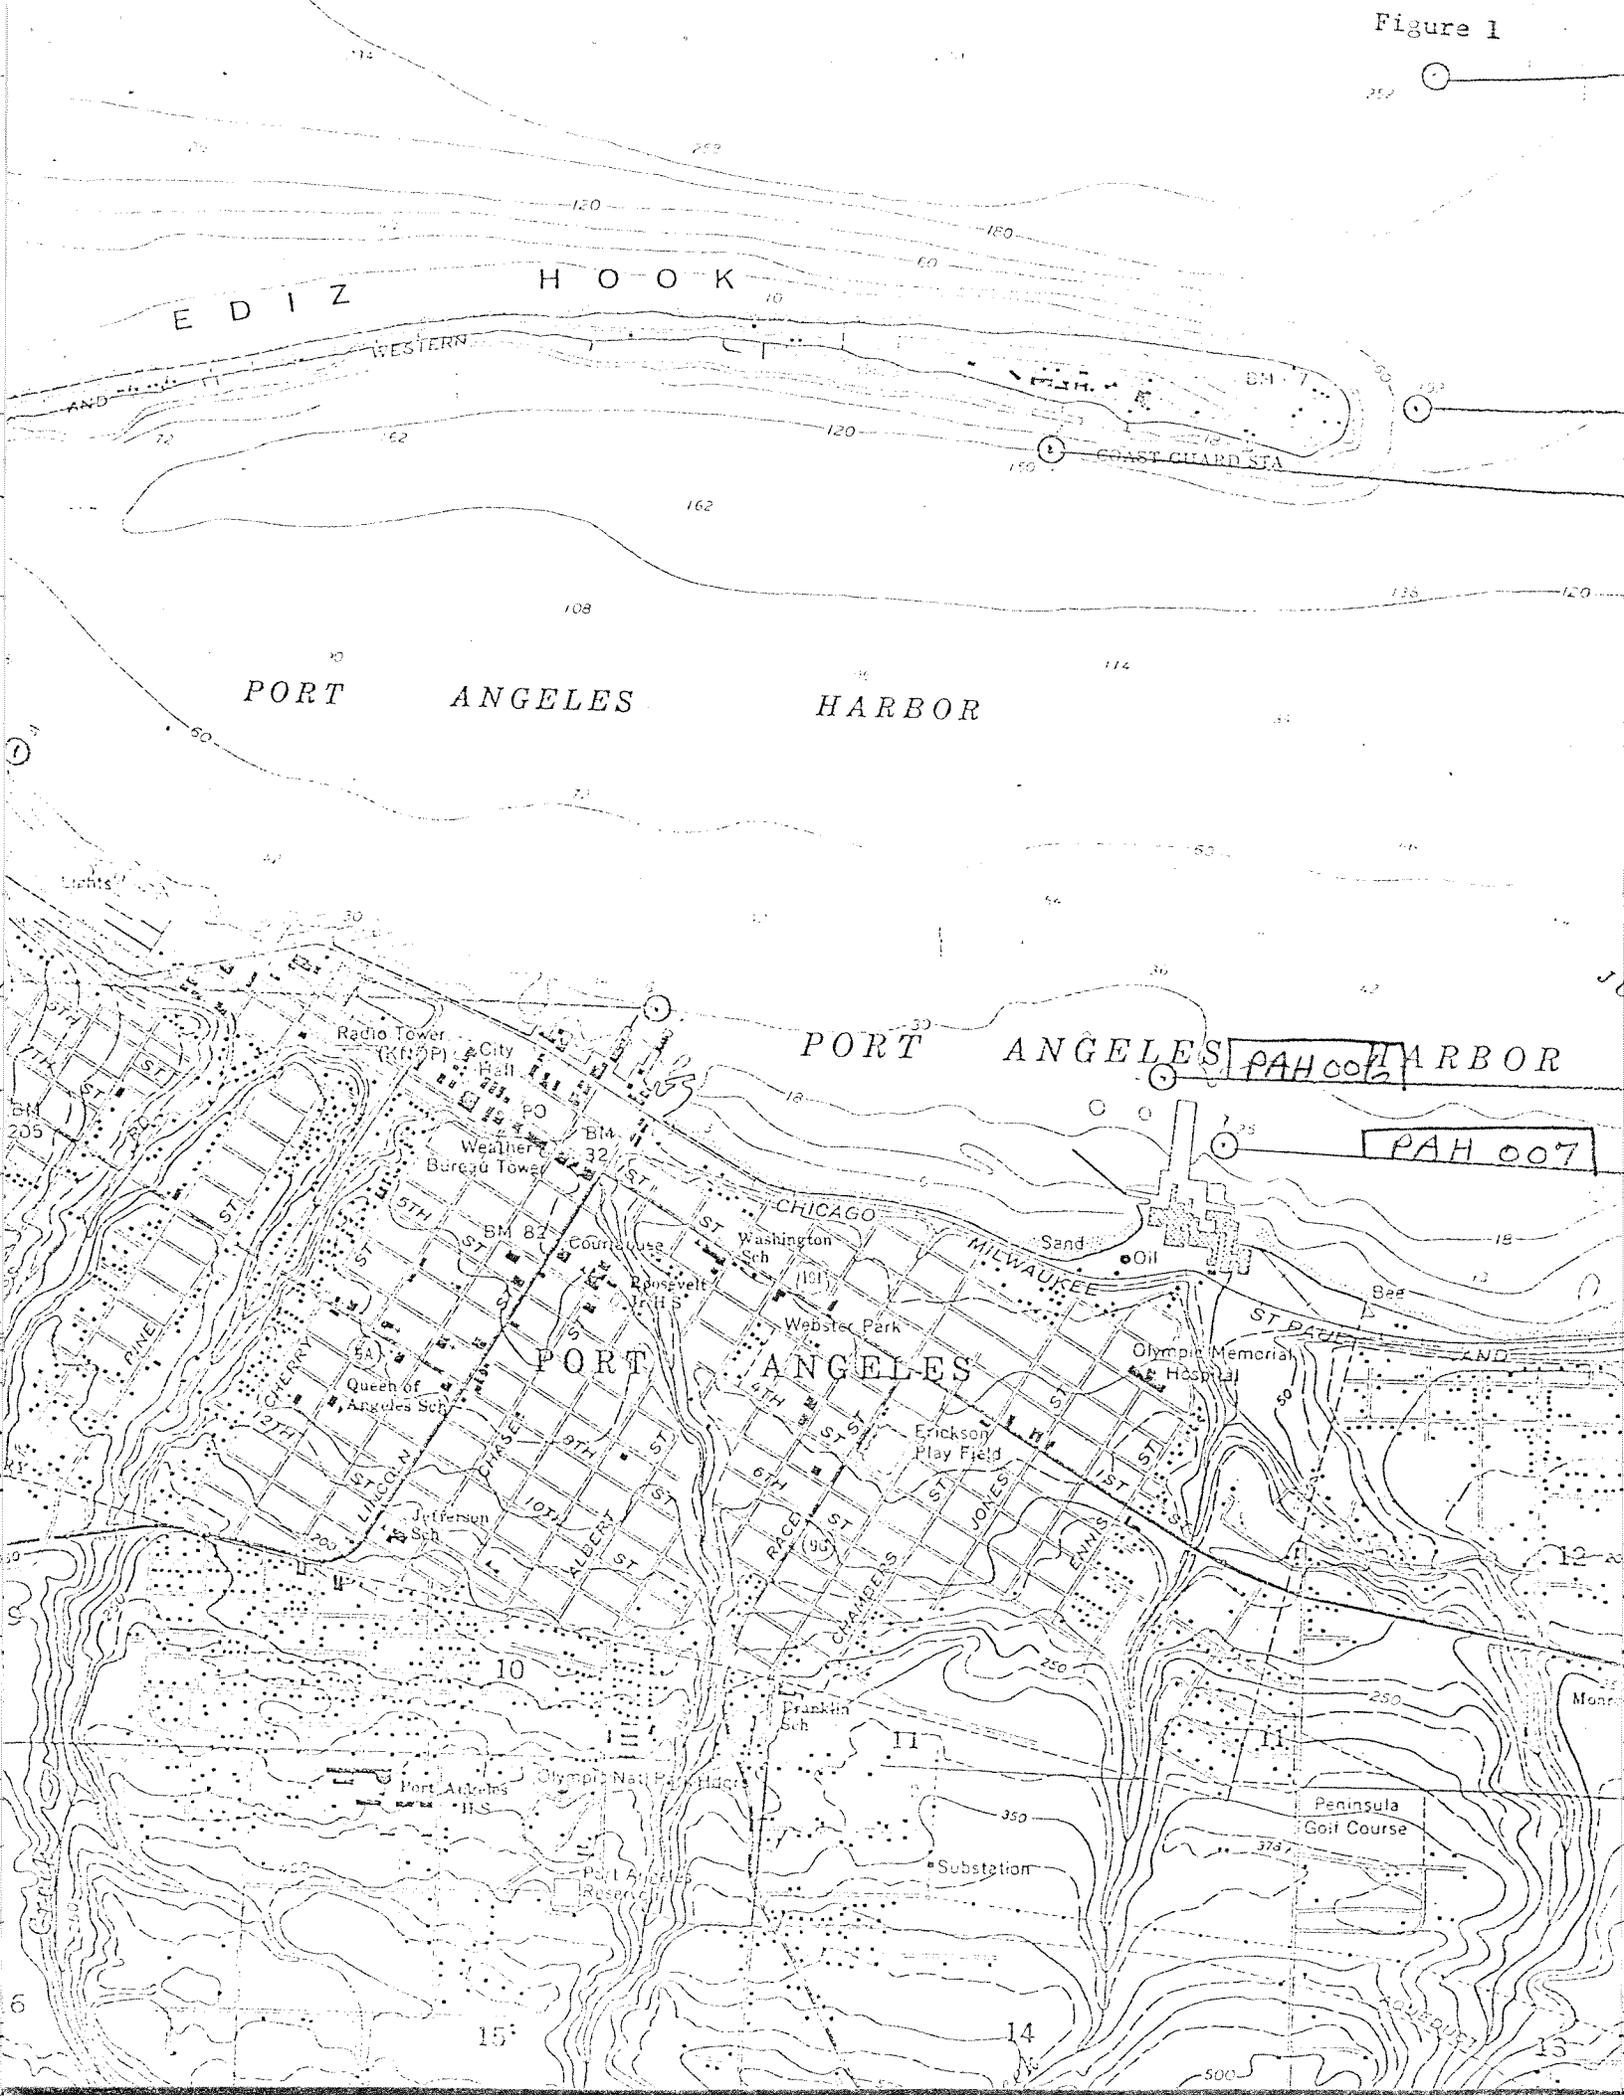
Figure 1

During the normal sampling of Routine Monitorings Marine Air Flights a change in water quality was observed at the ITT Rayonier Mill dock in Port Angeles. Two marine sampling stations, PAH 007 and PAH 006, are located on either side of the main finger pier (see accompanying map, Figure 1). During a period in May and June the mill was closed down due to contract negotiations. Within this period two routine visits were made to the Port Angeles Harbor area. The physical appearance of the water had greatly improved. The water had taken on a color more characteristic of the Straits instead of the brown-red or black color of sulfite liquor waste.

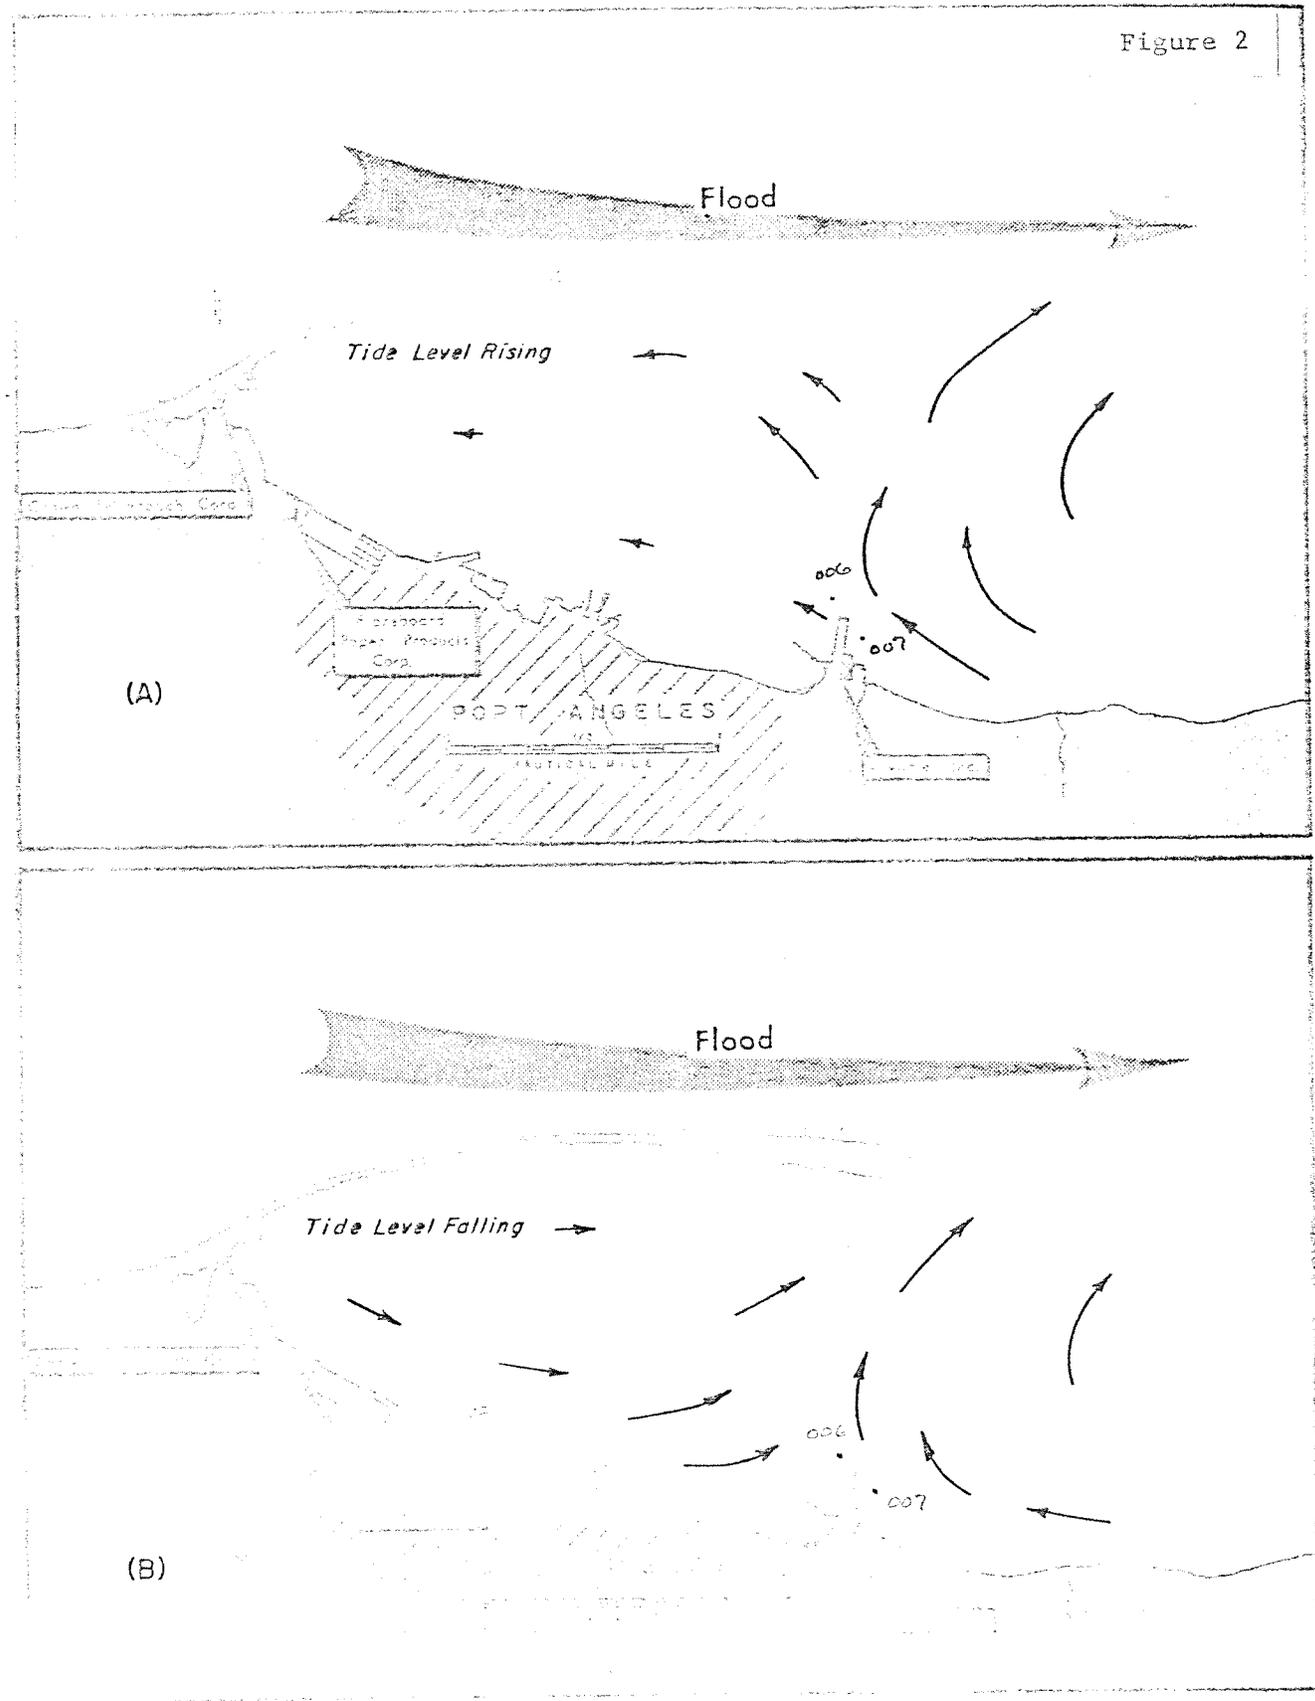
The two stations located at the mill are on a tide division line between the inner Port Angeles Harbor water and a large eddy of cleaner water from the Strait of Juan de Fuca. The maps (Figures 2 and 3) show the tidal current action on both flood and ebb tides (Pollutional Effects of Pulp and Mill Wastes in Puget Sound, March 1967). The historical data (9/27/67 - 9/16/70) indicates that PAH 006 station has a lower average SWL (229 mg/L) than PAH 007 (555 mg/L). This average is a combination of both surface and depth samples.

FIGURE 24-3. Patterns of surface circulation during flood current in the Strait and under conditions of (A) rising tide level and (B) falling tide level within the Harbor (after Charnell, 1958).

This would be substantiated by referring to Plates 2 and 3 and noticing the direction that the cleaner water travels in the area of the mill site. The only time that PAH 006 would possibly be as high or higher would be on a rising tide level of flood tide. If all tide cycles are considered, PAH 007 is within the SWL plume the majority of the time.

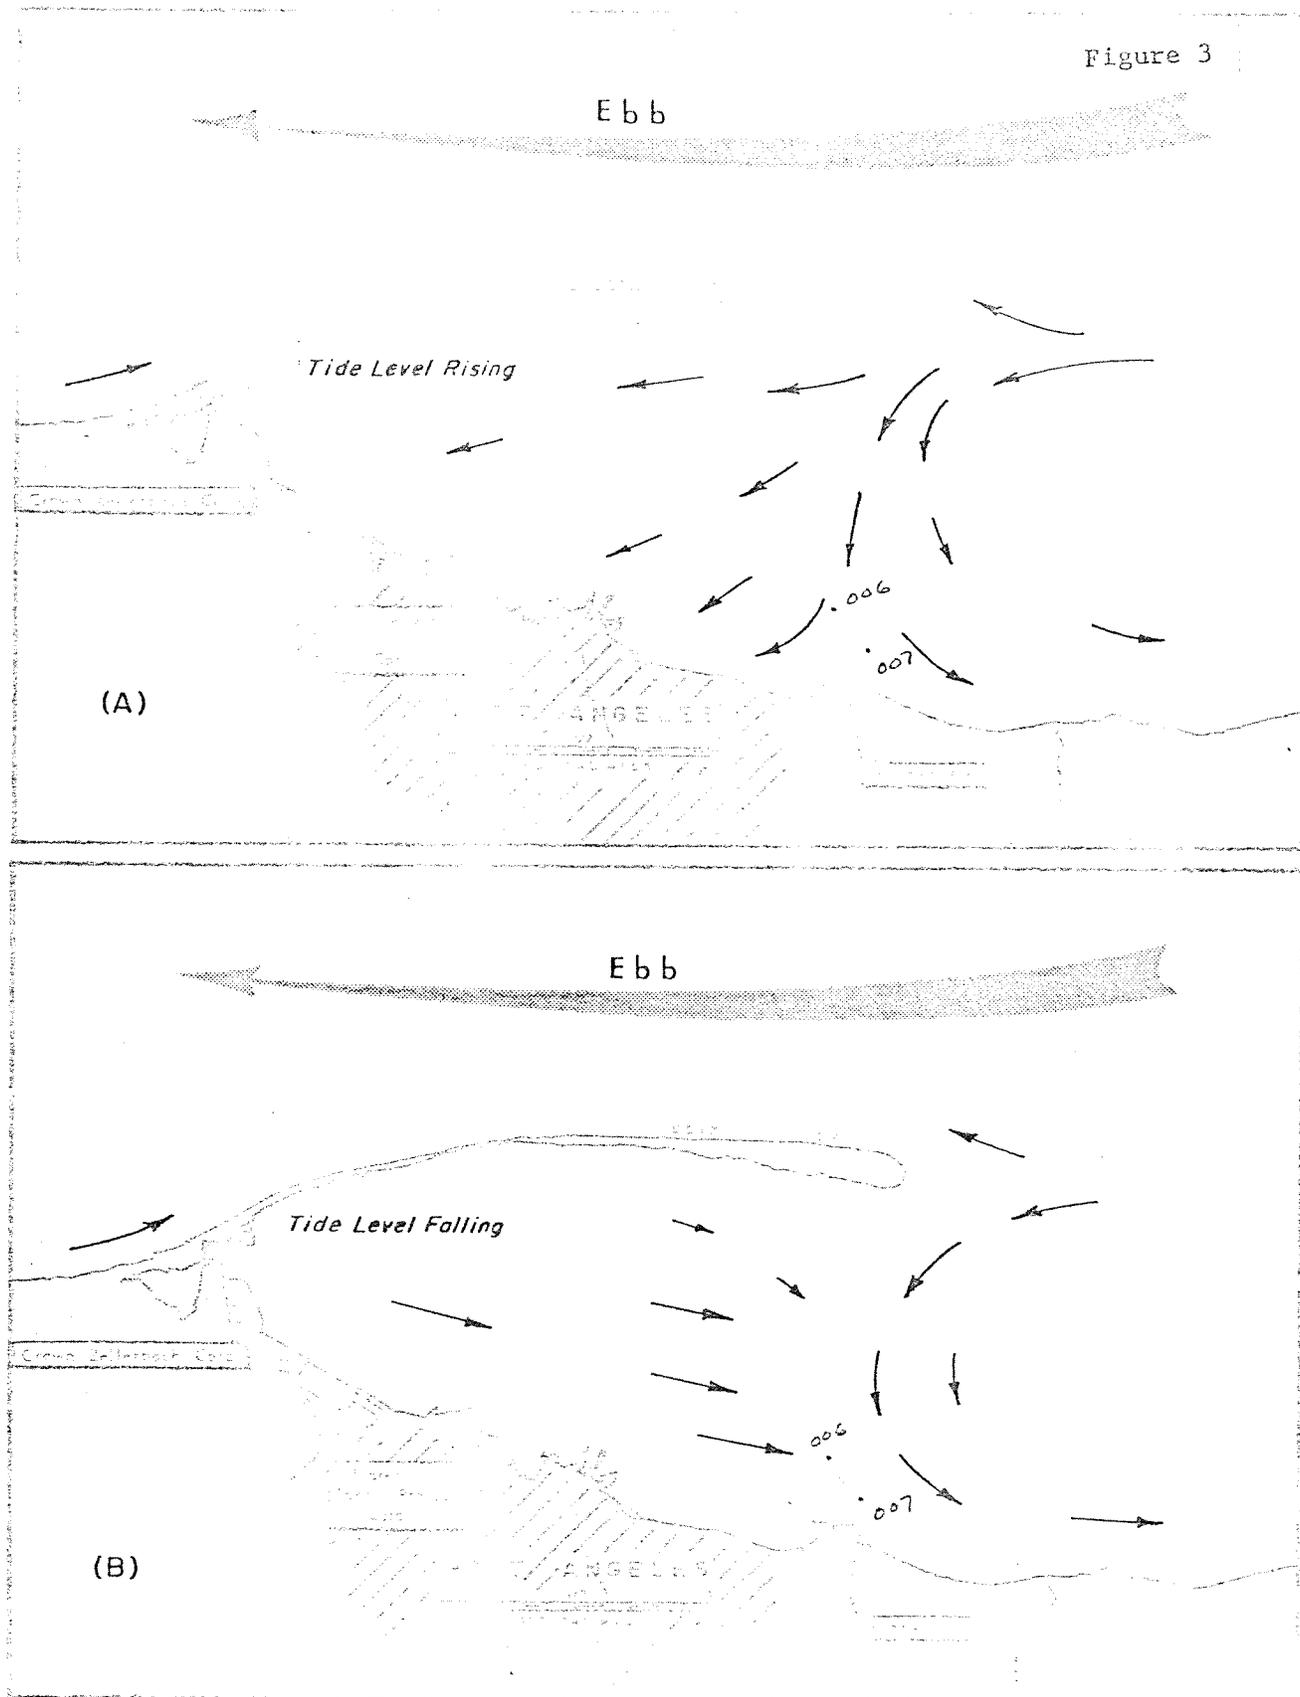
FIGURE 34-4. Patterns of surface circulation during ebb current in the Strait and under conditions of (A) rising tide level, and (B) falling tide level, within the Harbor (after Charnell, 1958).

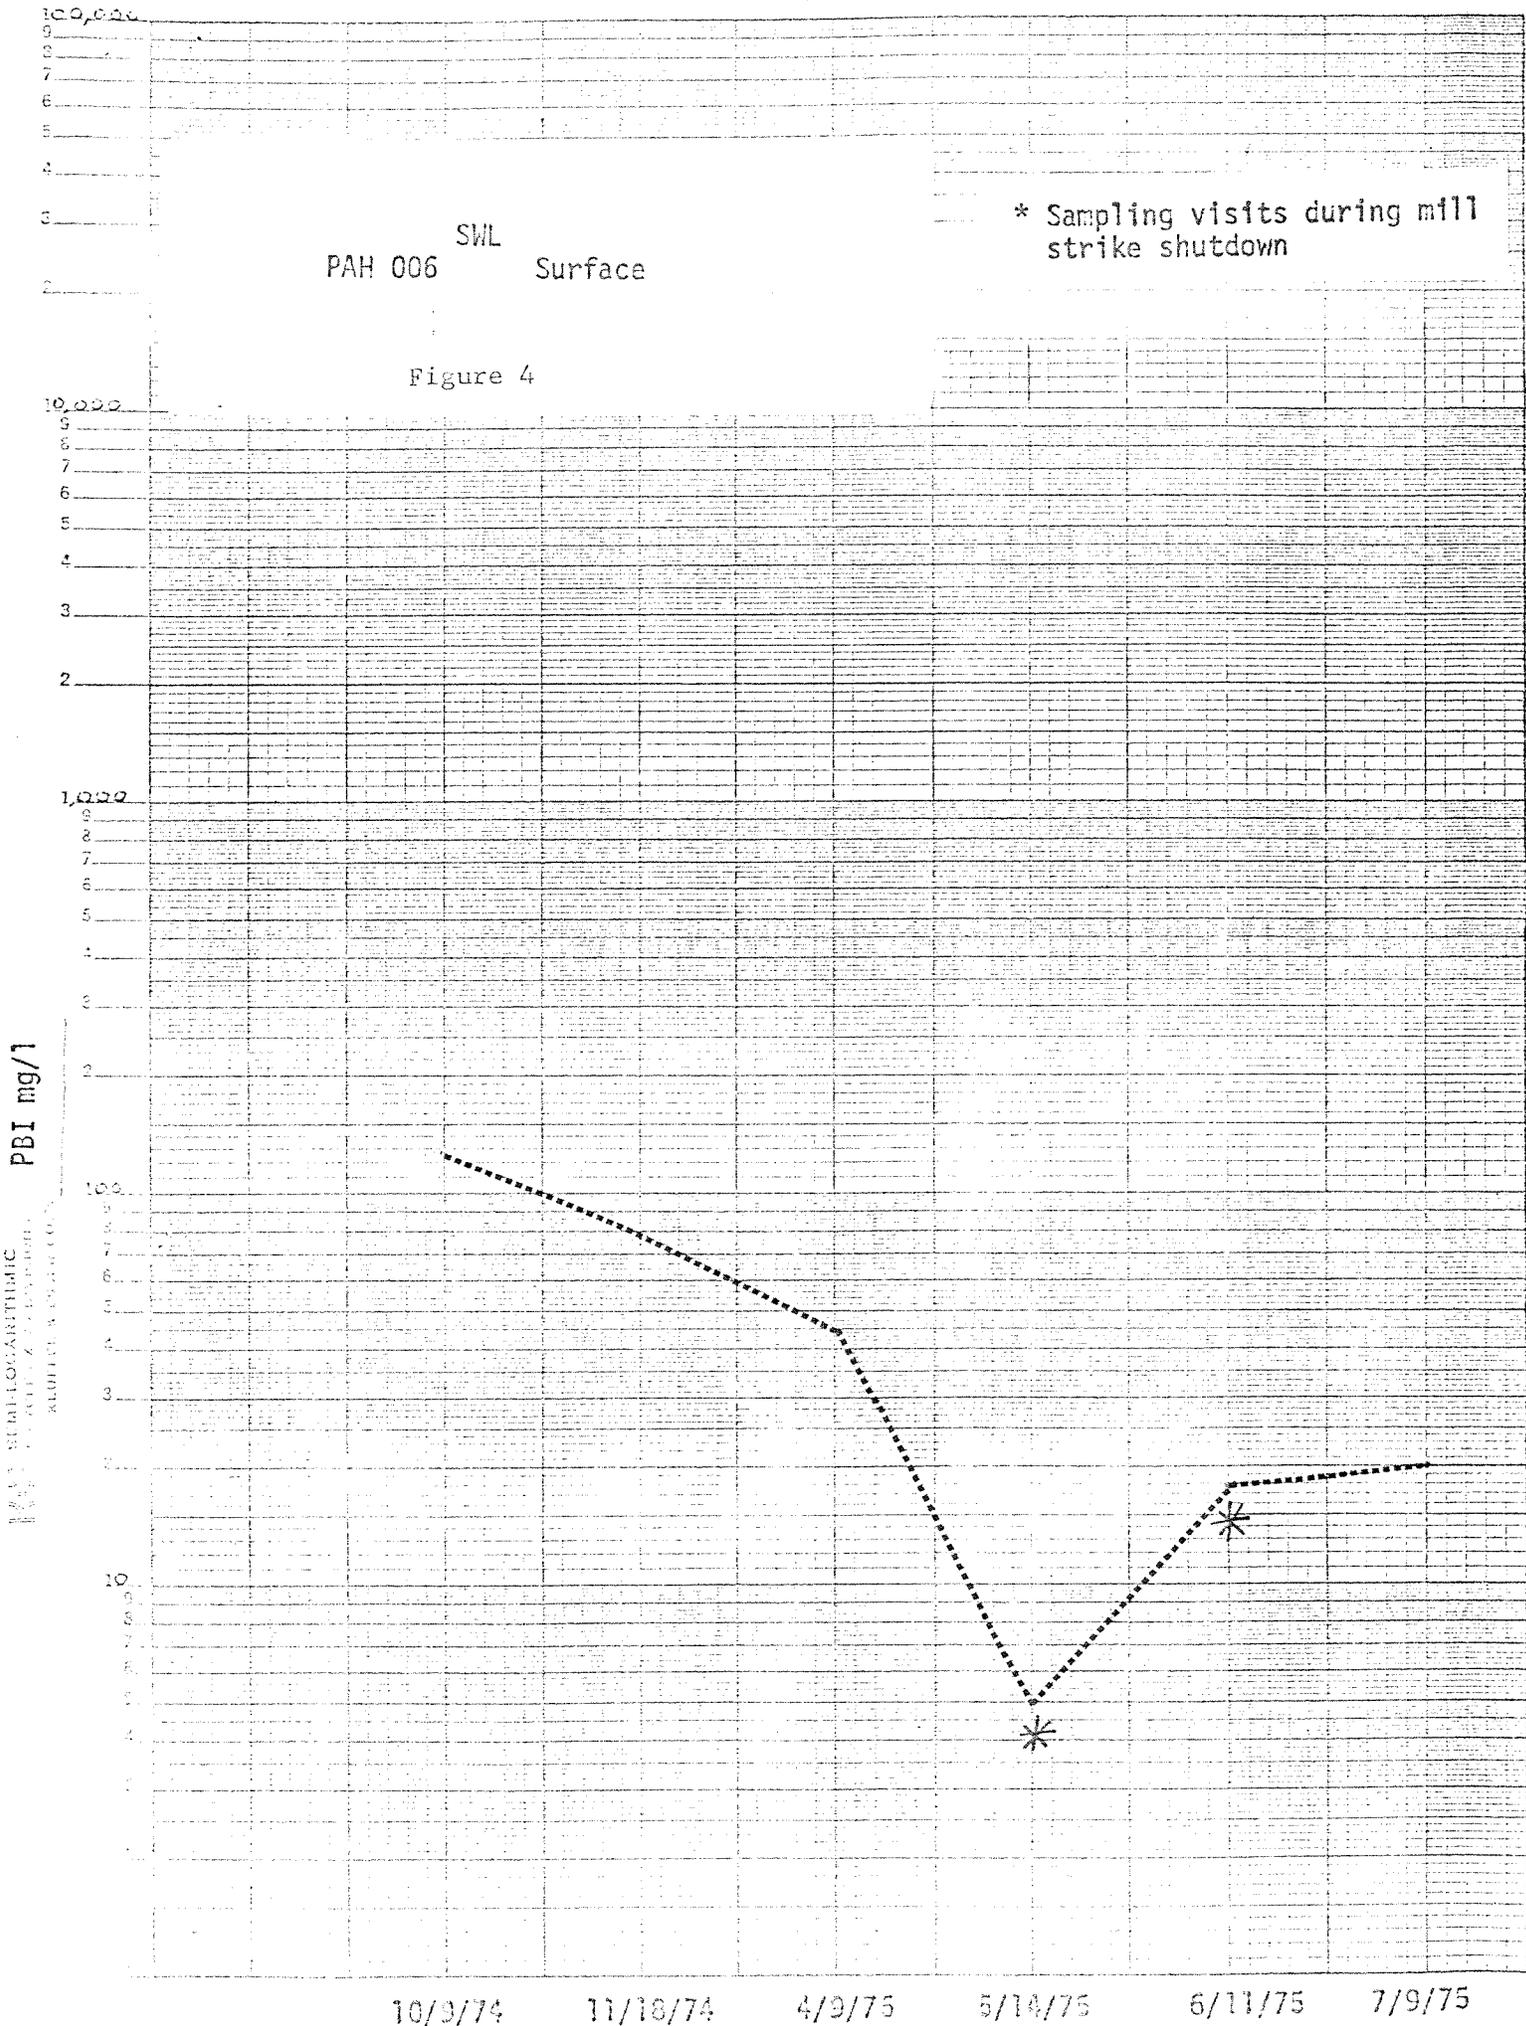
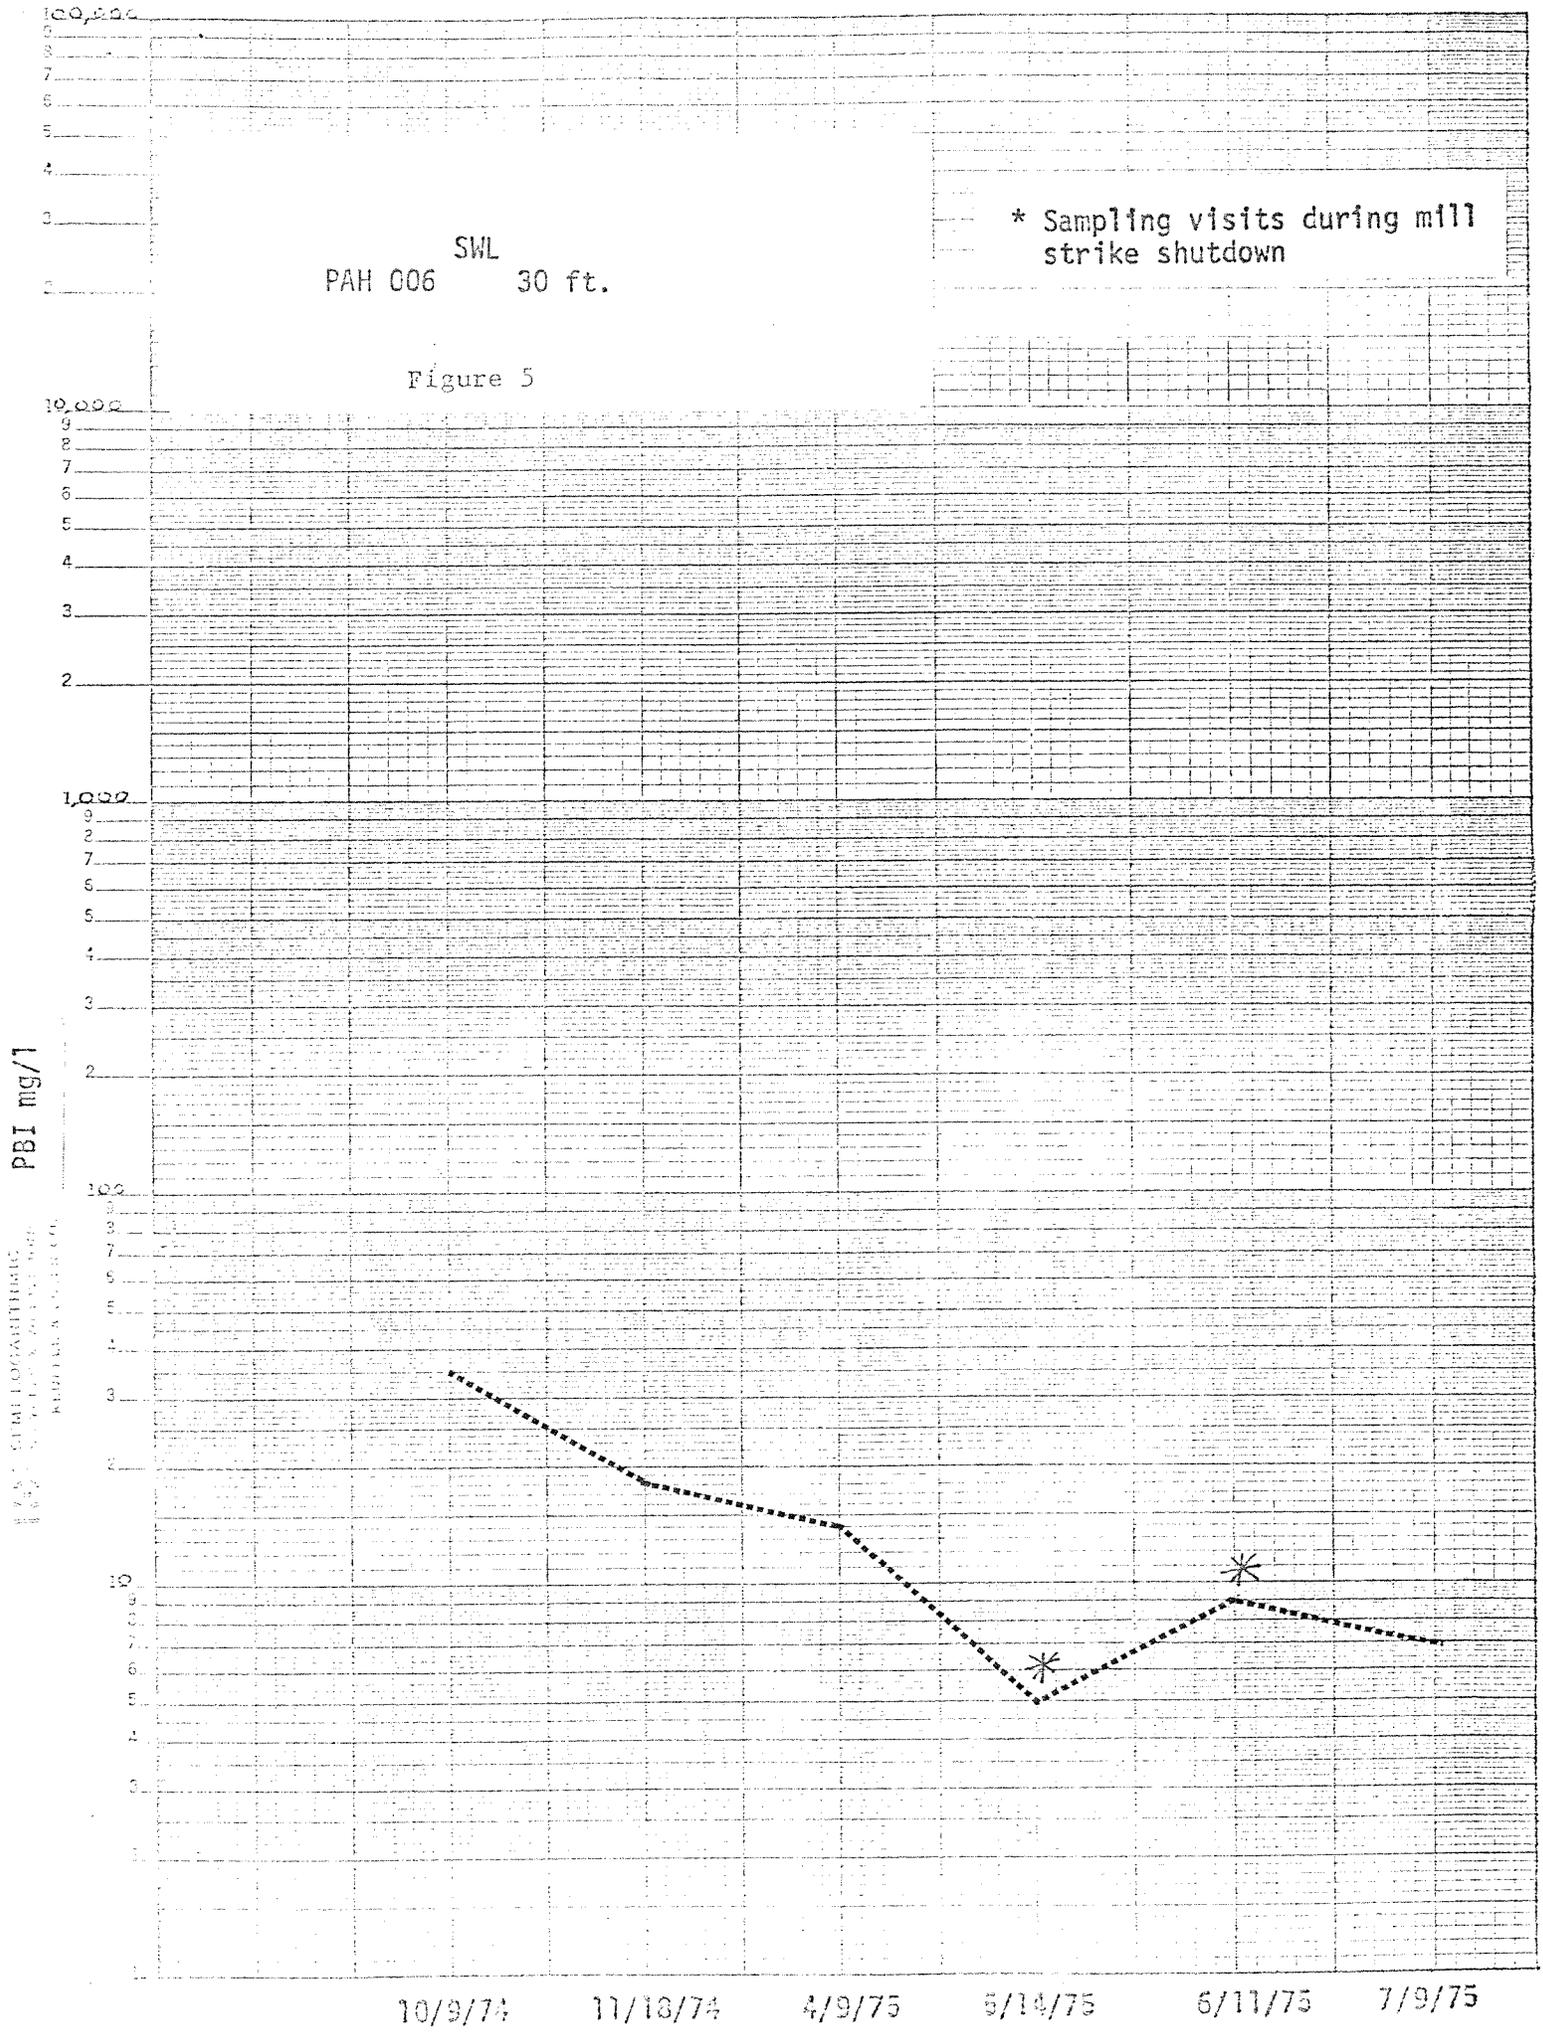
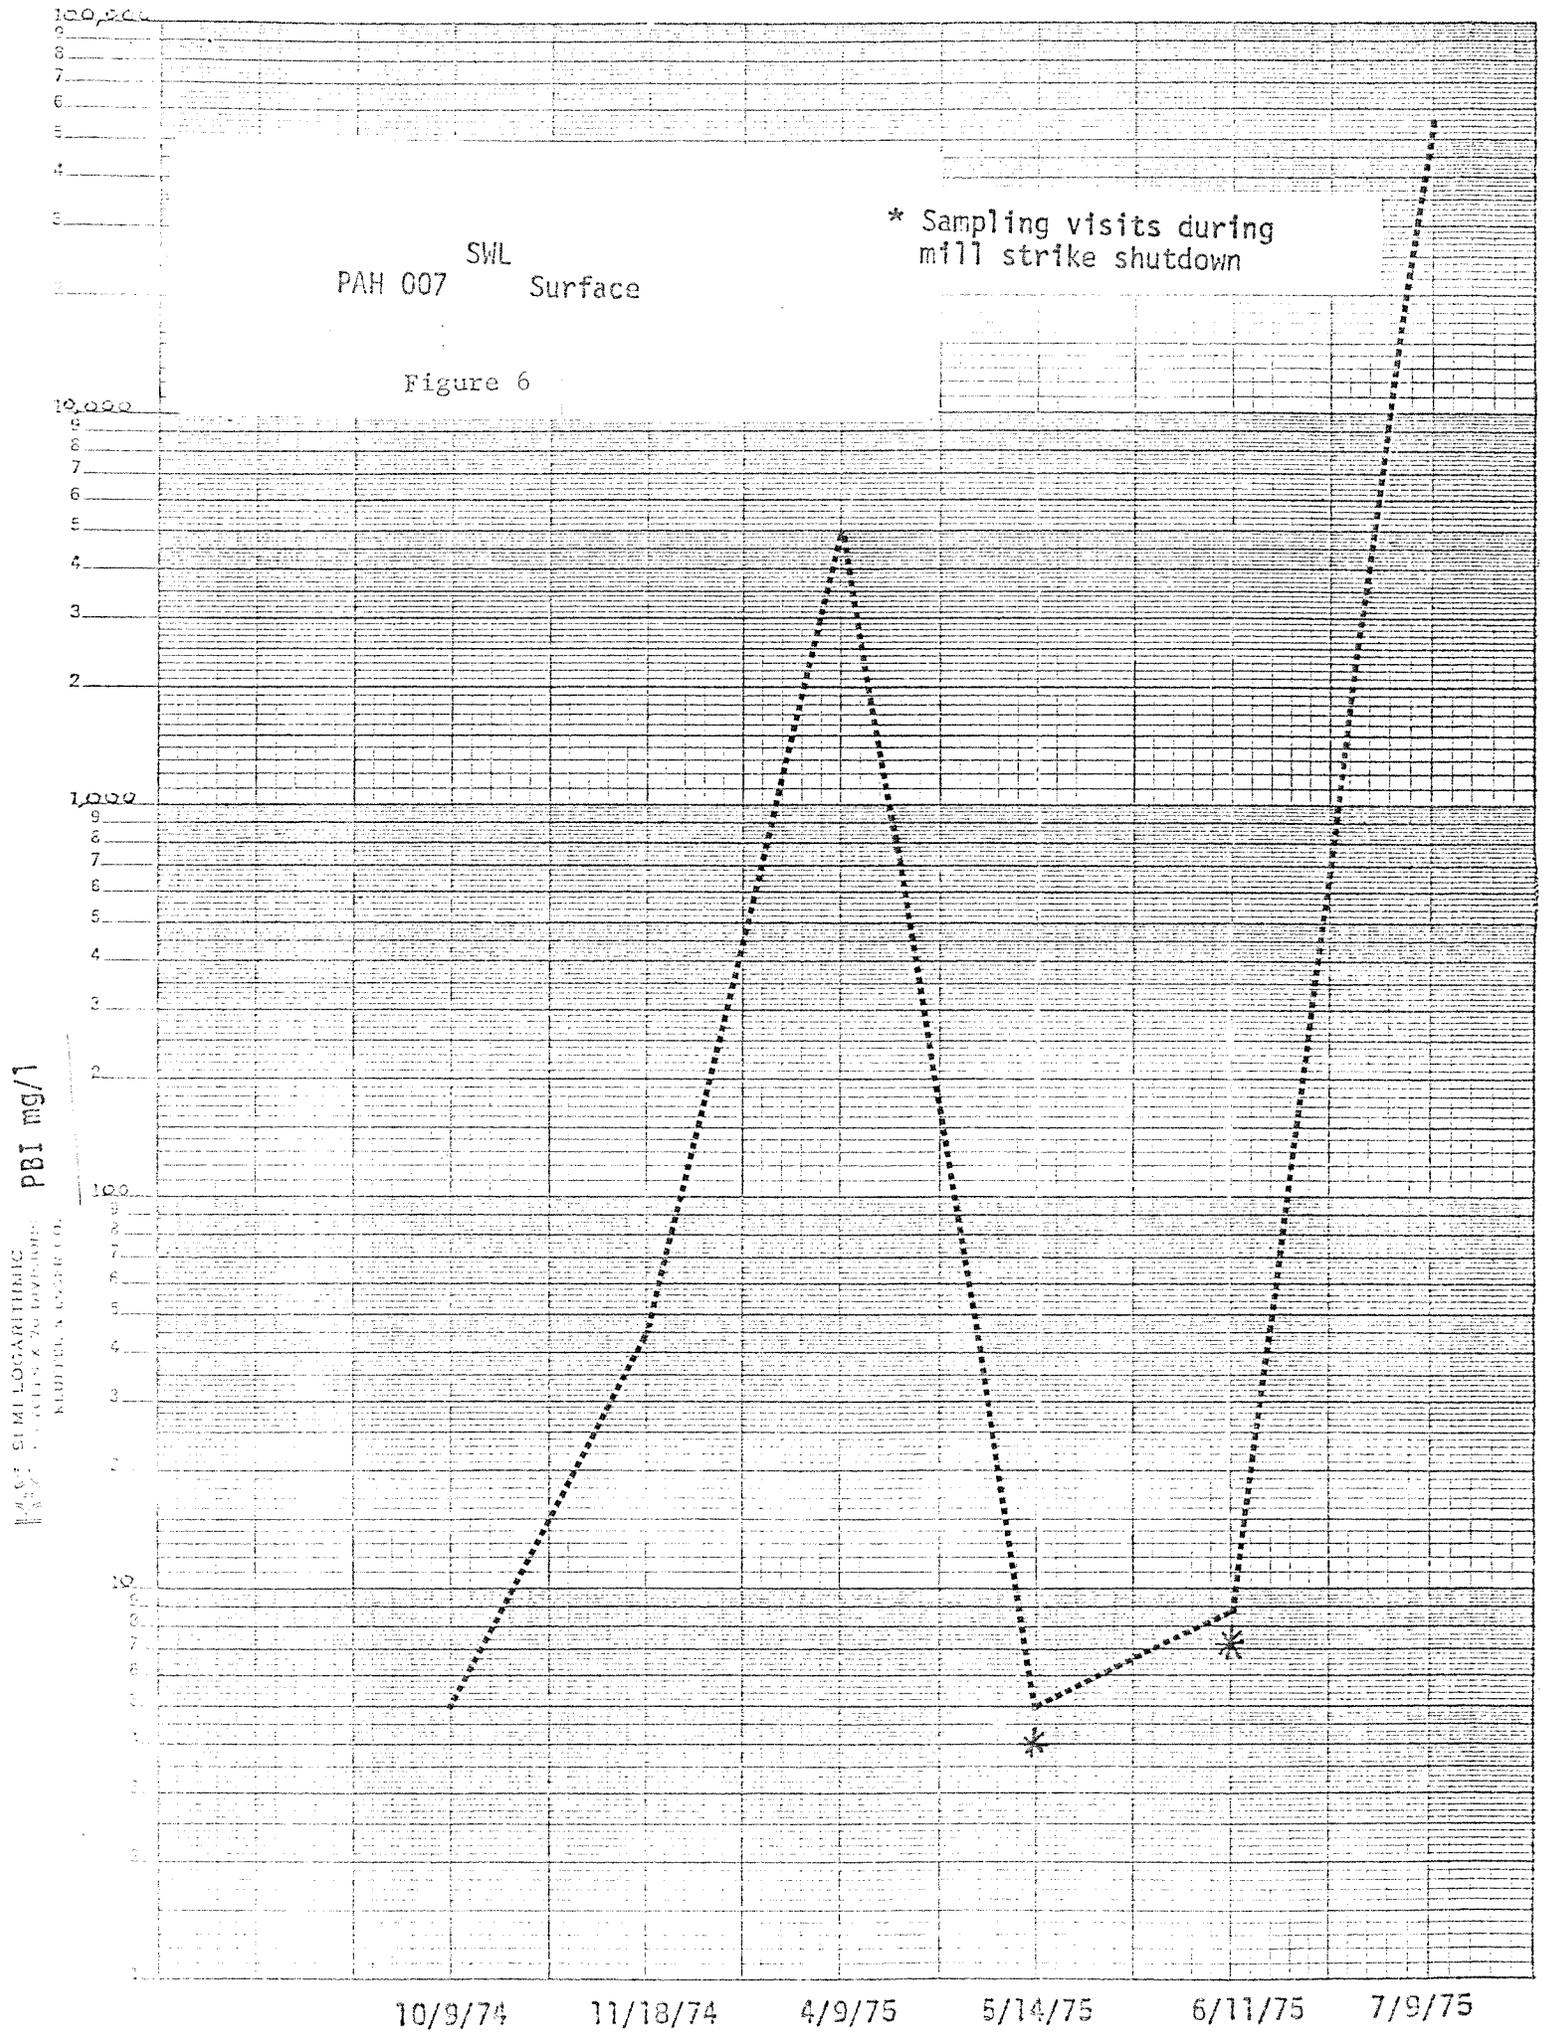
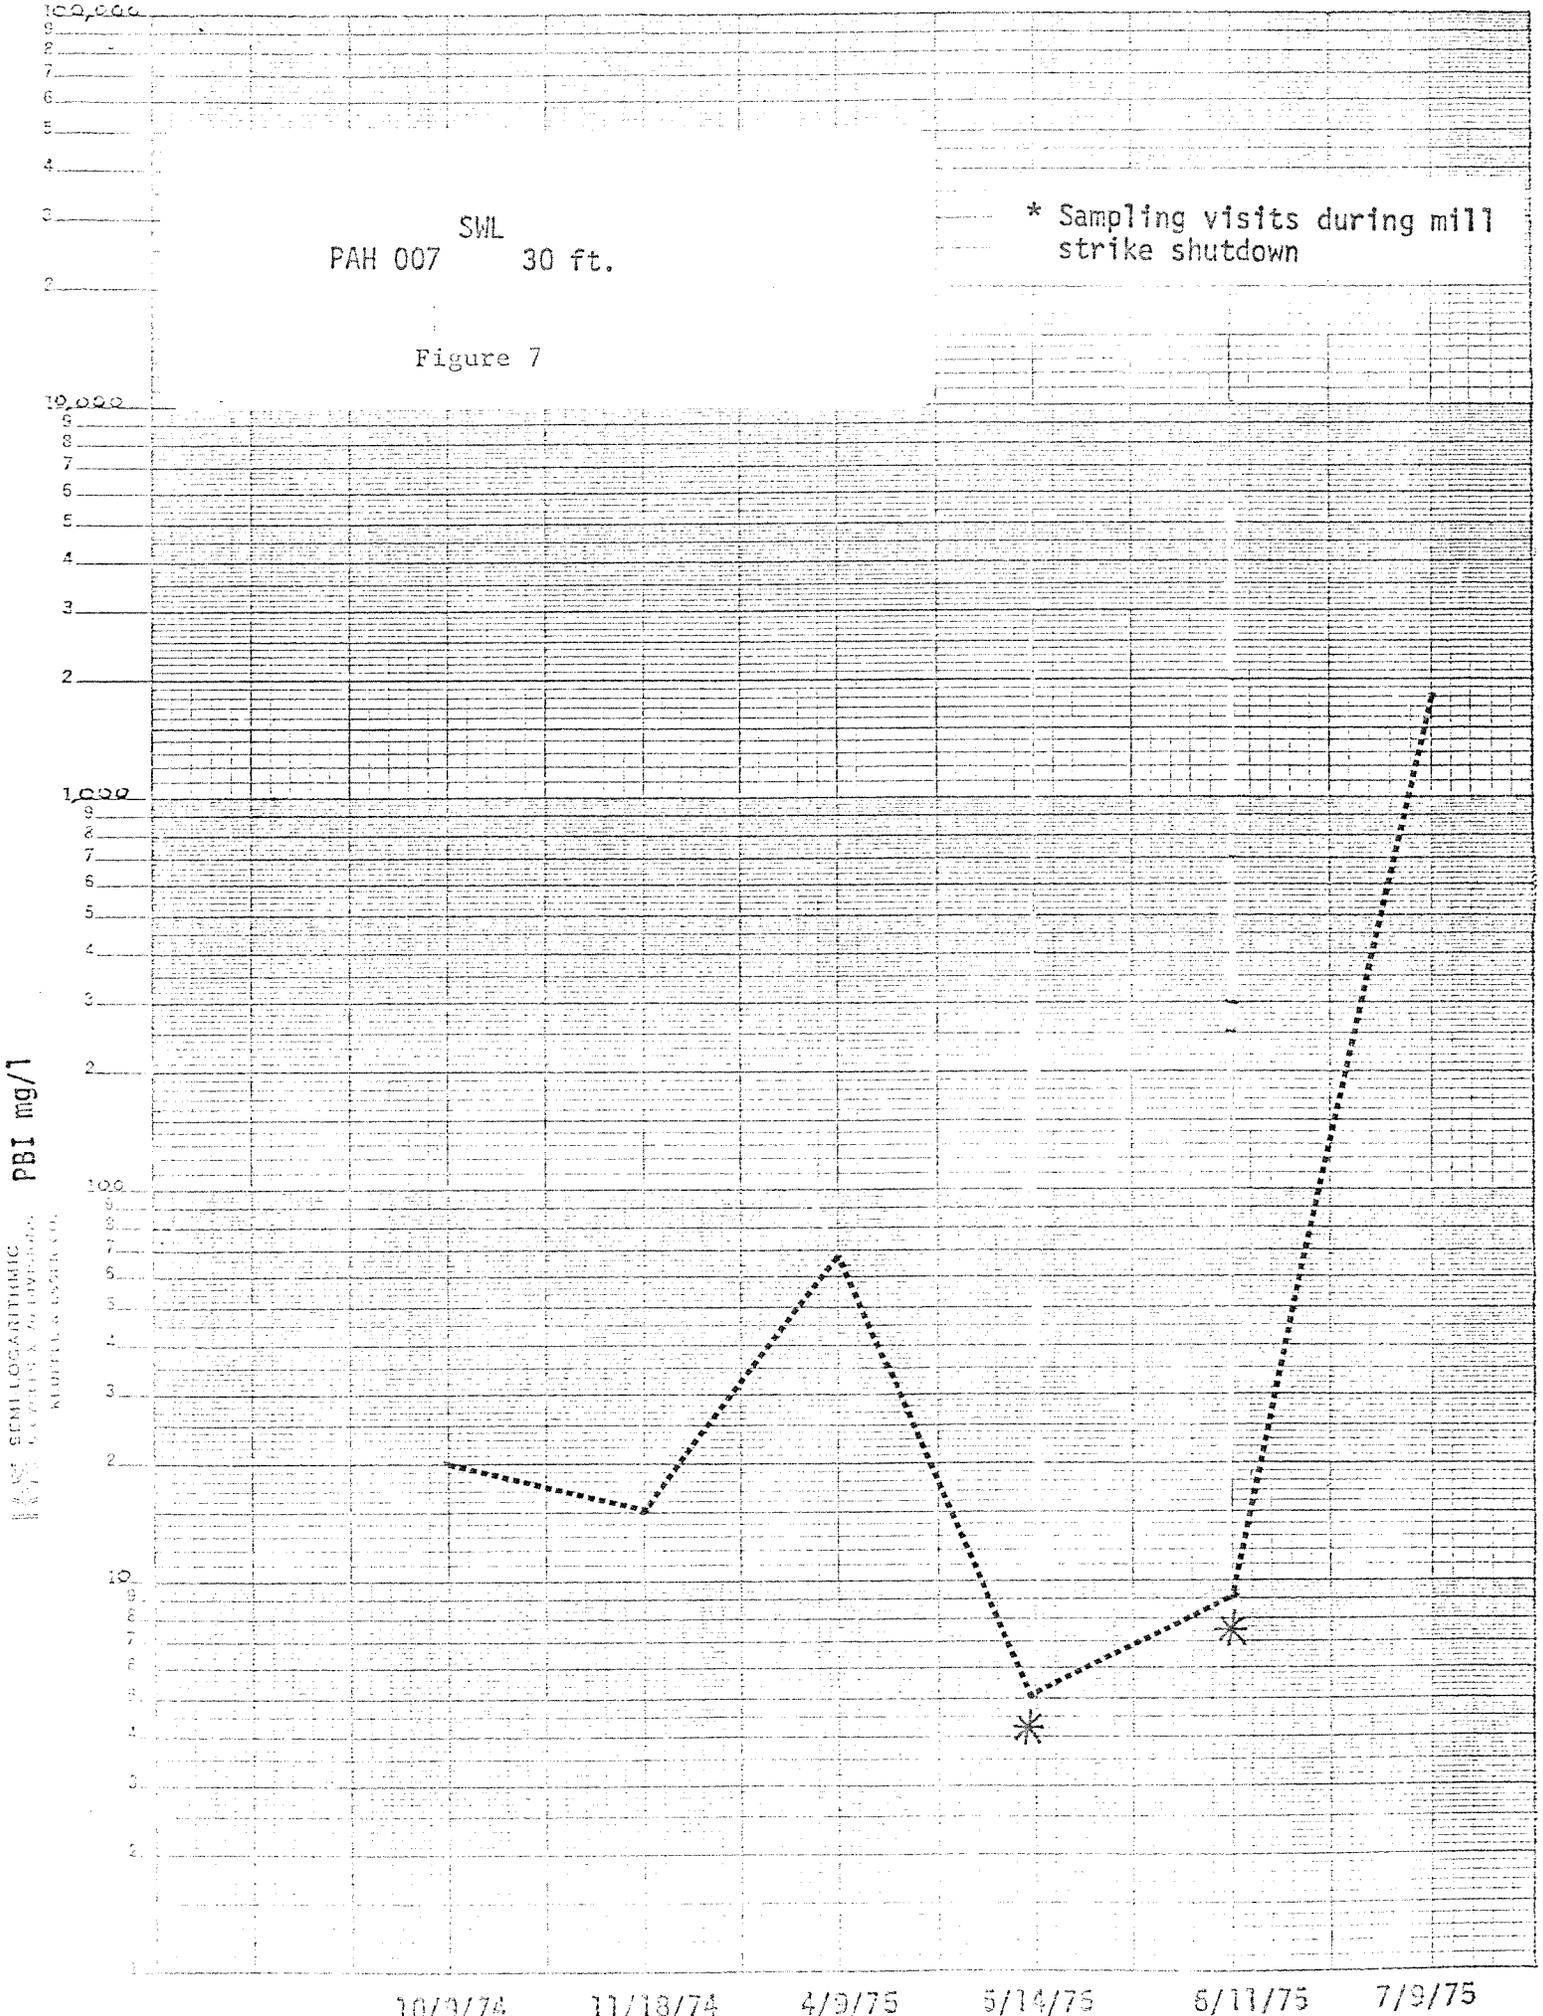
During the mill shutdown both PAH 007 and PAH 006 had low values on the surface and depth samples. This can be seen on Figures 4 - 7. The highest value of the samples during this time was 18 mg/L SWL. The NH_3 values also show low values during mill closure, the highest being .02 ppm. When the mill was reactivated the values on PAH 007 increased to 22 ppm on the surface and 5.6 ppm on the 30 ft. depth sample. This may be seen on Plates 8 and 9. As this is being written before the next scheduled sampling for the area, it is unknown if this condition is continuing.
