# Coastal Erosion Management Strategy

## Management Options for Unstable Coastal Bluffs in Puget Sound, Washington

Coastal Erosion Management Studies, Volume 8

August 1994  
94-81

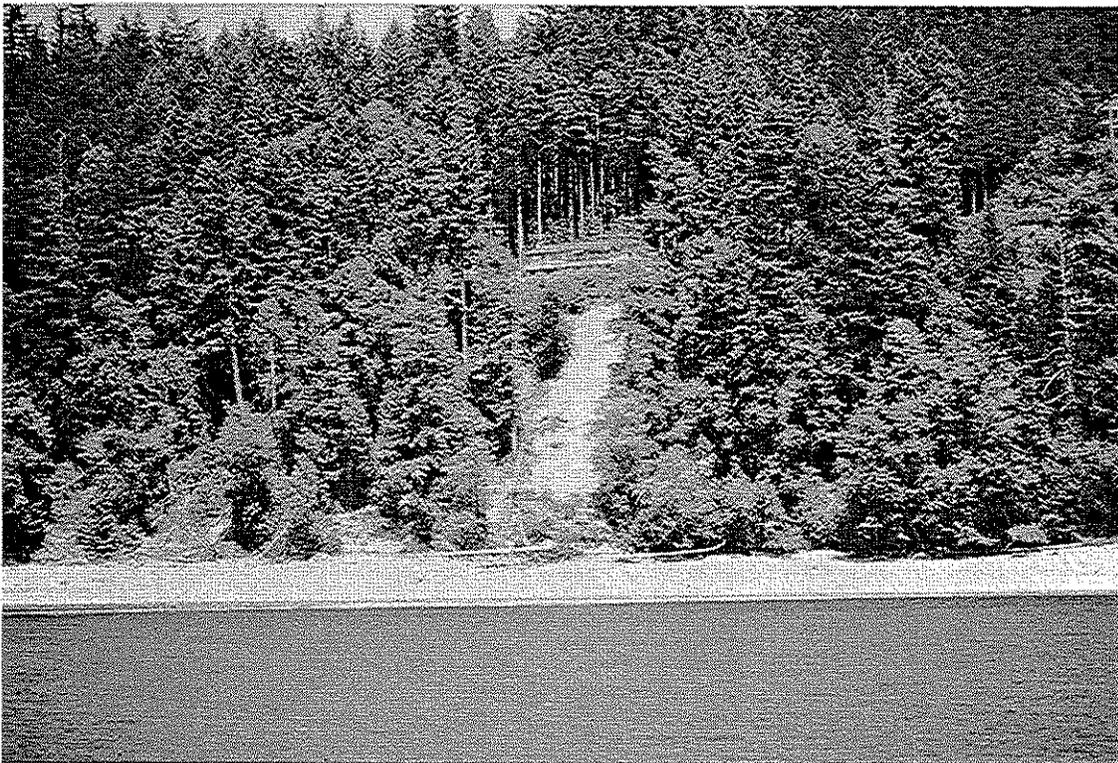
**Thurston County:** Debris slide-debris avalanche immediately below a bluff homesite.

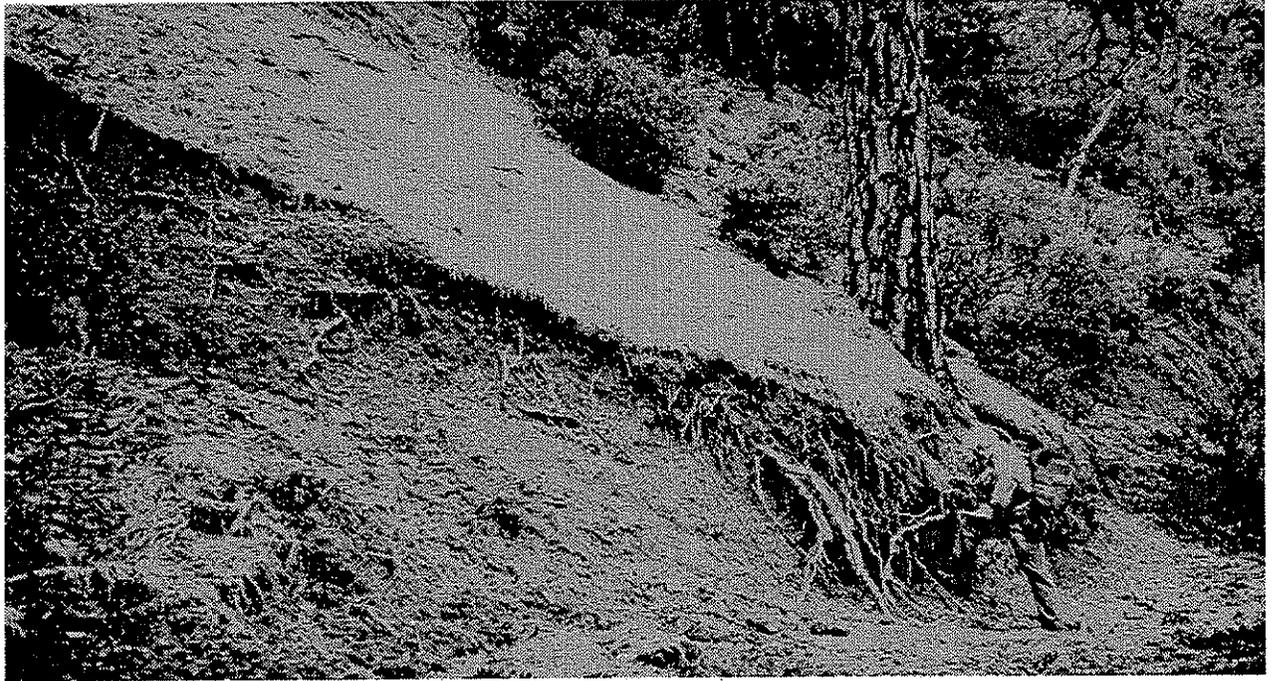
Slope buttressing by ponderosa pine, Mendocino National Forest, California  
Unbuttressed slope to the left has failed

The examples outlined above, along with other theoretical and experimental studies, clearly demonstrate that woody vegetation increases the soil shear resistance through root reinforcement, soil moisture depletion, and soil arching. All of these effects can enhance the stability of Puget Sound's coastal bank and bluff slopes. Gray and Leiser (1982) cite additional evidence from numerous studies of forest clear-cuts on watershed slopes in the Oregon western Cascades and elsewhere. Loss of rooting strength and increased soil moisture
