Publication No. 73-e40

MEMO TO: Bill Burwell
FROM: Ron Devitt *Red*
SUBJECT: Ace Galvanizing & Advance Electroplating

State of
Washington
Department
of Ecology

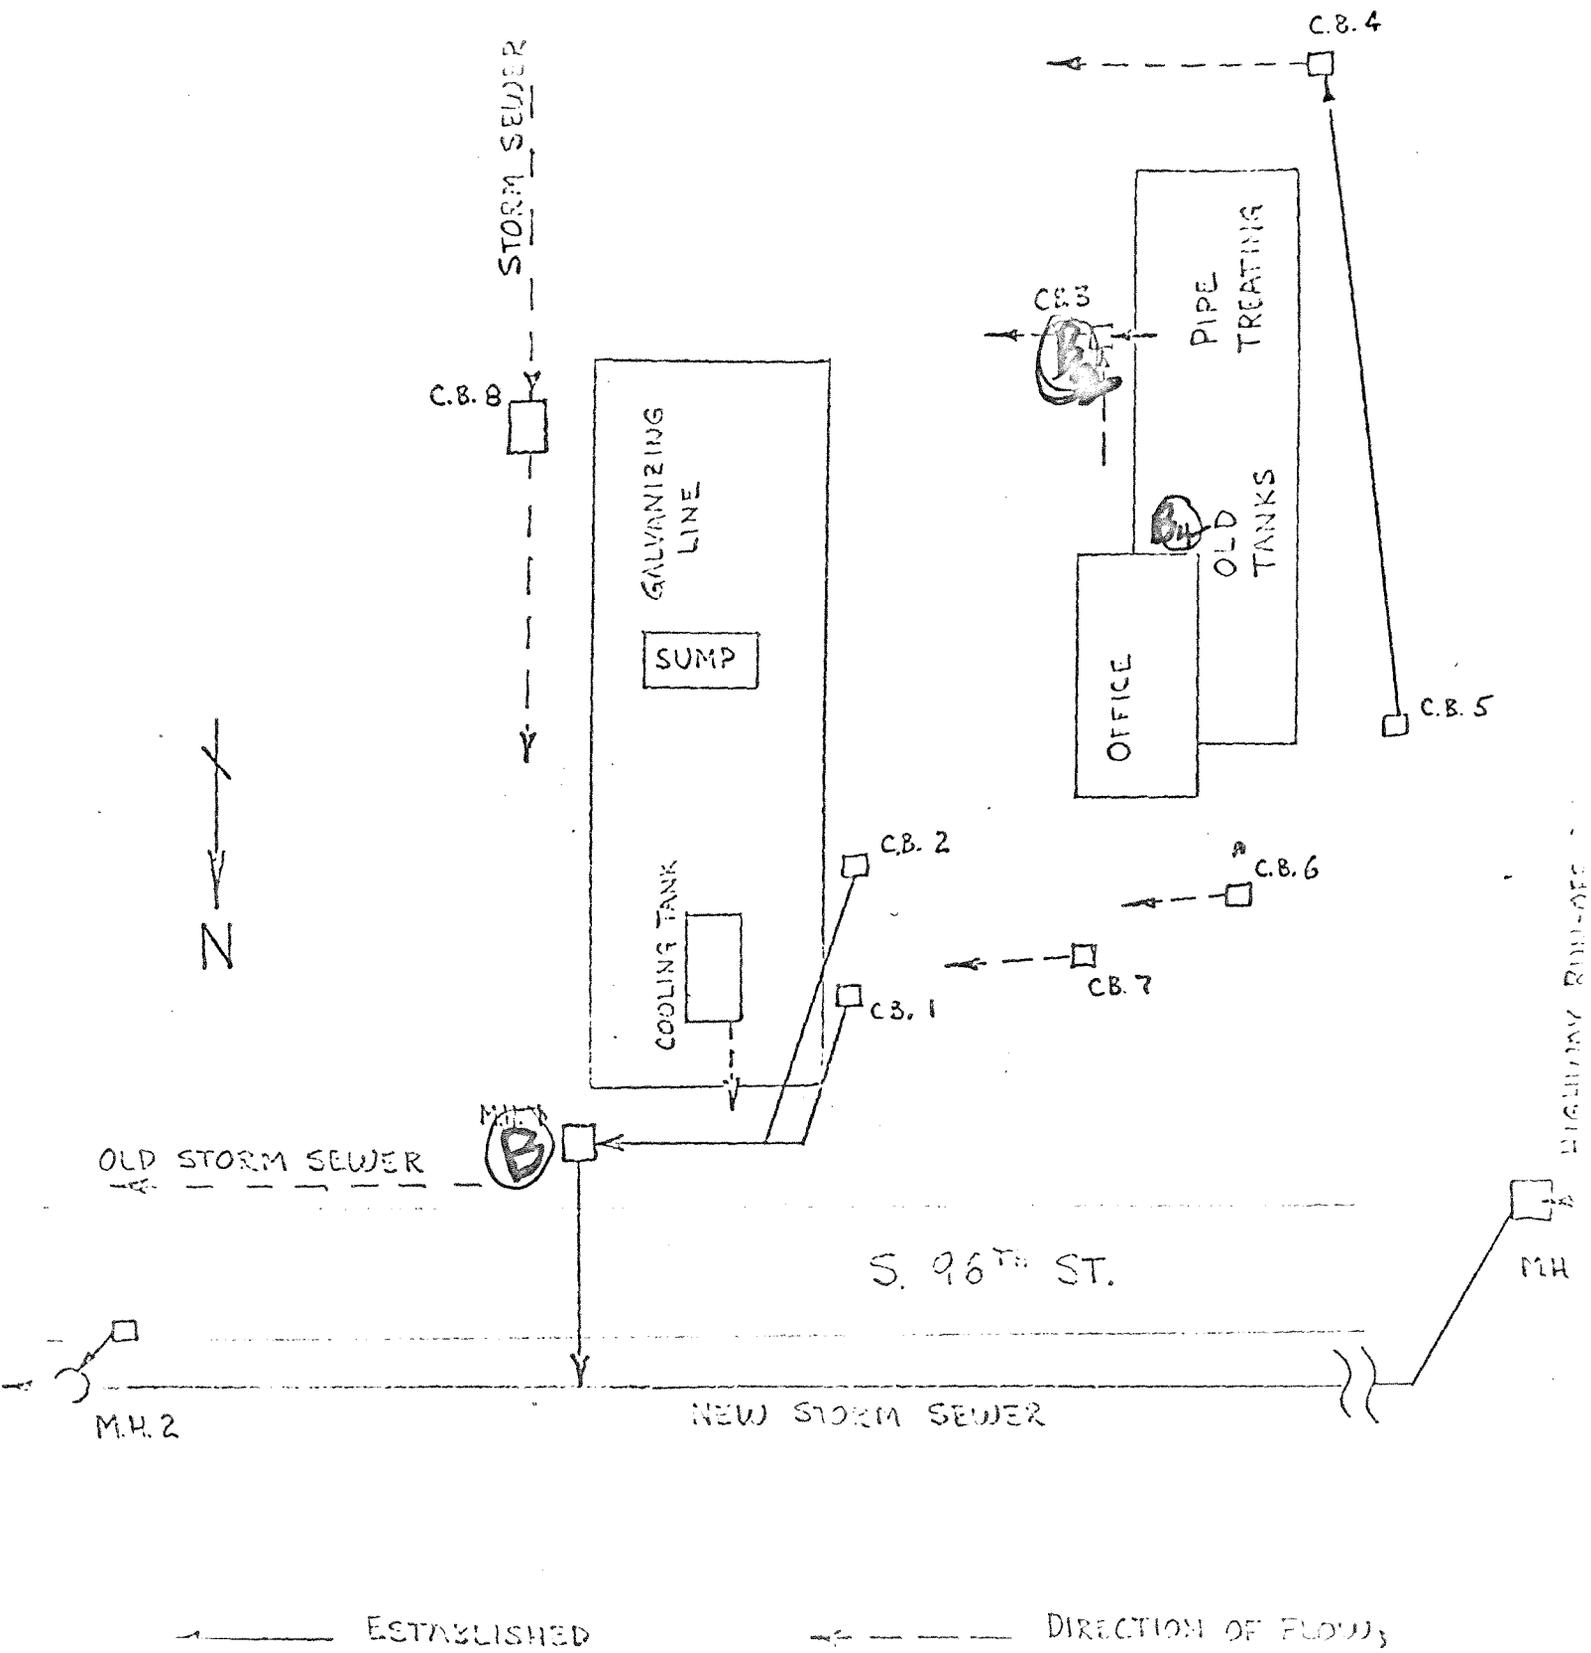
The following sampling locations were sampled as indicated by the attached schematic diagram:

<u>Station</u>	<u>Location</u>
A	@ intersection of S. 96th Street and 4th Avenue S. behind cyclone fence - large pipe. (Upstream control)
B*	Sump @ N.E. corner of Ace Galvanizing (Partial discharge)
B-1	Well Water used by Ace Galvanizing - (raw water control).
B-2	Industrial water discharge from metal cleansing area.
