MEMORANDUM

Publication No. 71-e05

SUBJECT: Tulalip Sanitary Landfill

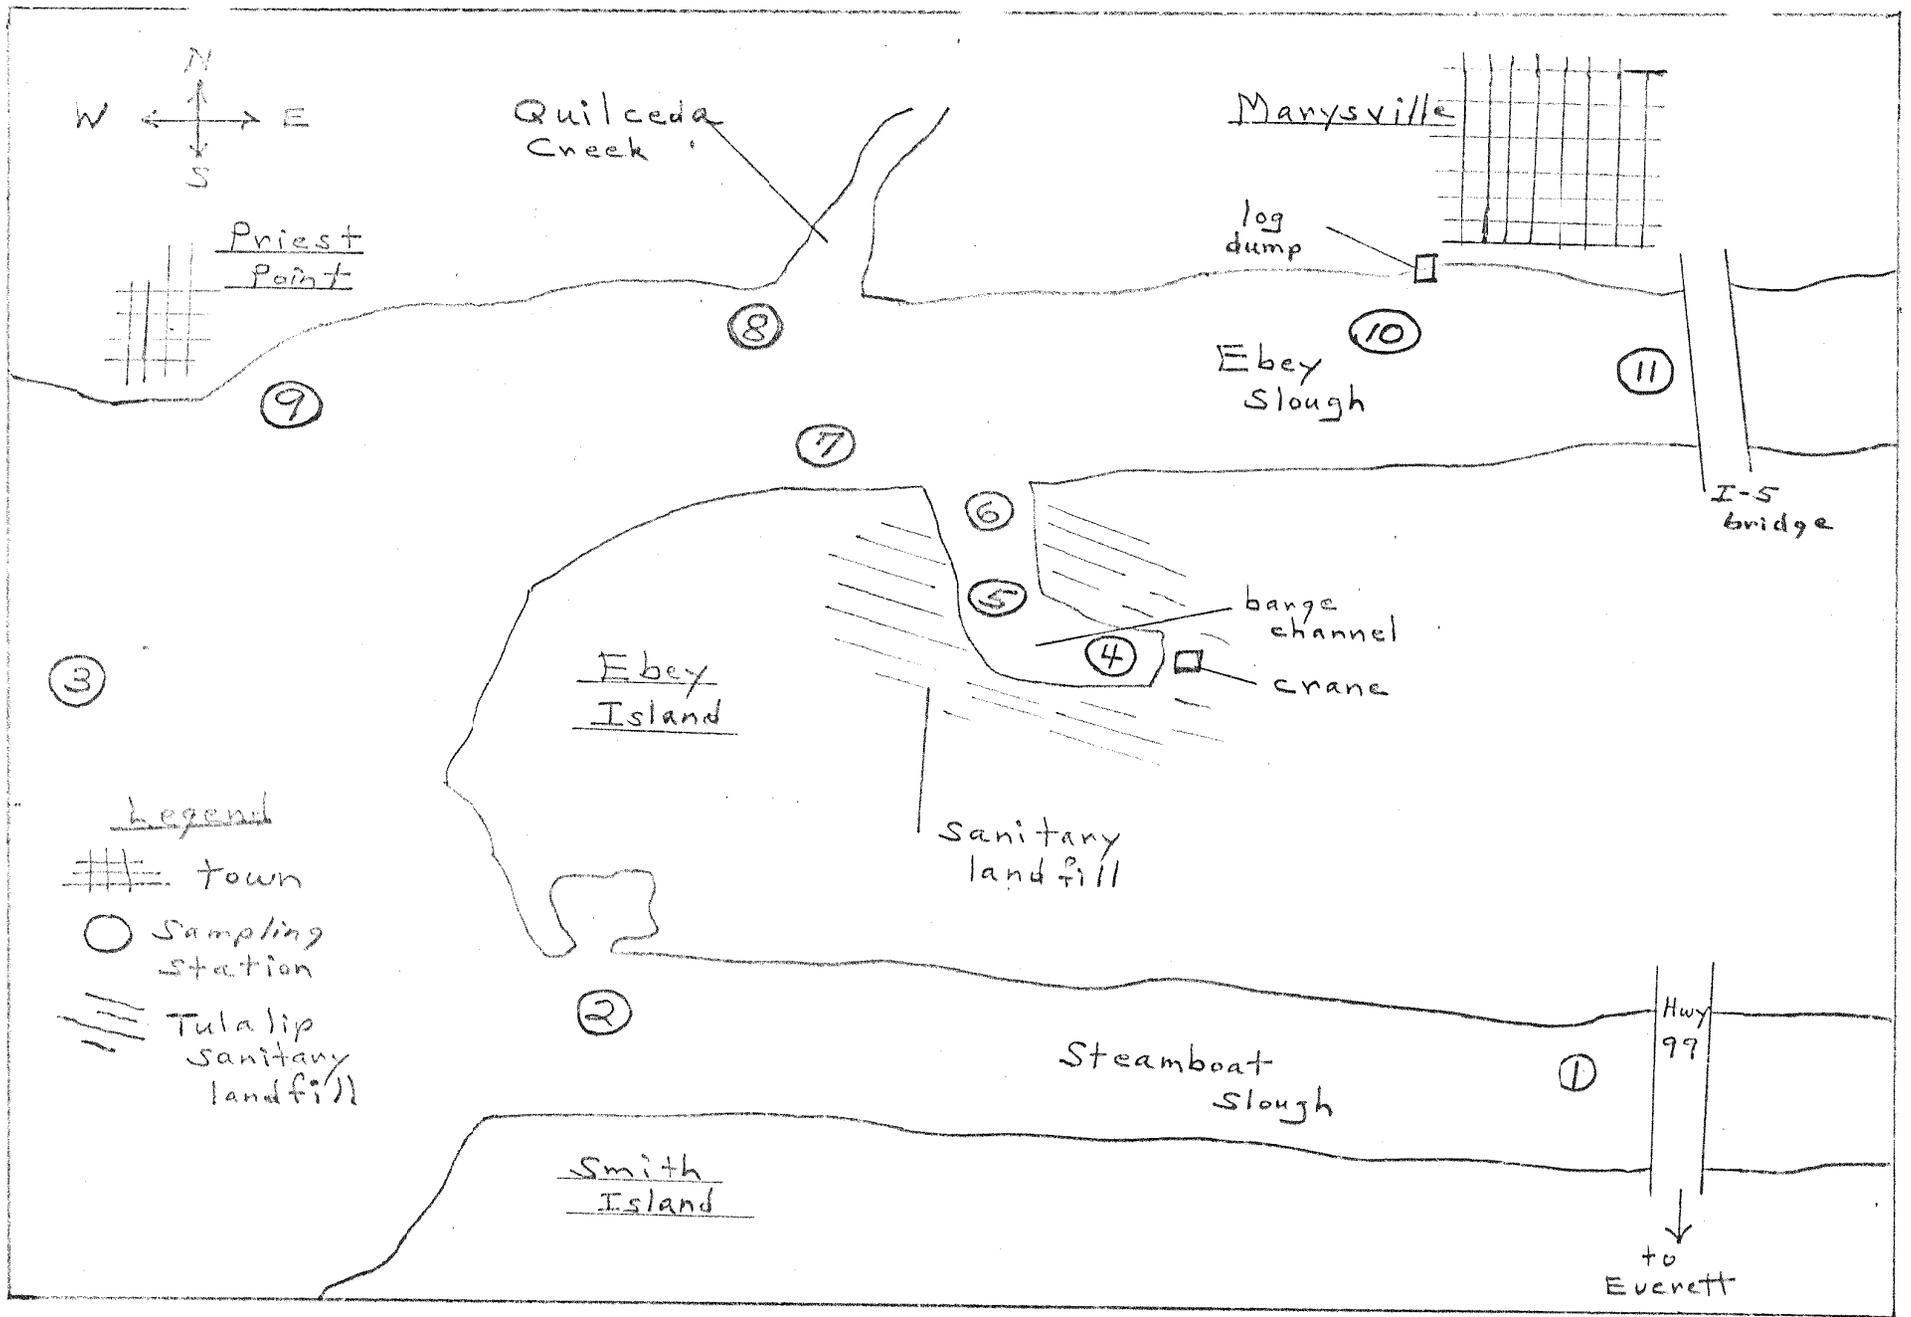
Figure 1. Illustration of sampling stations and landmarks for the Tulalip Sanitary Landfill Survey

Eleven stations were sampled during the day; Figures 1 and 2. The barge channel was about 200 feet wide and 300 yards long. Station 4 was 100 feet from the channel head, Station 5, 150 yards from the mouth, and 6, 30 feet up-channel from the mouth. Barges can only enter at high tide. Station 3, about one mile west of Ebey Island, and 1 and 2 in Steamboat Slough were designated as control stations. The entire sampling area is tide influenced, estuarine water. High tide was 7.4 feet at 1000 hours; the low of 2.8 feet was at 1600 hours. Sampling was conducted from 1000 hours to 1800 hours, field and lab measurements and tests were run; Tables 1 and 2.

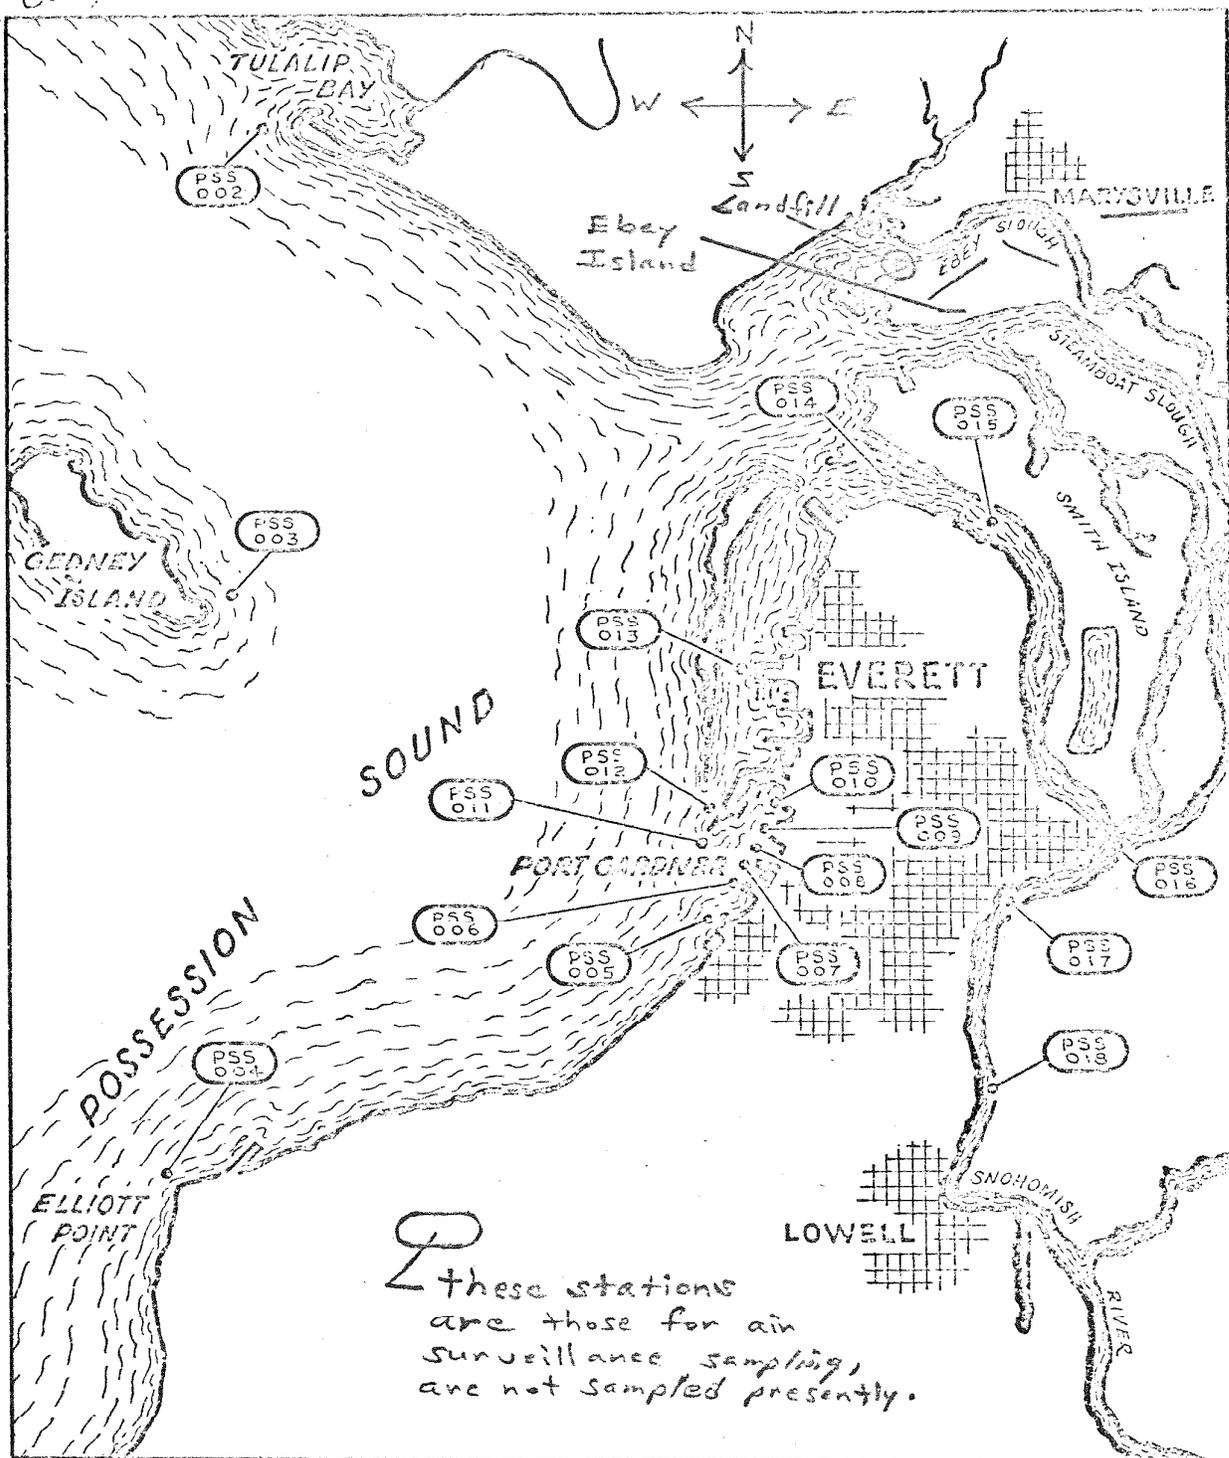
Figure 2. Relative location of Ebey Island to related landmarks.
